Our ref: 11220832-01

12 April 2021

Re: Terrain Analysis, Septic Assessment and Percolation Rate Evaluation
Proposed Commercial Development
Rideau Road and Somme Street
Gloucester Con 6 from Rideau River, Lot 26, Ottawa, Ontario

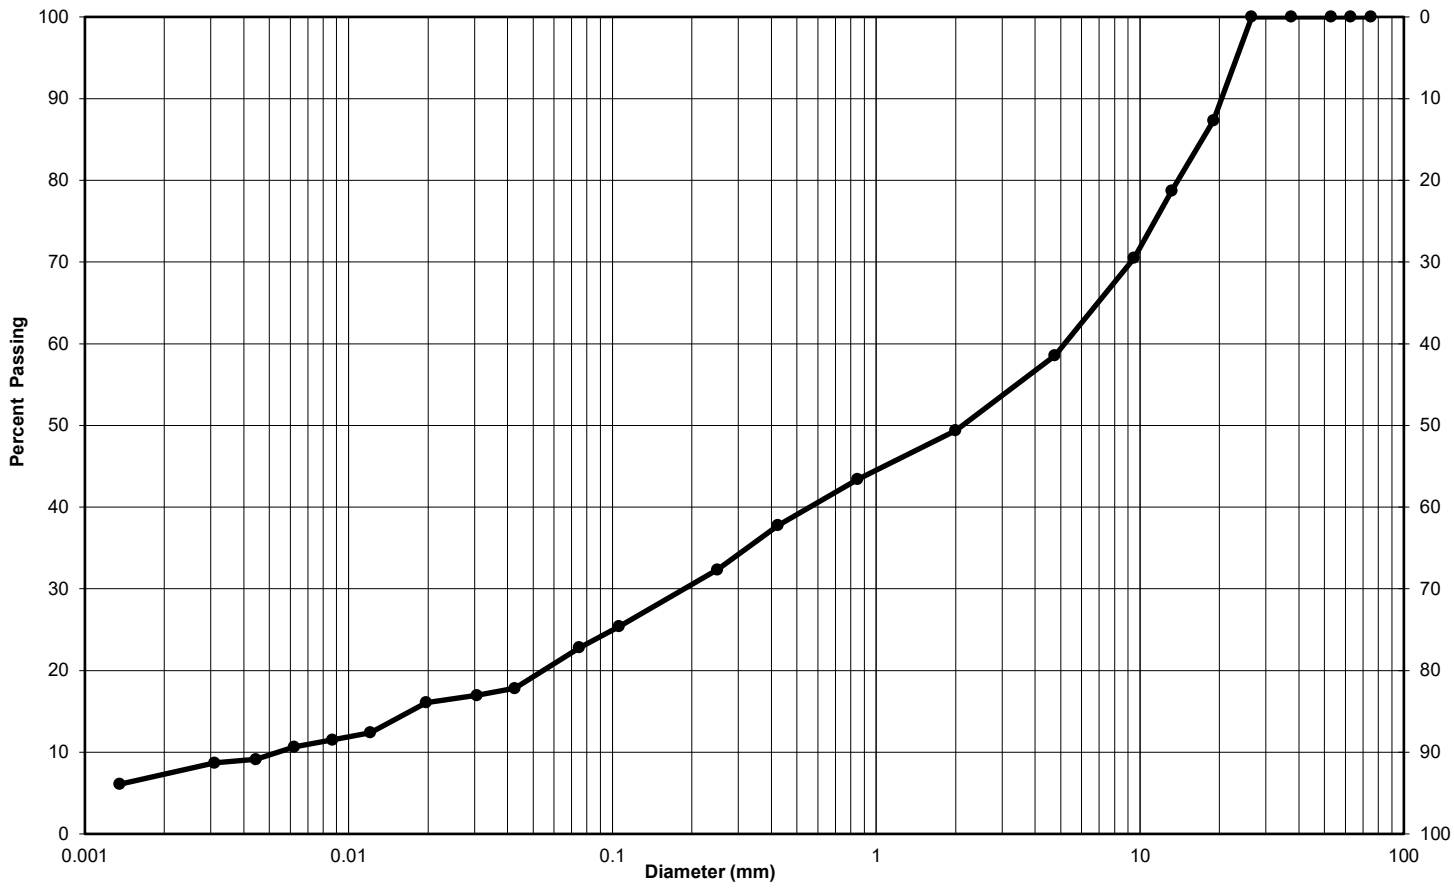
Borehole no.:	TP1	Sample no.:	GS2
Depth:	1.8 - 2.1 m	Enclosure:	A-7

Soil Description	Gravel (%)	Sand (%)	Clay & Silt (%)
	41	36	23
Silt-size particles (%):	16		
Clay-size particles (%) (<0.002mm):	7

Remarks: Moisture Content = 8.7% as per, ASTM D2216.

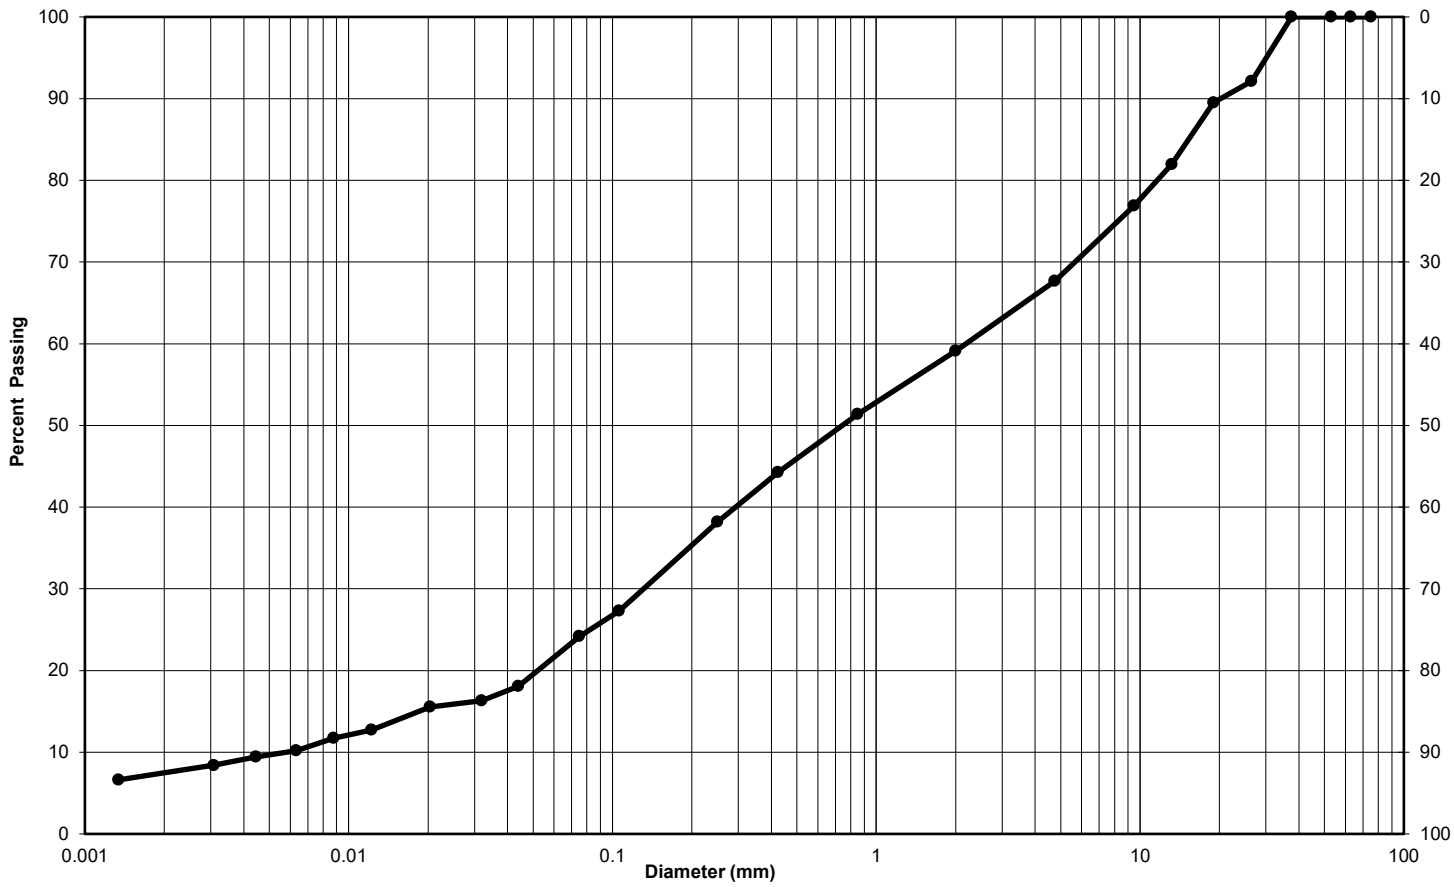
Borehole no.:	TP4	Sample no.:	GS1
Depth:	0.9 - 1.2 m	Enclosure:	A-8

Soil Description	Gravel (%)	Sand (%)	Clay & Silt (%)
	32	44	24
Silt-size particles (%):	17		
Clay-size particles (%) (<0.002mm):	7

Remarks: Moisture Content = 10.6% as per, ASTM D2216.

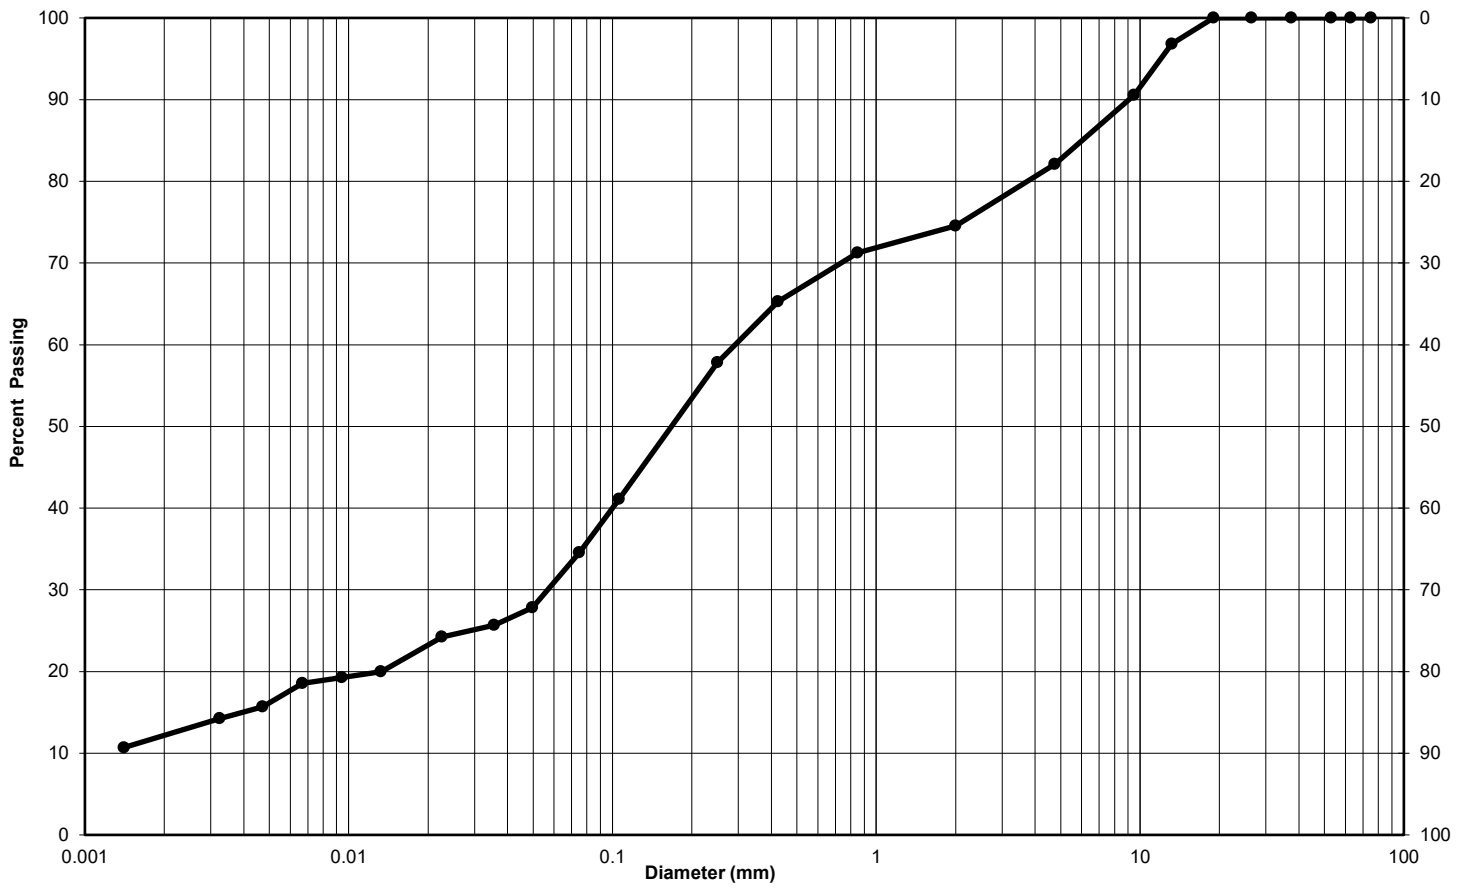
Borehole no.:	TP5	Sample no.:	GS2
Depth:	2.75 - 3.05 m	Enclosure:	A-9

Soil Description	Gravel (%)	Sand (%)	Clay & Silt (%)
	18	47	35
Silt-size particles (%):	23		
Clay-size particles (%) (<0.002mm):	12

Remarks: Moisture Content = 22.4% as per, ASTM D2216.
