Phase I - Environmental Site Assessment

1649 Montreal Road & 741 Blair Road
Ottawa, Ontario

October 9, 2020

Report: PE5061-1

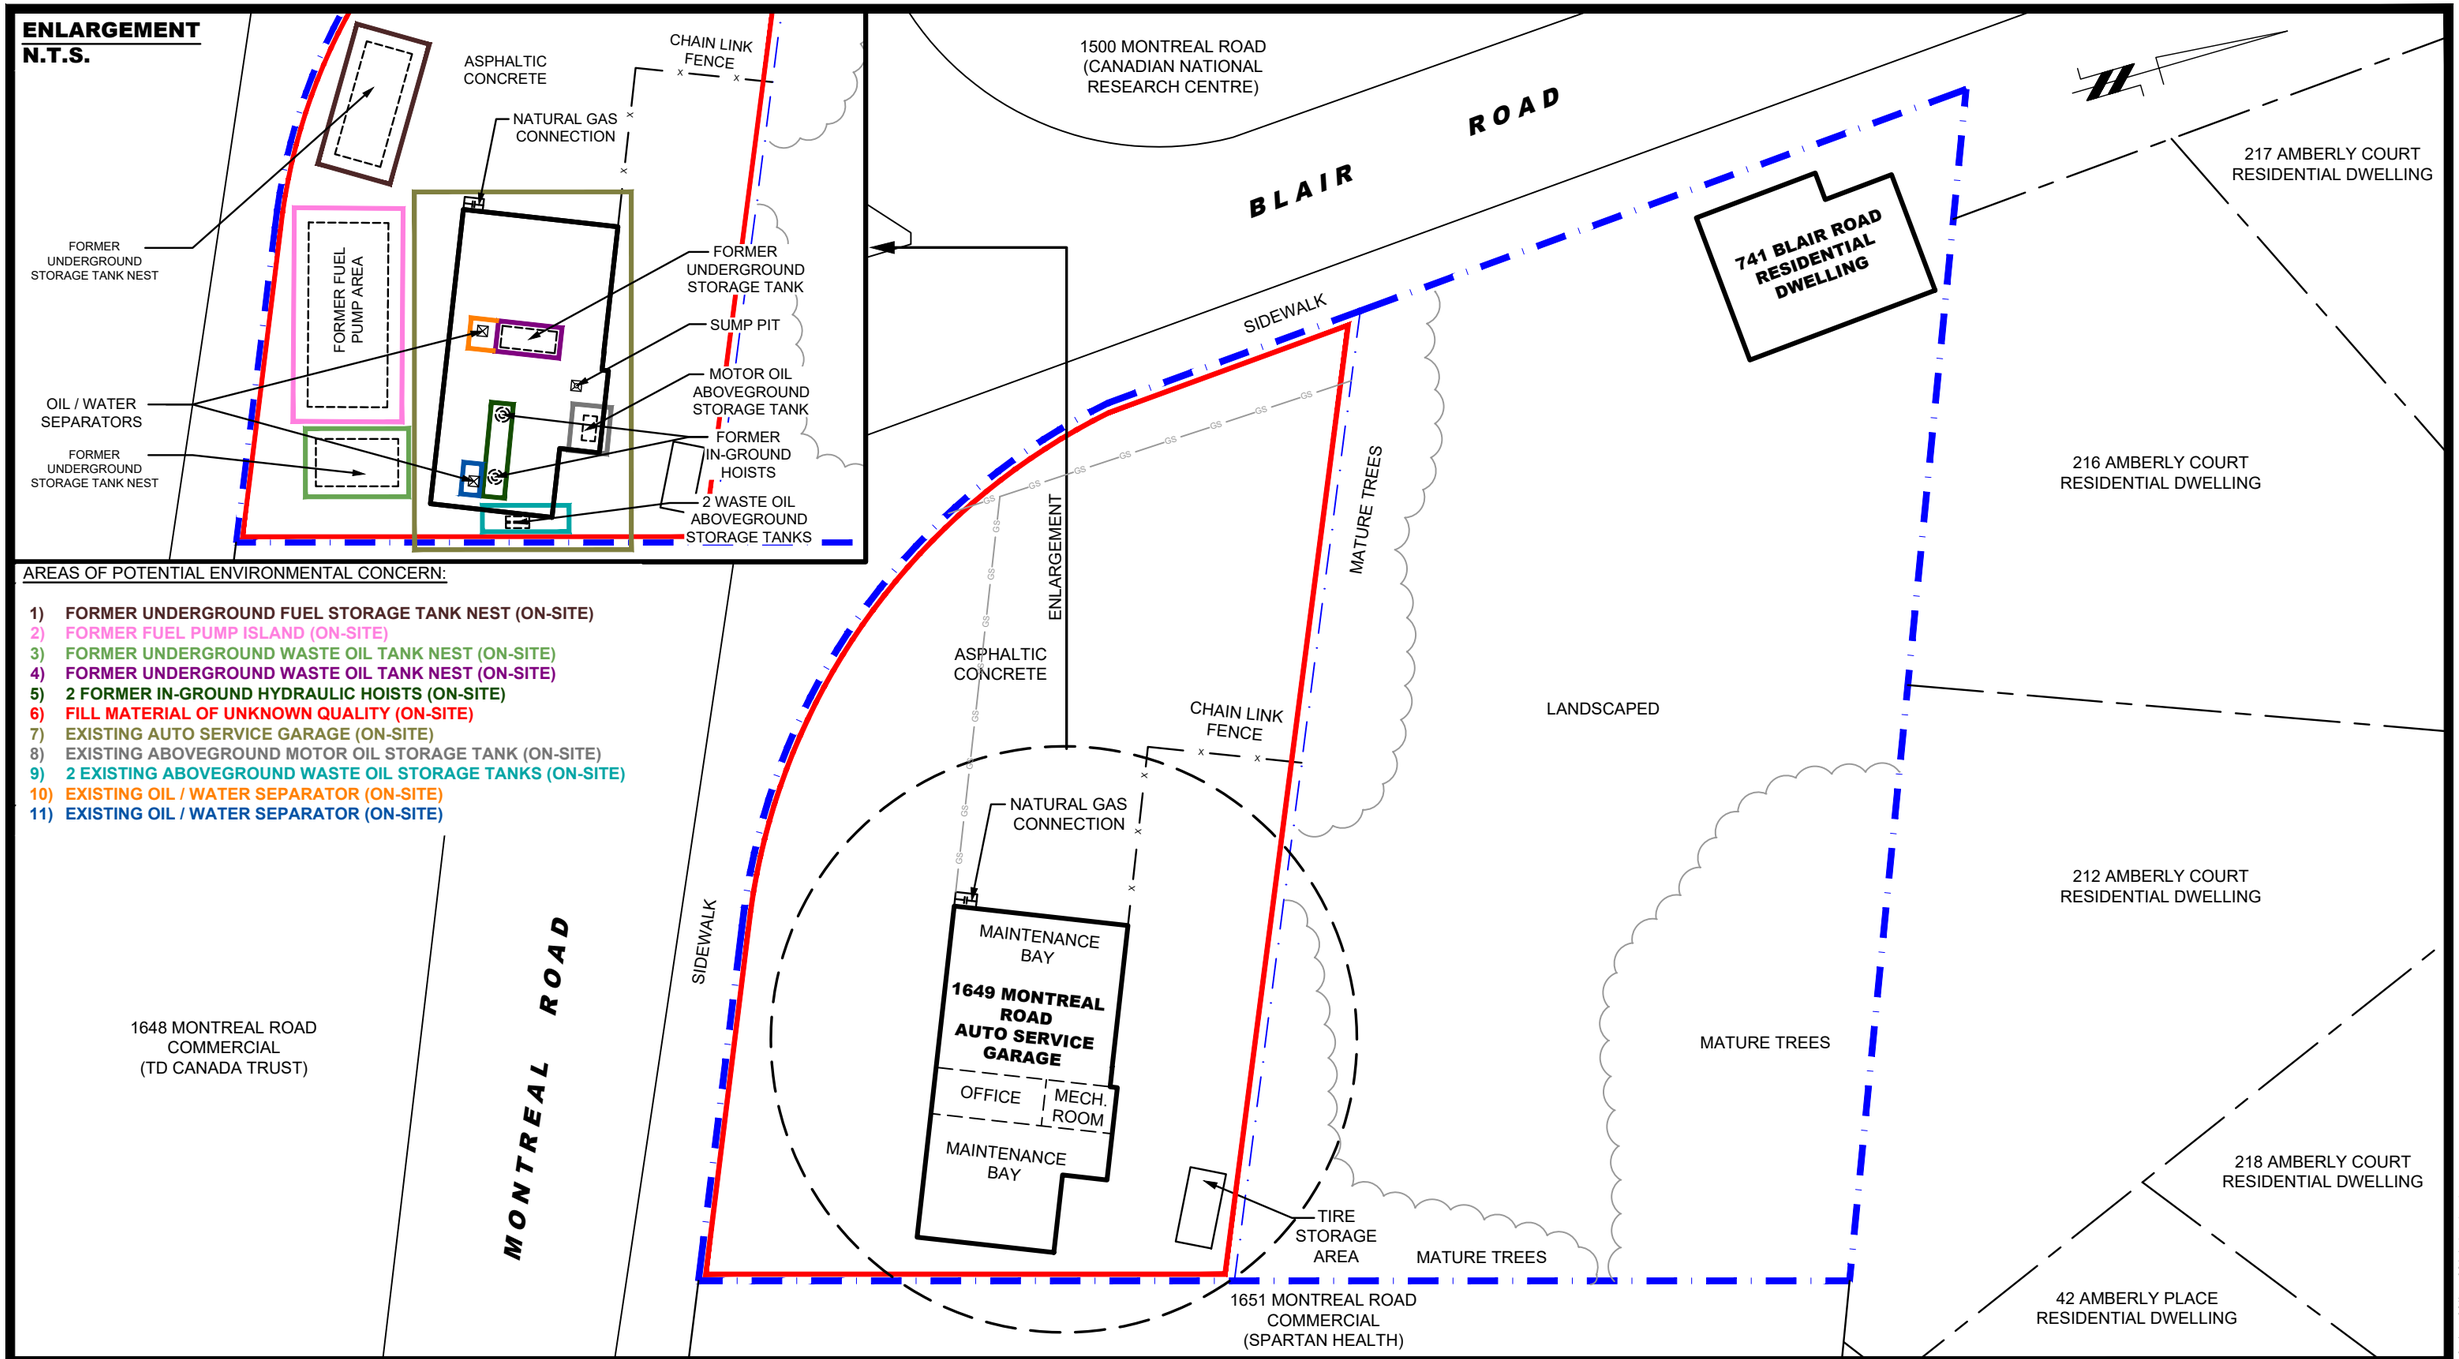
DRAWING PE5061-1 – SITE PLAN

AREAS OF POTENTIAL ENVIRONMENTAL CONCERN:

1) FORMER UNDERGROUND FUEL STORAGE TANK NEST (ON-SITE)
2) FORMER FUEL PUMP ISLAND (ON-SITE)
3) FORMER UNDERGROUND WASTE OIL TANK NEST (ON-SITE)
4) FORMER UNDERGROUND WASTE OIL TANK NEST (ON-SITE)
5) 2 FORMER IN-GROUND HYDRAULIC HOISTS (ON-SITE)
6) FILL MATERIAL OF UNKNOWN QUALITY (ON-SITE)
7) EXISTING AUTO SERVICE GARAGE (ON-SITE)
8) EXISTING ABOVEGROUND MOTOR OIL STORAGE TANK (ON-SITE)
9) 2 EXISTING ABOVEGROUND WASTE OIL STORAGE TANKS (ON-SITE)
10) EXISTING OIL / WATER SEPARATOR (ON-SITE)
11) EXISTING OIL / WATER SEPARATOR (ON-SITE)

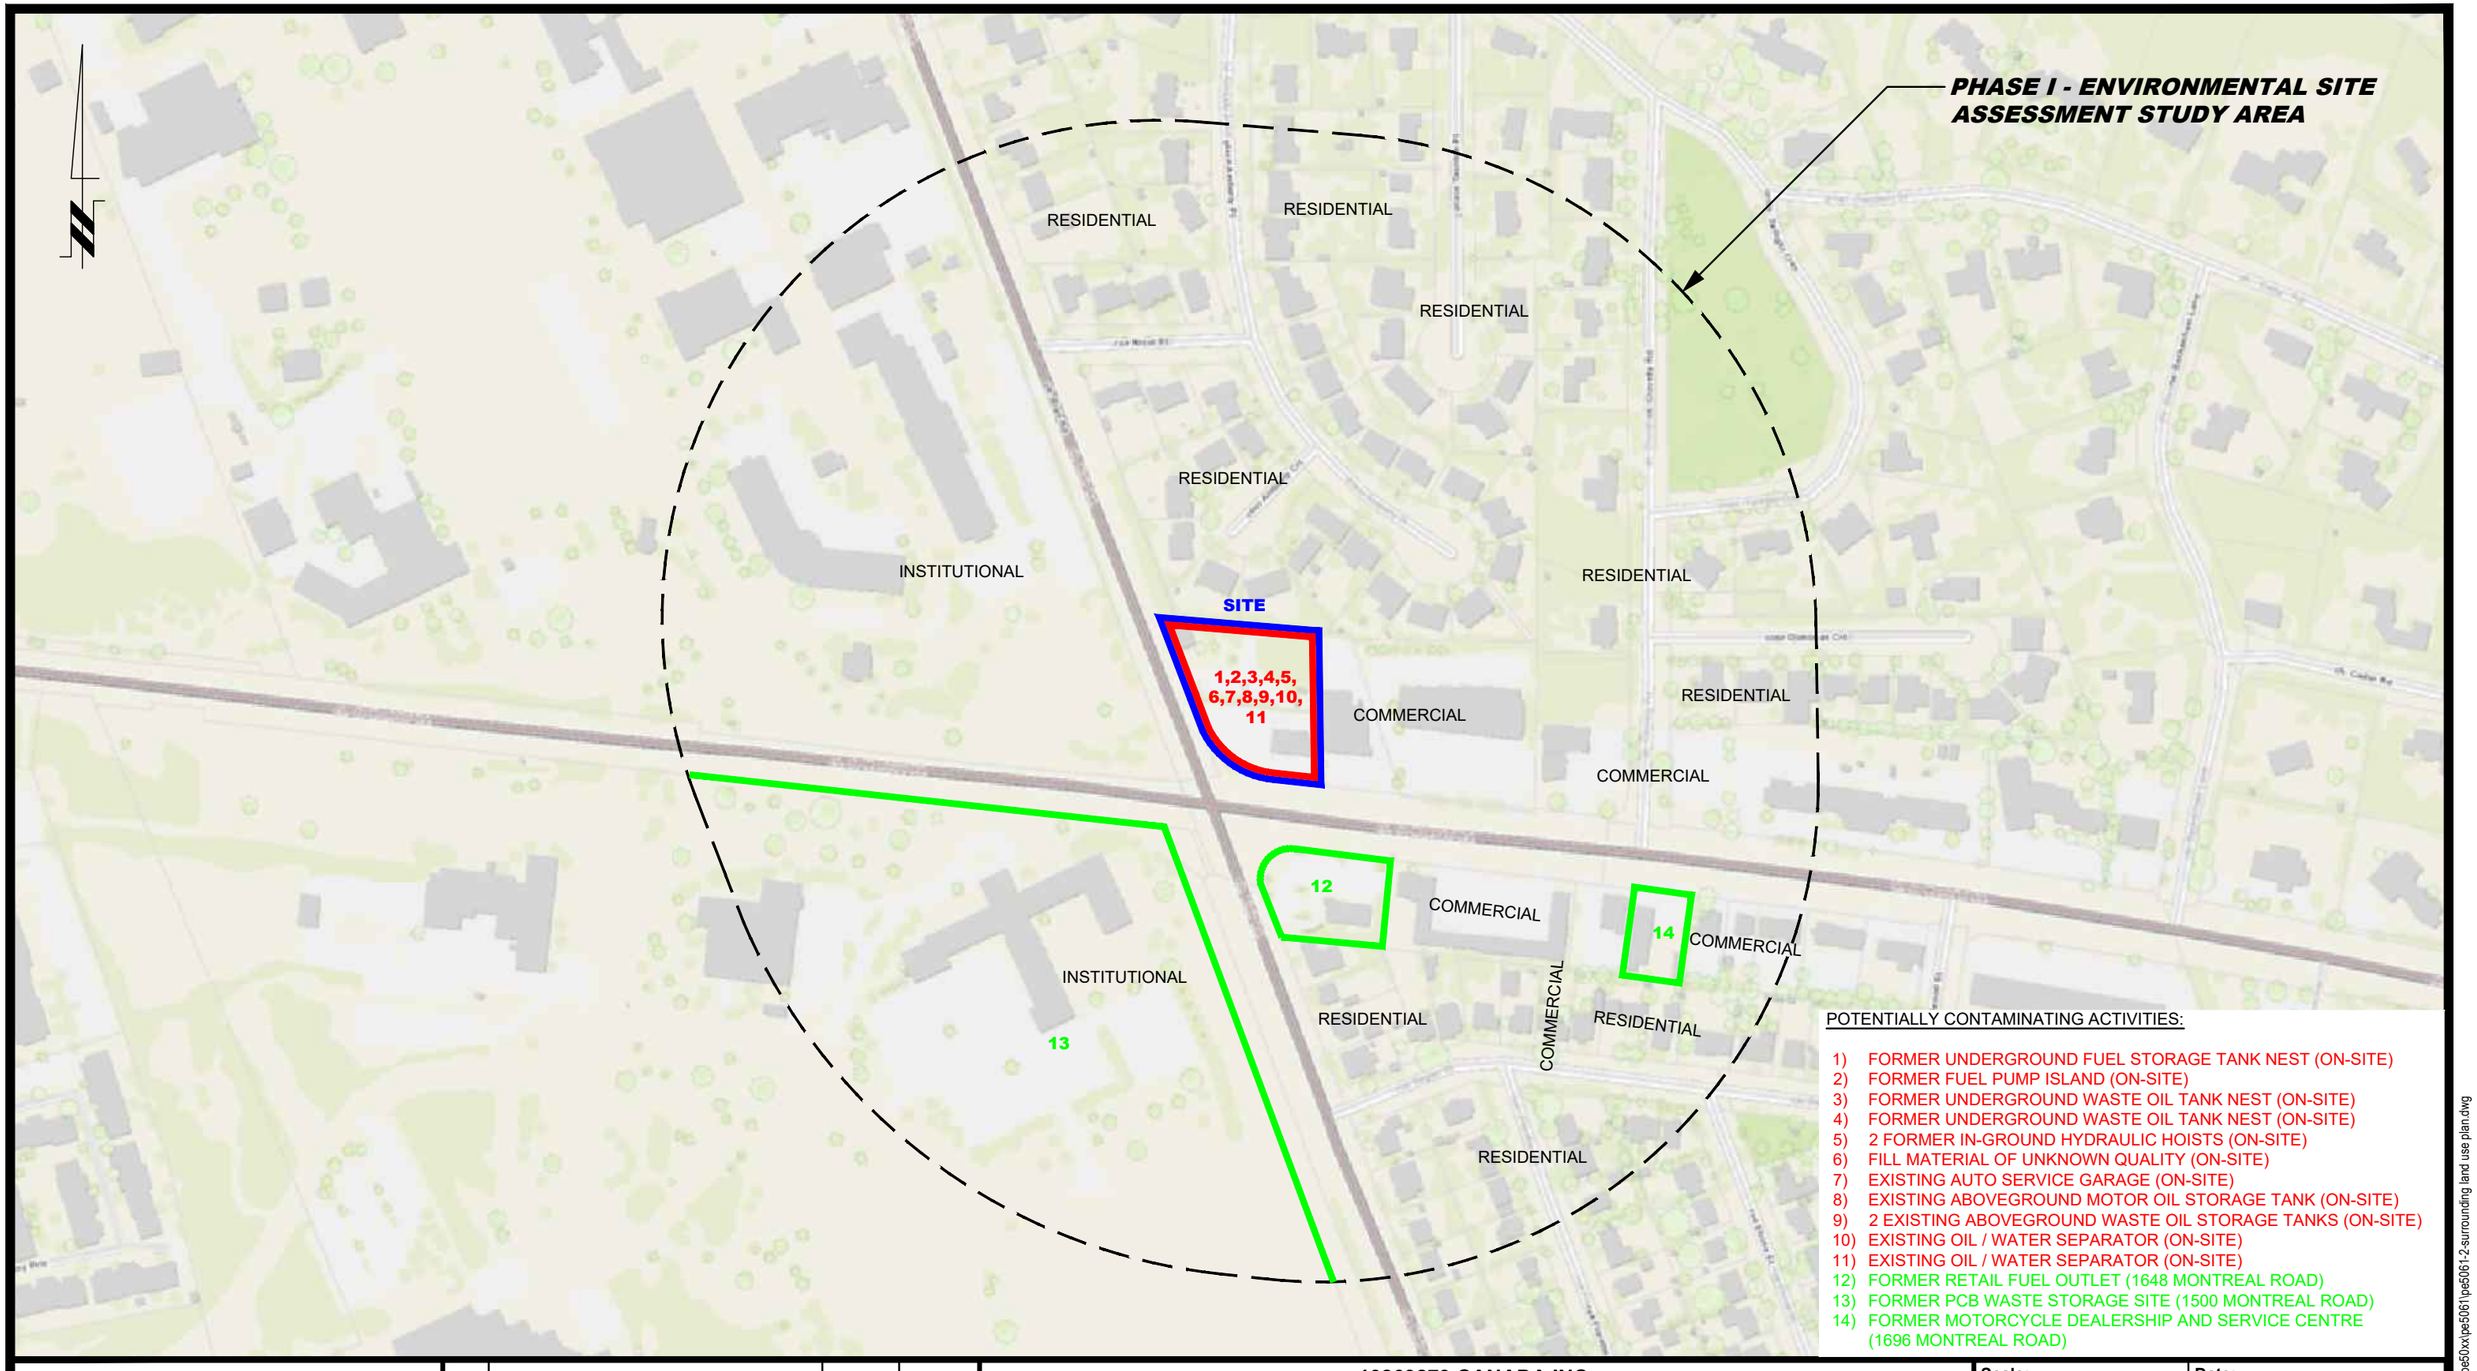
DRAWING PE5061-2 – SURROUNDING LAND USE PLAN

POTENTIALLY CONTAMINATING ACTIVITIES:

1) FORMER UNDERGROUND FUEL STORAGE TANK NEST (ON-SITE)
2) FORMER FUEL PUMP ISLAND (ON-SITE)
3) FORMER UNDERGROUND WASTE OIL TANK NEST (ON-SITE)
4) FORMER UNDERGROUND WASTE OIL TANK NEST (ON-SITE)
5) 2 FORMER IN-GROUND HYDRAULIC HOISTS (ON-SITE)
6) FILL MATERIAL OF UNKNOWN QUALITY (ON-SITE)
7) EXISTING AUTO SERVICE GARAGE (ON-SITE)
8) EXISTING ABOVEGROUND MOTOR OIL STORAGE TANK (ON-SITE)
9) 2 EXISTING ABOVEGROUND WASTE OIL STORAGE TANKS (ON-SITE)
10) EXISTING OIL / WATER SEPARATOR (ON-SITE)
11) EXISTING OIL / WATER SEPARATOR (ON-SITE)
12) FORMER RETAIL FUEL OUTLET (1648 MONTREAL ROAD)
13) FORMER PCB WASTE STORAGE SITE (1500 MONTREAL ROAD)
14) FORMER MOTORCYCLE DEALERSHIP AND SERVICE CENTRE (1696 MONTREAL ROAD)

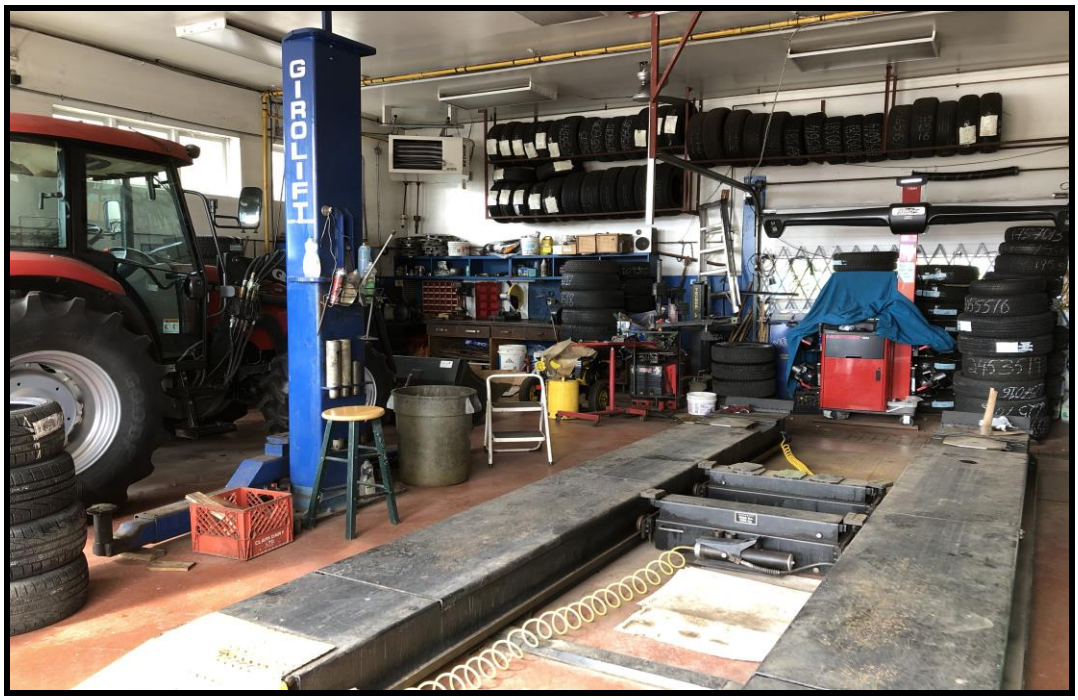
Photograph 4: View of the interior of the western portion of auto service garage, facing north.

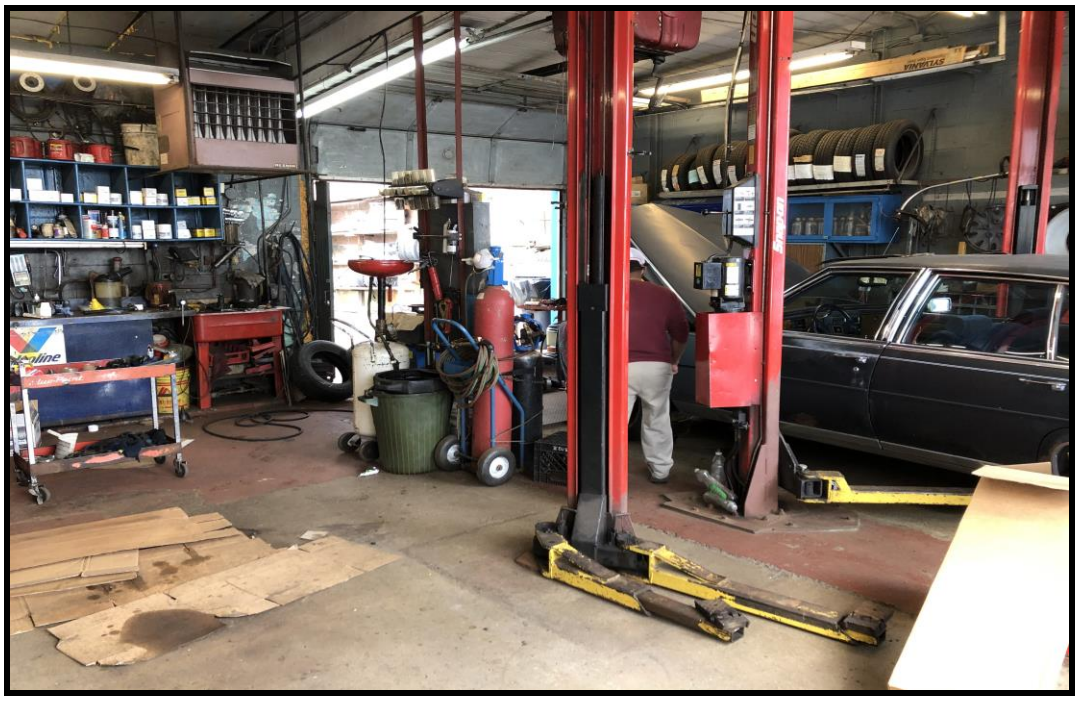
One (1) aboveground oil storage tank was identified within maintenance bay of the auto service garage (1649 Montreal Road). The tank was noted to be constructed with a single 2 mm thick steel wall and contained a capacity for 1,000 L of motor oil. The tank was noted to be in good condition, with no signs of leaks or stains observed at the time of the site inspection. The underlying floor was observed to consist of poured concrete, which was also noted to be in good condition at the time of the site inspection, with no signs of cracks visible. The presence of this oil tank is considered to represent an APEC with respect to the subject site.

Photograph 5: View of the interior of the eastern portion of the auto service garage and an aboveground motor oil storage tank, facing north.
