TREE CONSERVATION REPORT

PROJECT NAME:	359 Kent Street
PROJECT NO.	21819-1
LOCATION	359 Kent Street, Ottawa ON, K2P 0R6
DATE:	August 11, 2021

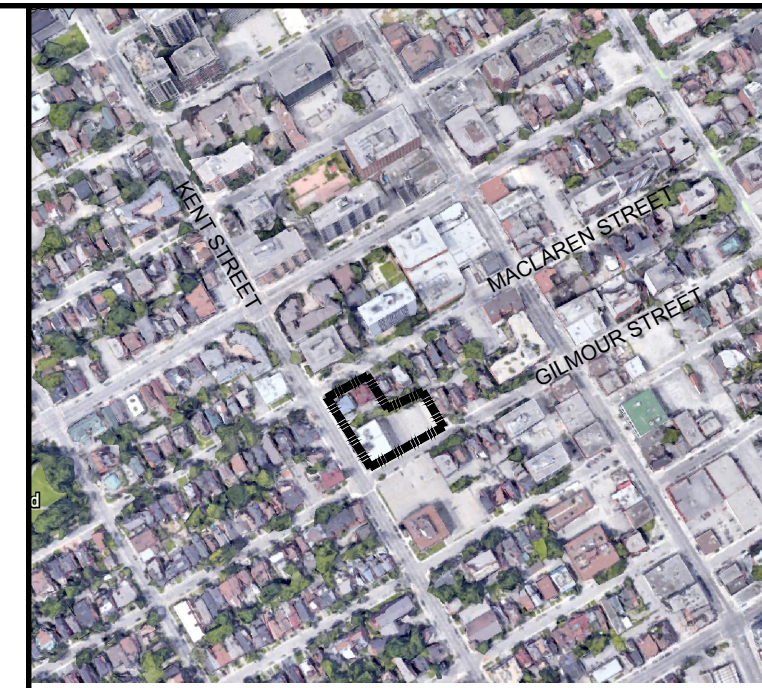
EXISTING TREES				
NO.	SPECIES	DBH (CM)	HEALTH	COMMENTS
1	Manitoba Maple / Acer negundo	17, 35	Poor	Trunk damage, wire conflict, 2 stems joined at base
2	Silver Maple / Acer saccharinum	74	Fair	Branch dieback, on adjacent property
3	Manitoba Maple / Acer negundo	20, 24	Poor	Included fence, trunk damage, 2 stems joined at base
4	Manitoba Maple / Acer negundo	15	Poor	Included fence, trunk damage
5	Manitoba Maple / Acer negundo	19	Poor	Included fence, trunk damage
6	Manitoba Maple / Acer negundo	26	Poor	Included fence, trunk damage
7	Manitoba Maple / Acer negundo	29	Poor	Included fence, trunk damage, internal rot
8	Manitoba Maple / Acer negundo	23	Poor	Included fence, trunk damage
9	Manitoba Maple / Acer negundo	17, 17, 20	Poor	Included fence, trunk damage, 3 stems joined at base
10	Manitoba Maple / Acer negundo	25, 28	Poor	Included fence, trunk damage, 2 stems joined at base
11	Manitoba Maple / Acer negundo	17	Poor	Included fence, trunk damage

12	Manitoba Maple / Acer negundo	28	Poor	Included fence, trunk damage
13	Manitoba Maple / Acer negundo	25, 30	Poor	Included fence, trunk damage, 2 stems joined at 1m
14	Manitoba Maple / Acer negundo	41, 58	Poor	Included fence, trunk damage, 2 stems joined at base, fungal fruiting bodies
15	Manitoba Maple / Acer negundo	19, 27	Fair	2 stems joined at base
16	Manitoba Maple / Acer negundo	31, 39	Poor	2 stems joined at base, longitudinal cracking
17	Crabapple / Malus sp.	10	Good	City Tree
18	Crabapple / Malus sp.	14	Good	City Tree
19	Crabapple / Malus sp.	10	Good	City Tree
20	Crabapple / Malus sp.	14	Good	City Tree
21	Crabapple / Malus sp.	14	Good	City Tree
22	Tree Lilac / Syringa reticulata	10	Good	City Tree
23	Tree Lilac / Syringa reticulata	10	Good	City Tree
24	Tree Lilac / Syringa reticulata	14	Good	City Tree
25	Tree Lilac / Syringa reticulata	10	Good	City Tree
26	Tree Lilac / Syringa reticulata	10	Good	City Tree

27	Norway Maple / Acer platanoides	38	Good	City Tree
28	Crabapple / Malus sp.	5	Good	City Tree
