## TREE CONSERVATION REPORT

| PROJECT NAME: | 359 Kent Street |
| PROJECT NO. | 21819-1 |
| DATE: | August 11, 2021 |

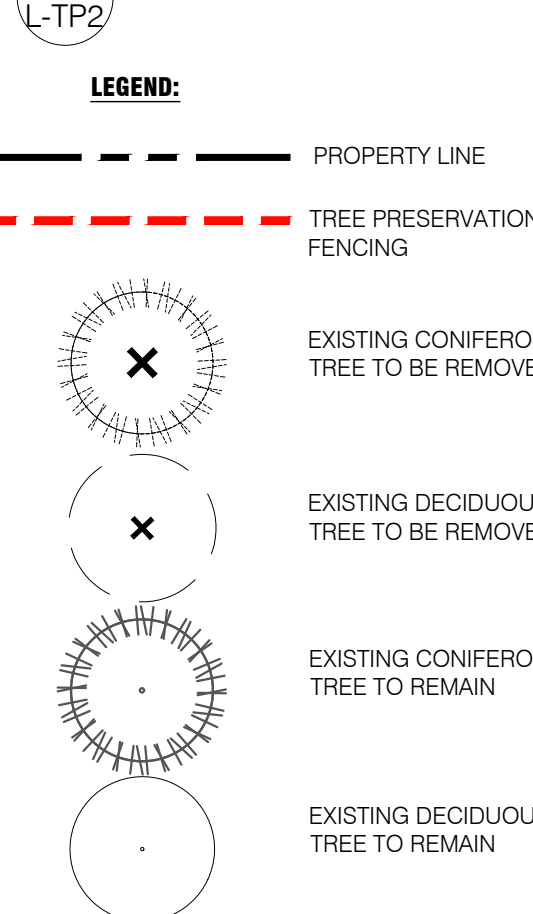
1 POST DEVELOPMENT VEGETATION

| EXISTING TREES TO BE REMOVED | | | | |
|---|---|---|---|--|
| 1 | Manitoba Maple / Acer negundo | 17, 35 | Poor | Trunk damage, wire conflict, 2 stems joined at base |
| 3 | Manitoba Maple / Acer negundo | 20, 24 | Poor | Included fence, trunk damage, 2 stems joined at base |
| 4 | Manitoba Maple / Acer negundo | 15 | Poor | Included fence, trunk damage |
| 5 | Manitoba Maple | 19 | Poor | Included fence, trunk damage |
| 6 | Manitoba Maple / Acer negundo | 26 | Poor | Included fence, trunk damage |
| 7 | Manitoba Maple / Acer negundo | 29 | Poor | Included fence, trunk damage, internal rot |
| 8 | Manitoba Maple / Acer negundo | 23 | Poor | Included fence, trunk damage |
| 9 | Manitoba Maple / Acer negundo | 17, 17, 20 | Poor | Included fence, trunk damage, 3 stems joined at base |
| 10 | Manitoba Maple / Acer negundo | 25, 28 | Poor | Included fence, trunk damage, 2 stems joined at base |
| 11 | Manitoba Maple / Acer negundo | 17 | Poor | Included fence, trunk damage |
| 12 | Manitoba Maple / Acer negundo | 28 | Poor | Included fence, trunk damage |
| 13 | Manitoba Maple / Acer negundo | 25, 30 | Poor | Included fence, trunk damage, 2 stems joined at 1m |
| 14 | Manitoba Maple / Acer negundo | 41, 58 | Poor | Included fence, trunk damage, 2 stems joined at base, fungal fruiting bodies |
| 16 | Manitoba Maple / Acer negundo | 31, 39 | Poor | 2 stems joined at base, longitudinal cracking |
