CONSERVATION PLAN

359 KENT STREET, 436 & 444 MACLAREN STREET, OTTAWA

March 2023

Application File Number: D02-02-21-0095 [ZBLA] & D01-01- 21-0015 [OPA]

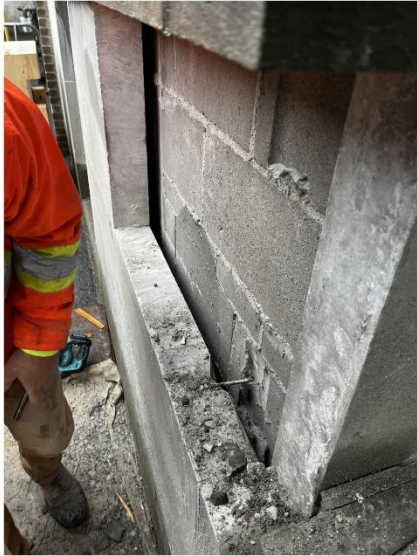
Figure 6: View of a test removal panel from a building at 100 Argyle constructed circa 1955 using a similar limestone cladding material as 359 Kent. The limestone cladding units are secured to the concrete block back-up wall with a single metal anchor centred on the width of the panel. Source: Heritage Grade Test Removal Report, 100 Argyle.

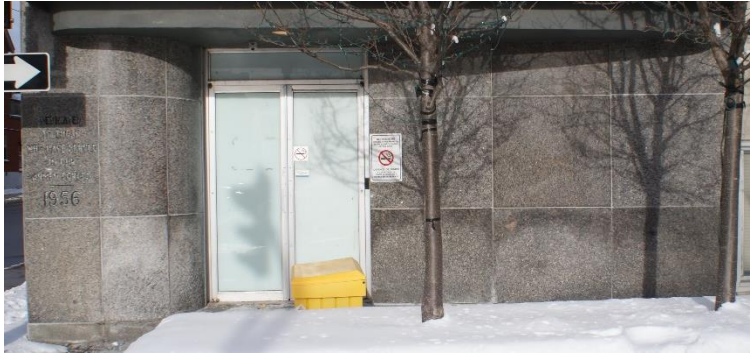
Figure 8: View of granite inset entrance with canopy

Condition: De-icing slats have had a major impact on the lower three stones set at floor level. The surfaces are disaggregated and crumble to the touch. The memorial stone with an incised date and inscription is in better condition although it is not clear when the inscription was incised.

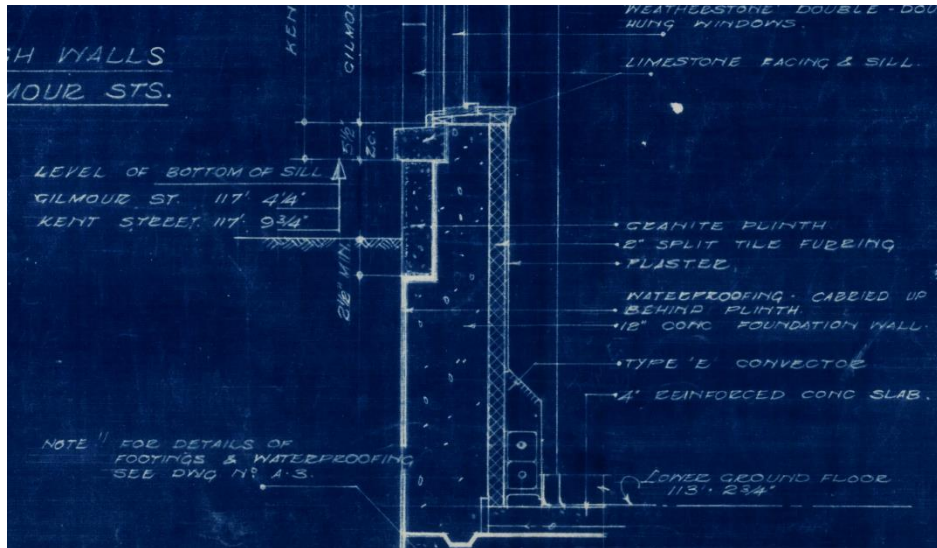
Description: A granite plinth course is located at the base of the Kent and Gilmour Street walls. The material is 100mm in thickness and is bonded to the cast concrete foundation walls. The granite forms a sill evident at the base of the three-storey window on Kent Street. The granite is similar in colour to the limestone cladding panels. The granite is not the same granite that was used to clad the Gilmour entrance walls.

Condition: The granite sill on the Kent Street window is in good condition. The condition of the granite plinth course buried below grade has not been determined.

Figure 17: Detail section through the Kent and Gilmour Street façades. A 100mm thick granite plinth is detailed in the drawing. Source: Original 1955 Drawing Set A4.

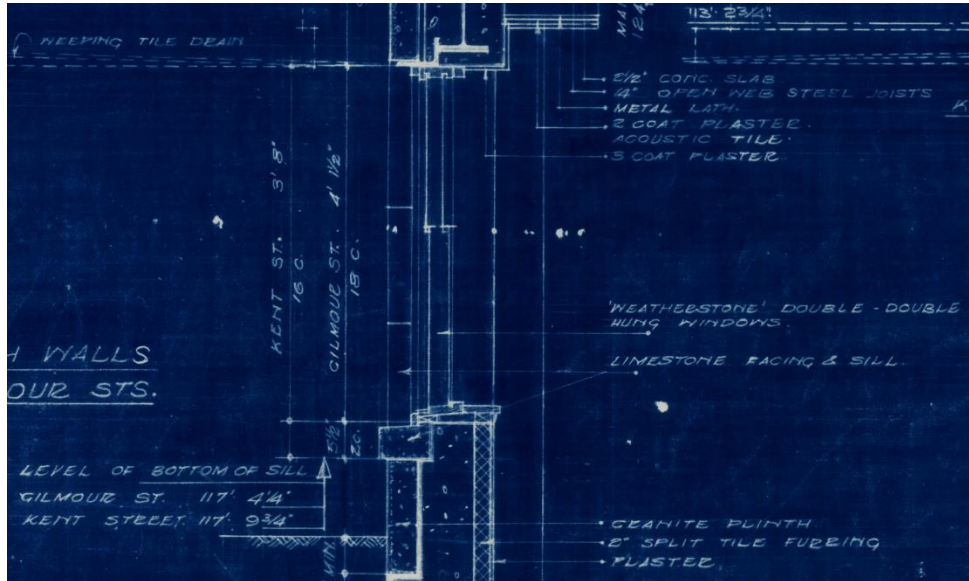
Description Windows: All of the original windows have been replaced with the exception of the three-storey window above the Gilmour Street entrance and the three-storey unit on the Kent Street façade. A character defining feature of the International Style was in the use of metals as a finish, aluminium in this case. The original sash configuration in the horizontal window bands consisted of units with a two-over-two light configuration. The width of the units corresponded with the width of the limestone window sill course units and the coursing width of the limestone cladding panels.

Condition: The existing windows are being replaced with new aluminium thermal units. The original vertical and horizontal division of the lights will be replicated in the three-storey windows on the Kent and Gilmour façades.

Figure 22: Detail section through the Kent and Gilmour Street façades illustrating the horizontal placement of the window assemblies within the exterior walls. The varying window heights between the Kent and Gilmour façades are related to the differing grades. Source: Original 1955 Drawing Set A4.

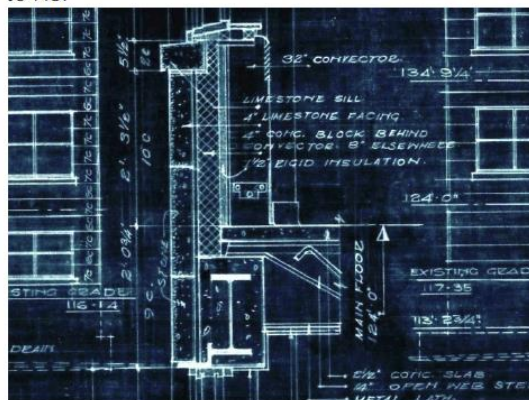
Figure 3 – Existing Legion House wall section

As described in the structural engineering feasibility review letter, dated October 11th 2022, prepared by Cunliffe & Associates, the Legion House was erected using a steel structure with poured concrete floors supported by open web steel joists. As depicted in Figure 3, the south and west exterior walls are composed of a limestone masonry finish and supported by block masonry wall behind. The exterior wall assembly offers only 1.5 inches of rigid insulation; the R-value of this wall assembly is estimated to be as low as R5 to R8.

Additionally, the minimal 1.5 inches of rigid insulation shown in Figure 3 does not provide a sufficient insulation value to meet today's energy performance standards set out in the Ontario Building Code Supplementary Standards, SB-12. We would propose a new wall assembly that would offer a more robust insulation thickness to meet or exceed the current building code requirements, while also considering future requirements.

Currently, our recommendation is to:

- Existing limestone panel masonry ties are likely in poor condition given their material and age,
- Serious concerns about the intergrity of the limestone panels during blasting activities for rock excavation within metres of the façade,
- Structural challenges surrounding the retention of the existing building relative to a new underground parking structure,
- Exterior wall assembly components and the overall environmental performance of the building facades,
- Conformance with the Landmark Building policy under which this development application is being reviewed; and
- Ensuring the heritage attributes of the Legion House are conserved in a long-lasting and conscientious manner.
