# Landslide Hazard Assessment

## Proposed Multi-Storey Building

3030 Saint Joseph Boulevard  
Ottawa, Ontario

Report PG6609 - 2 dated February 12, 2024

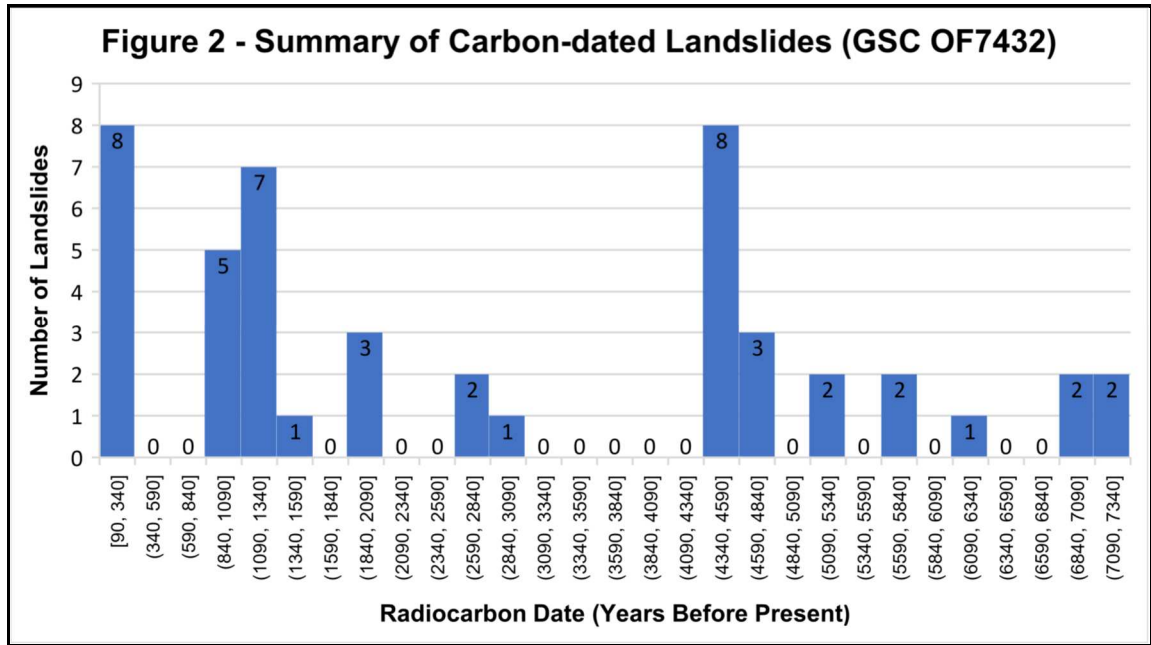
The results from the study and approximations provided by OF8600, neglecting the potential deviation and range of uncertainty, are summarized in Figure 2 below.

Temporal factors such as periods of increased earthquakes and climatic factors affecting these frequencies have been explored by others. Based on the above, more than half of the carbon dated landslides have occurred within the past 3,090 years, and over a quarter within the past 1,090 years.

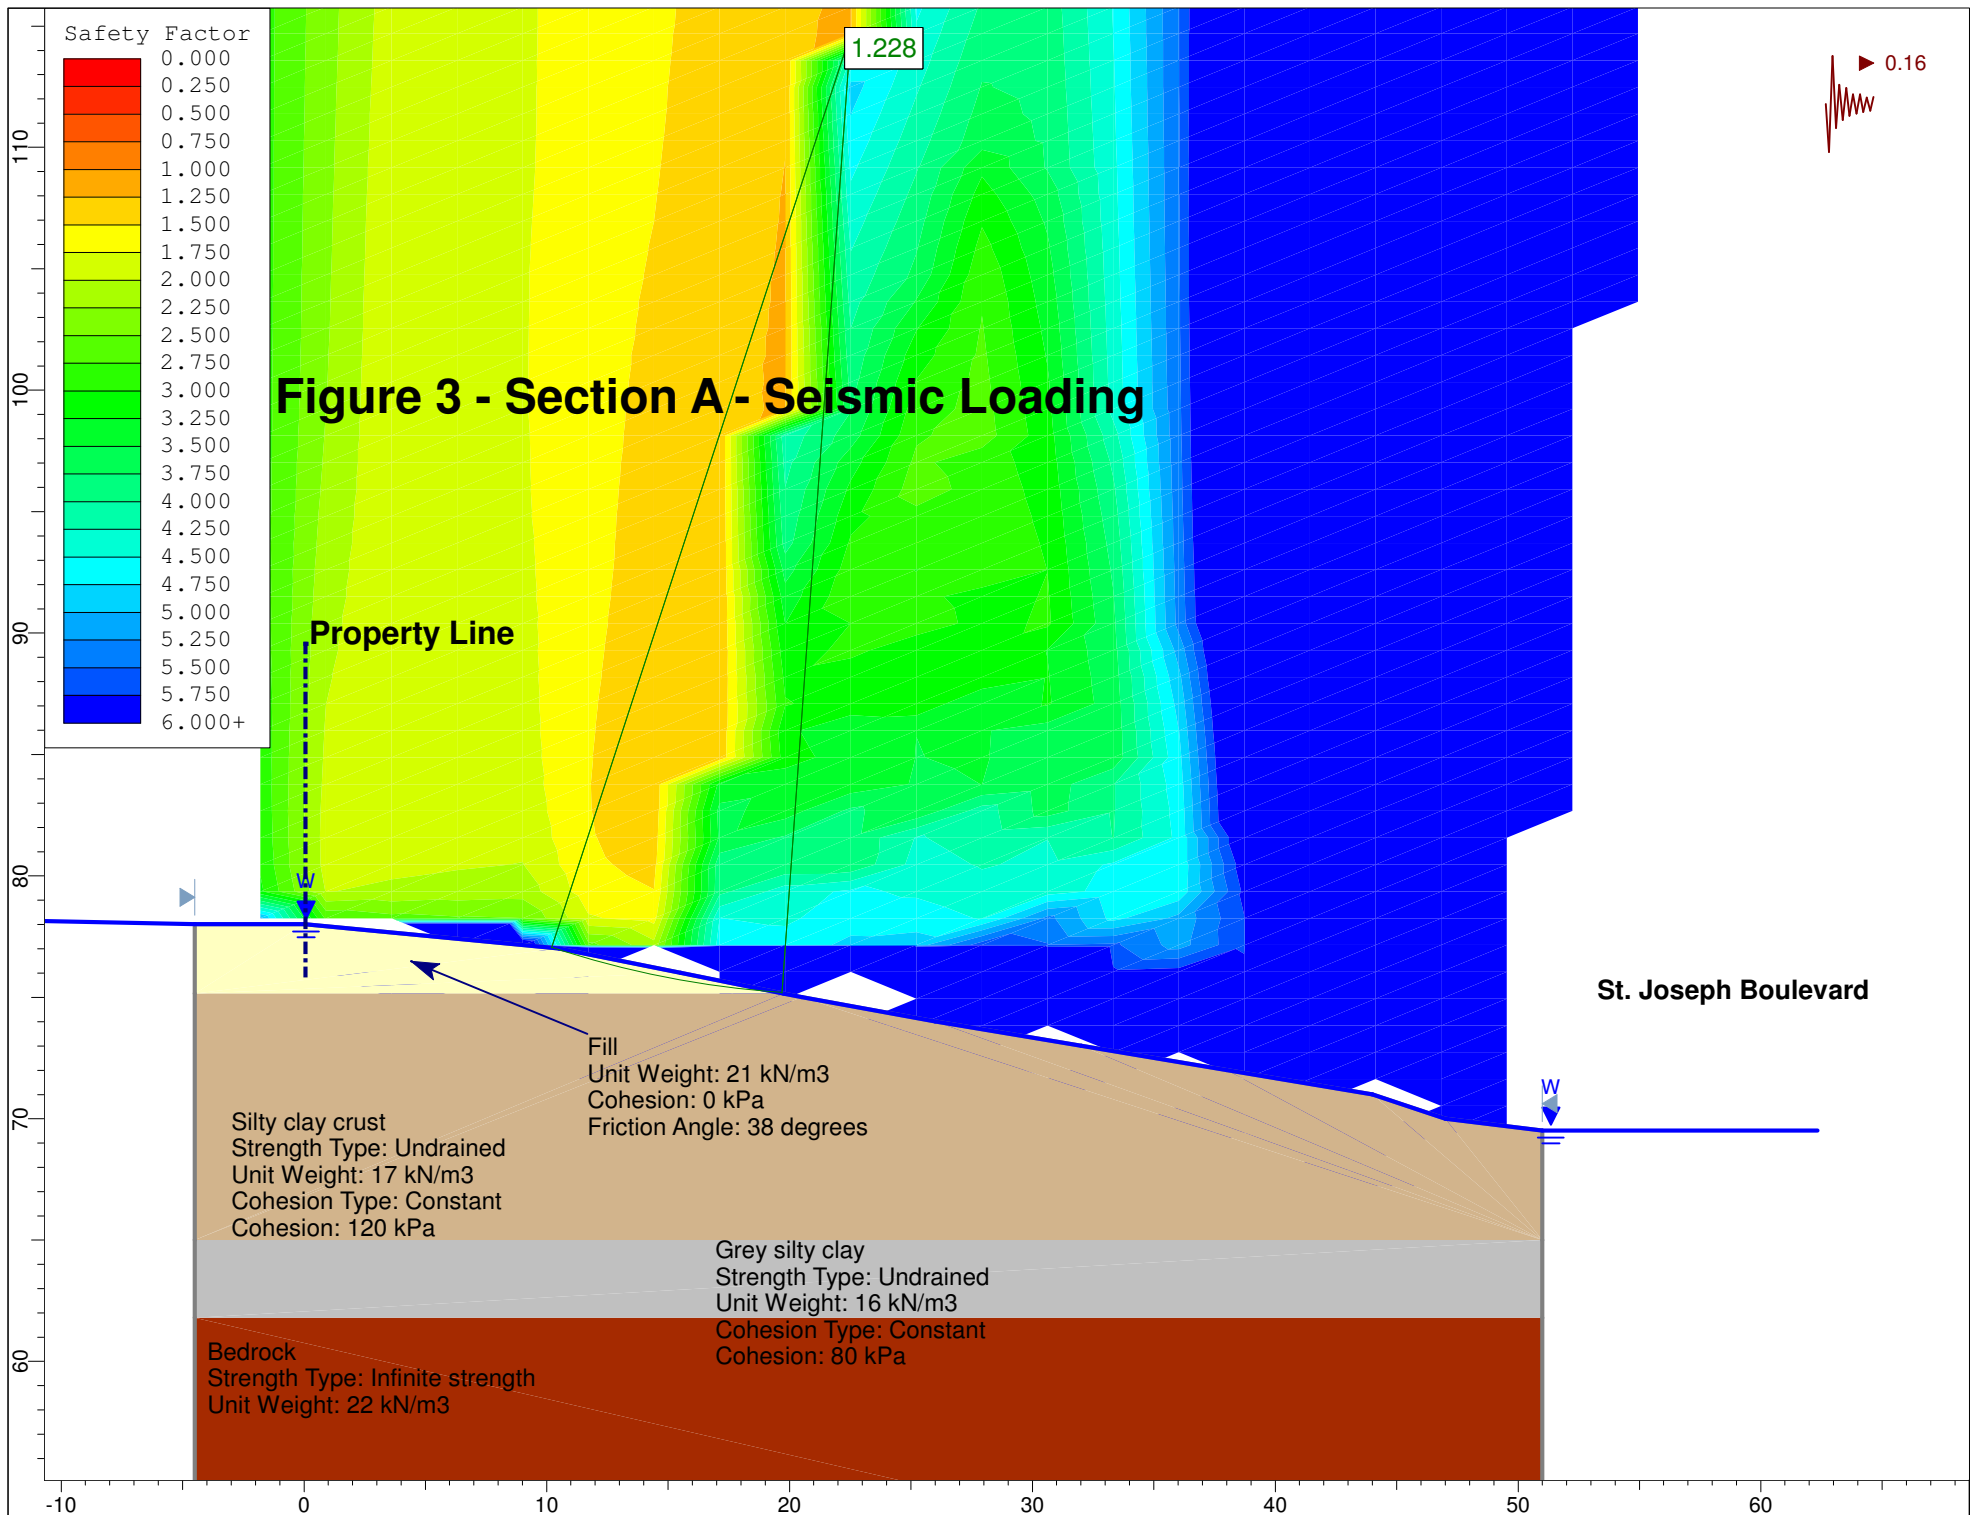
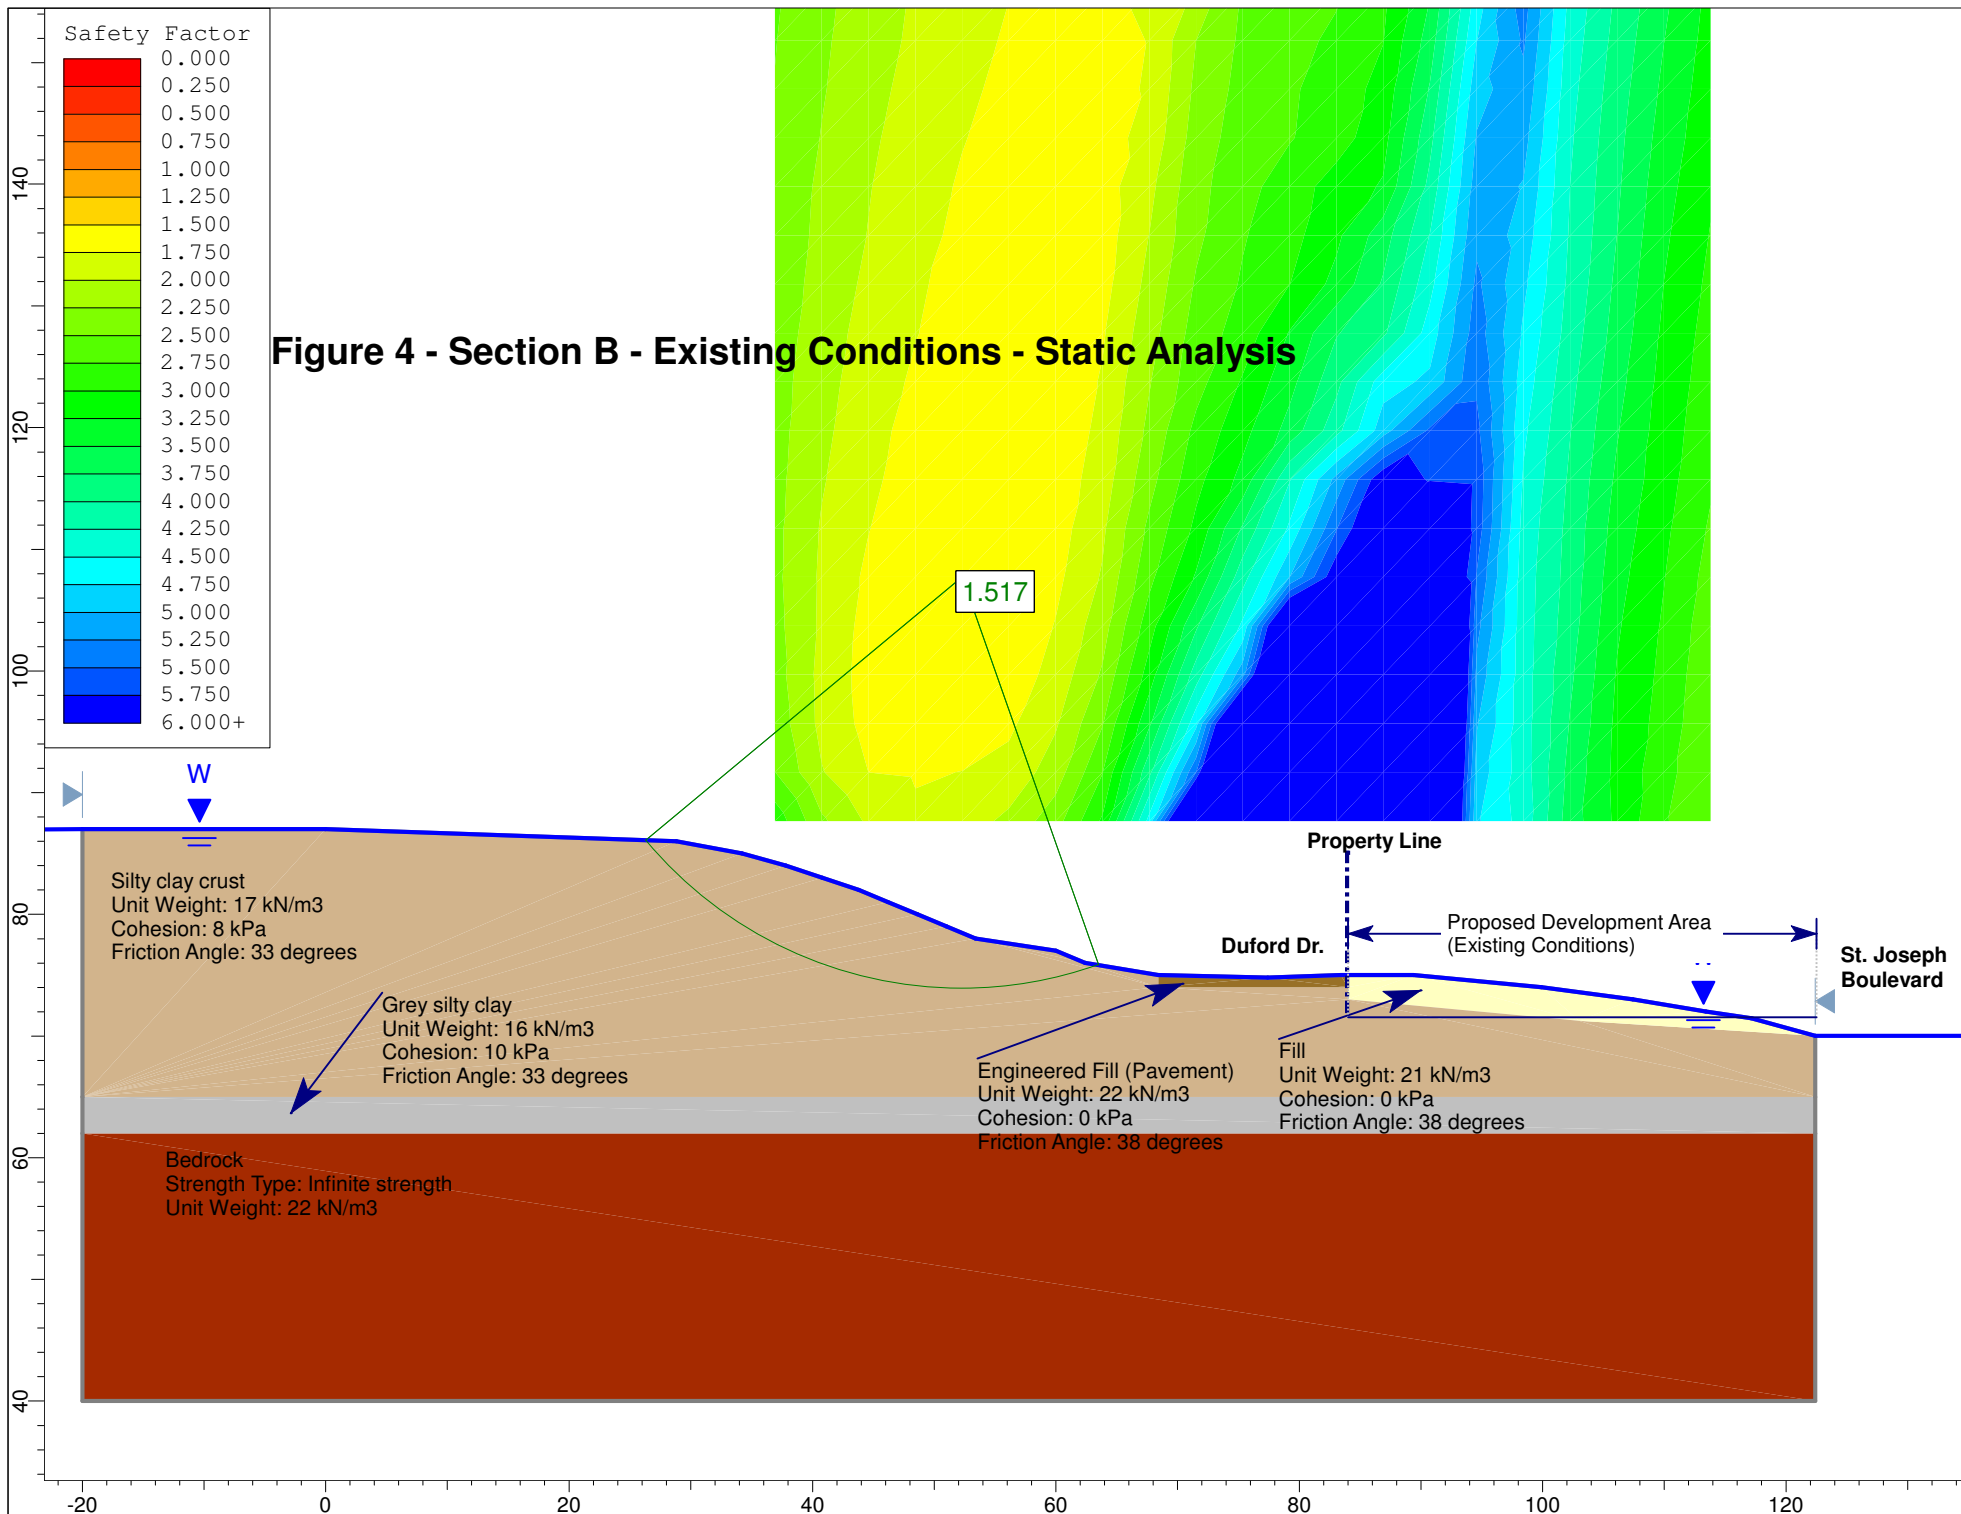
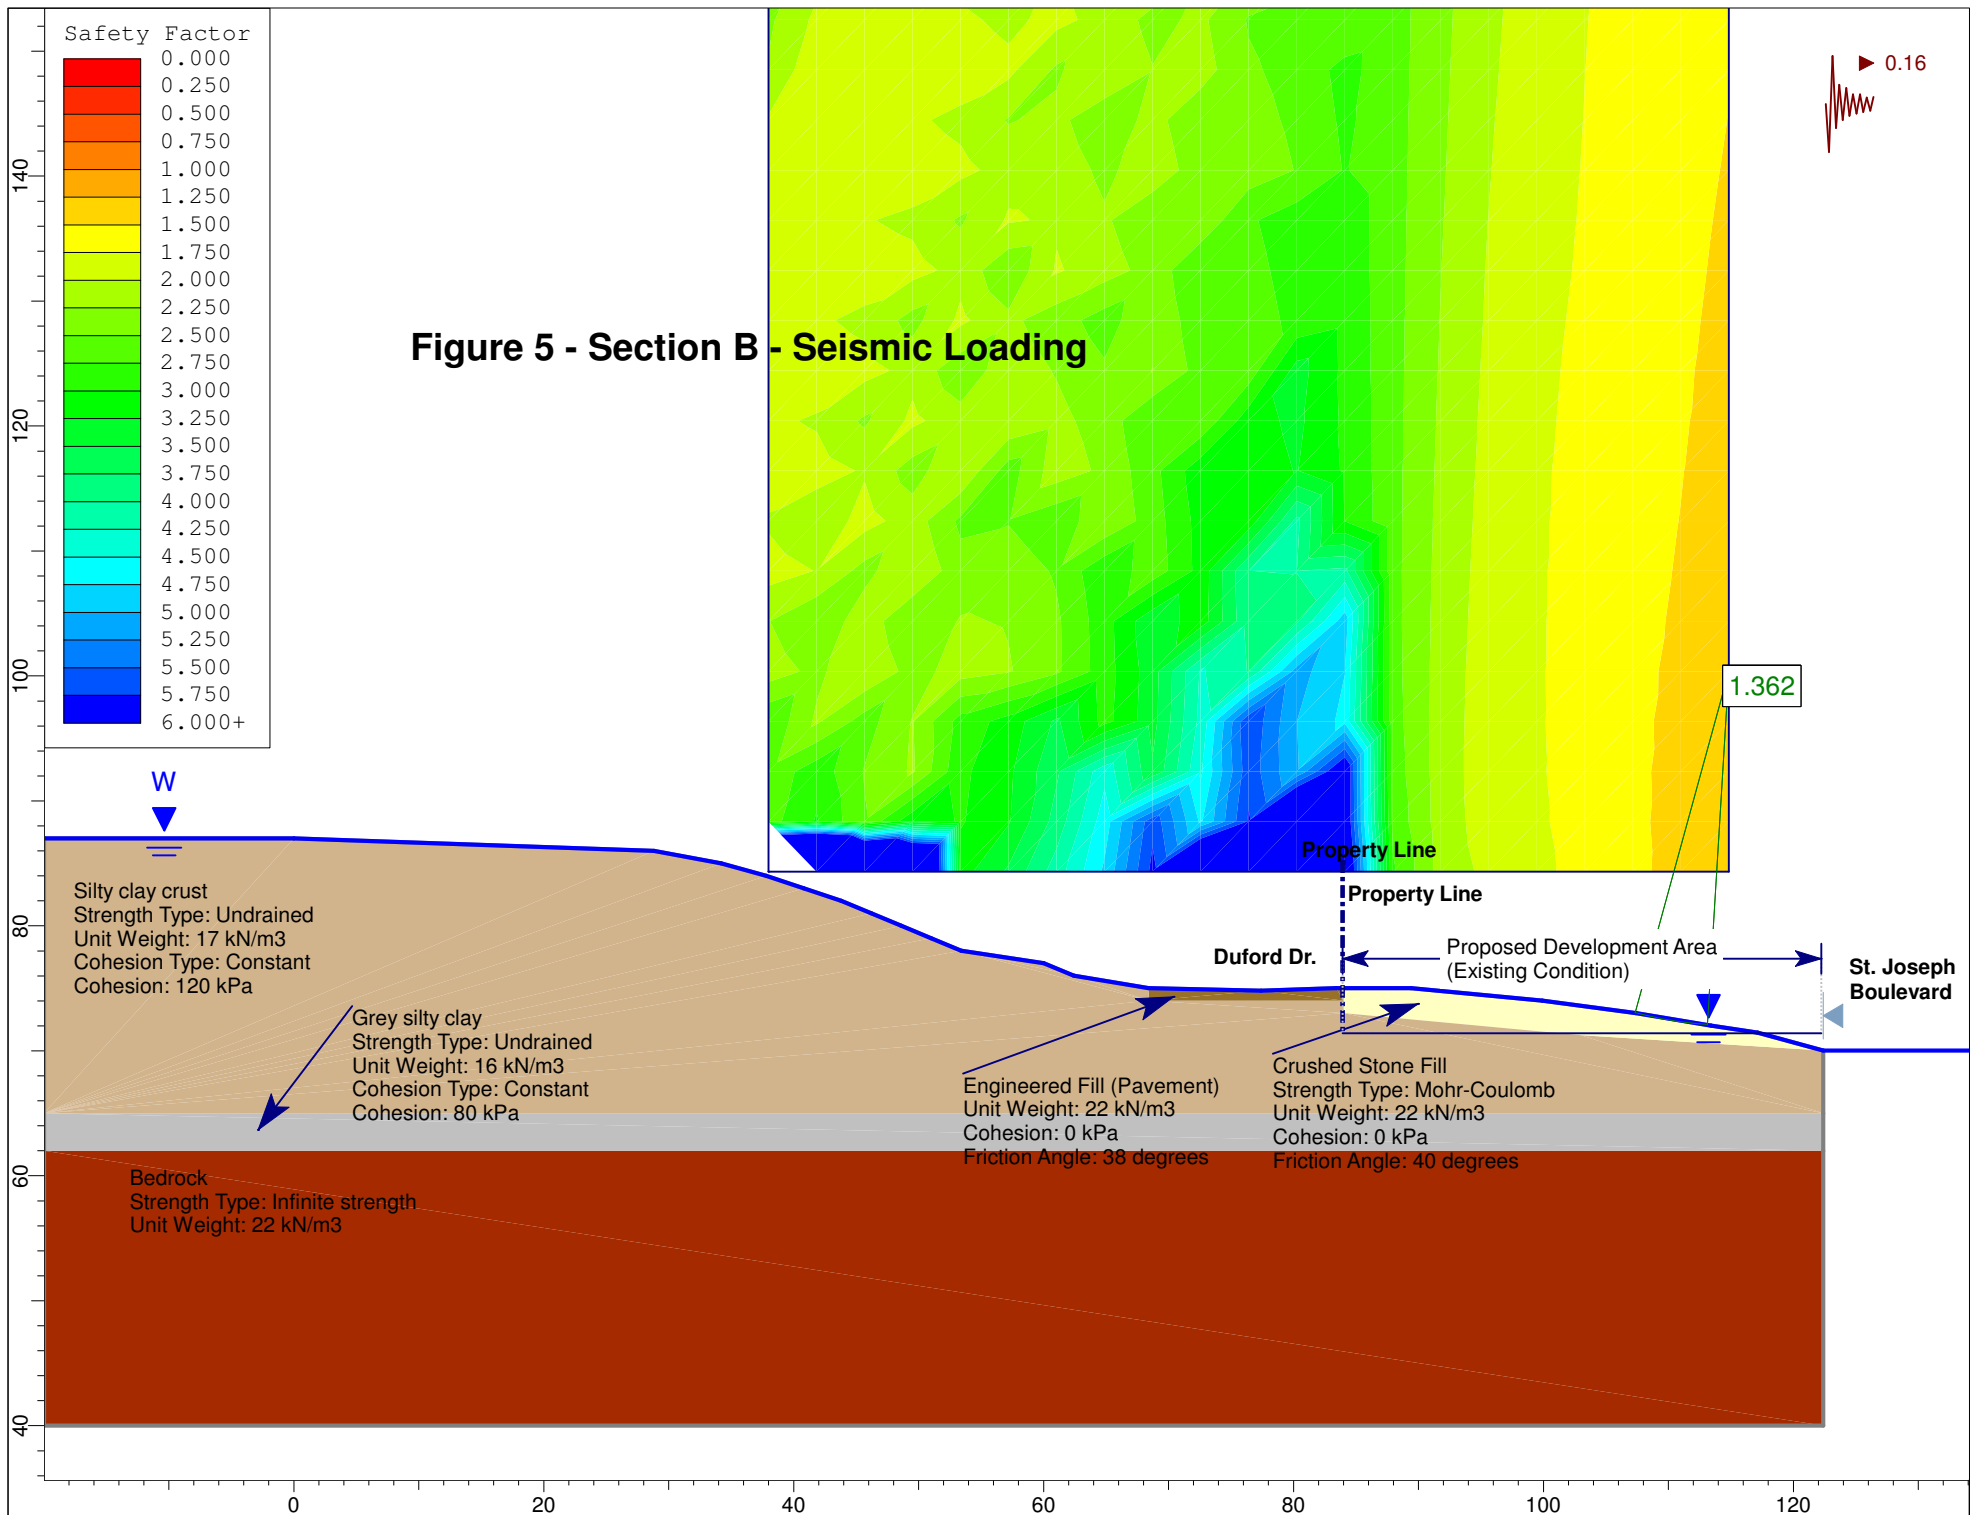
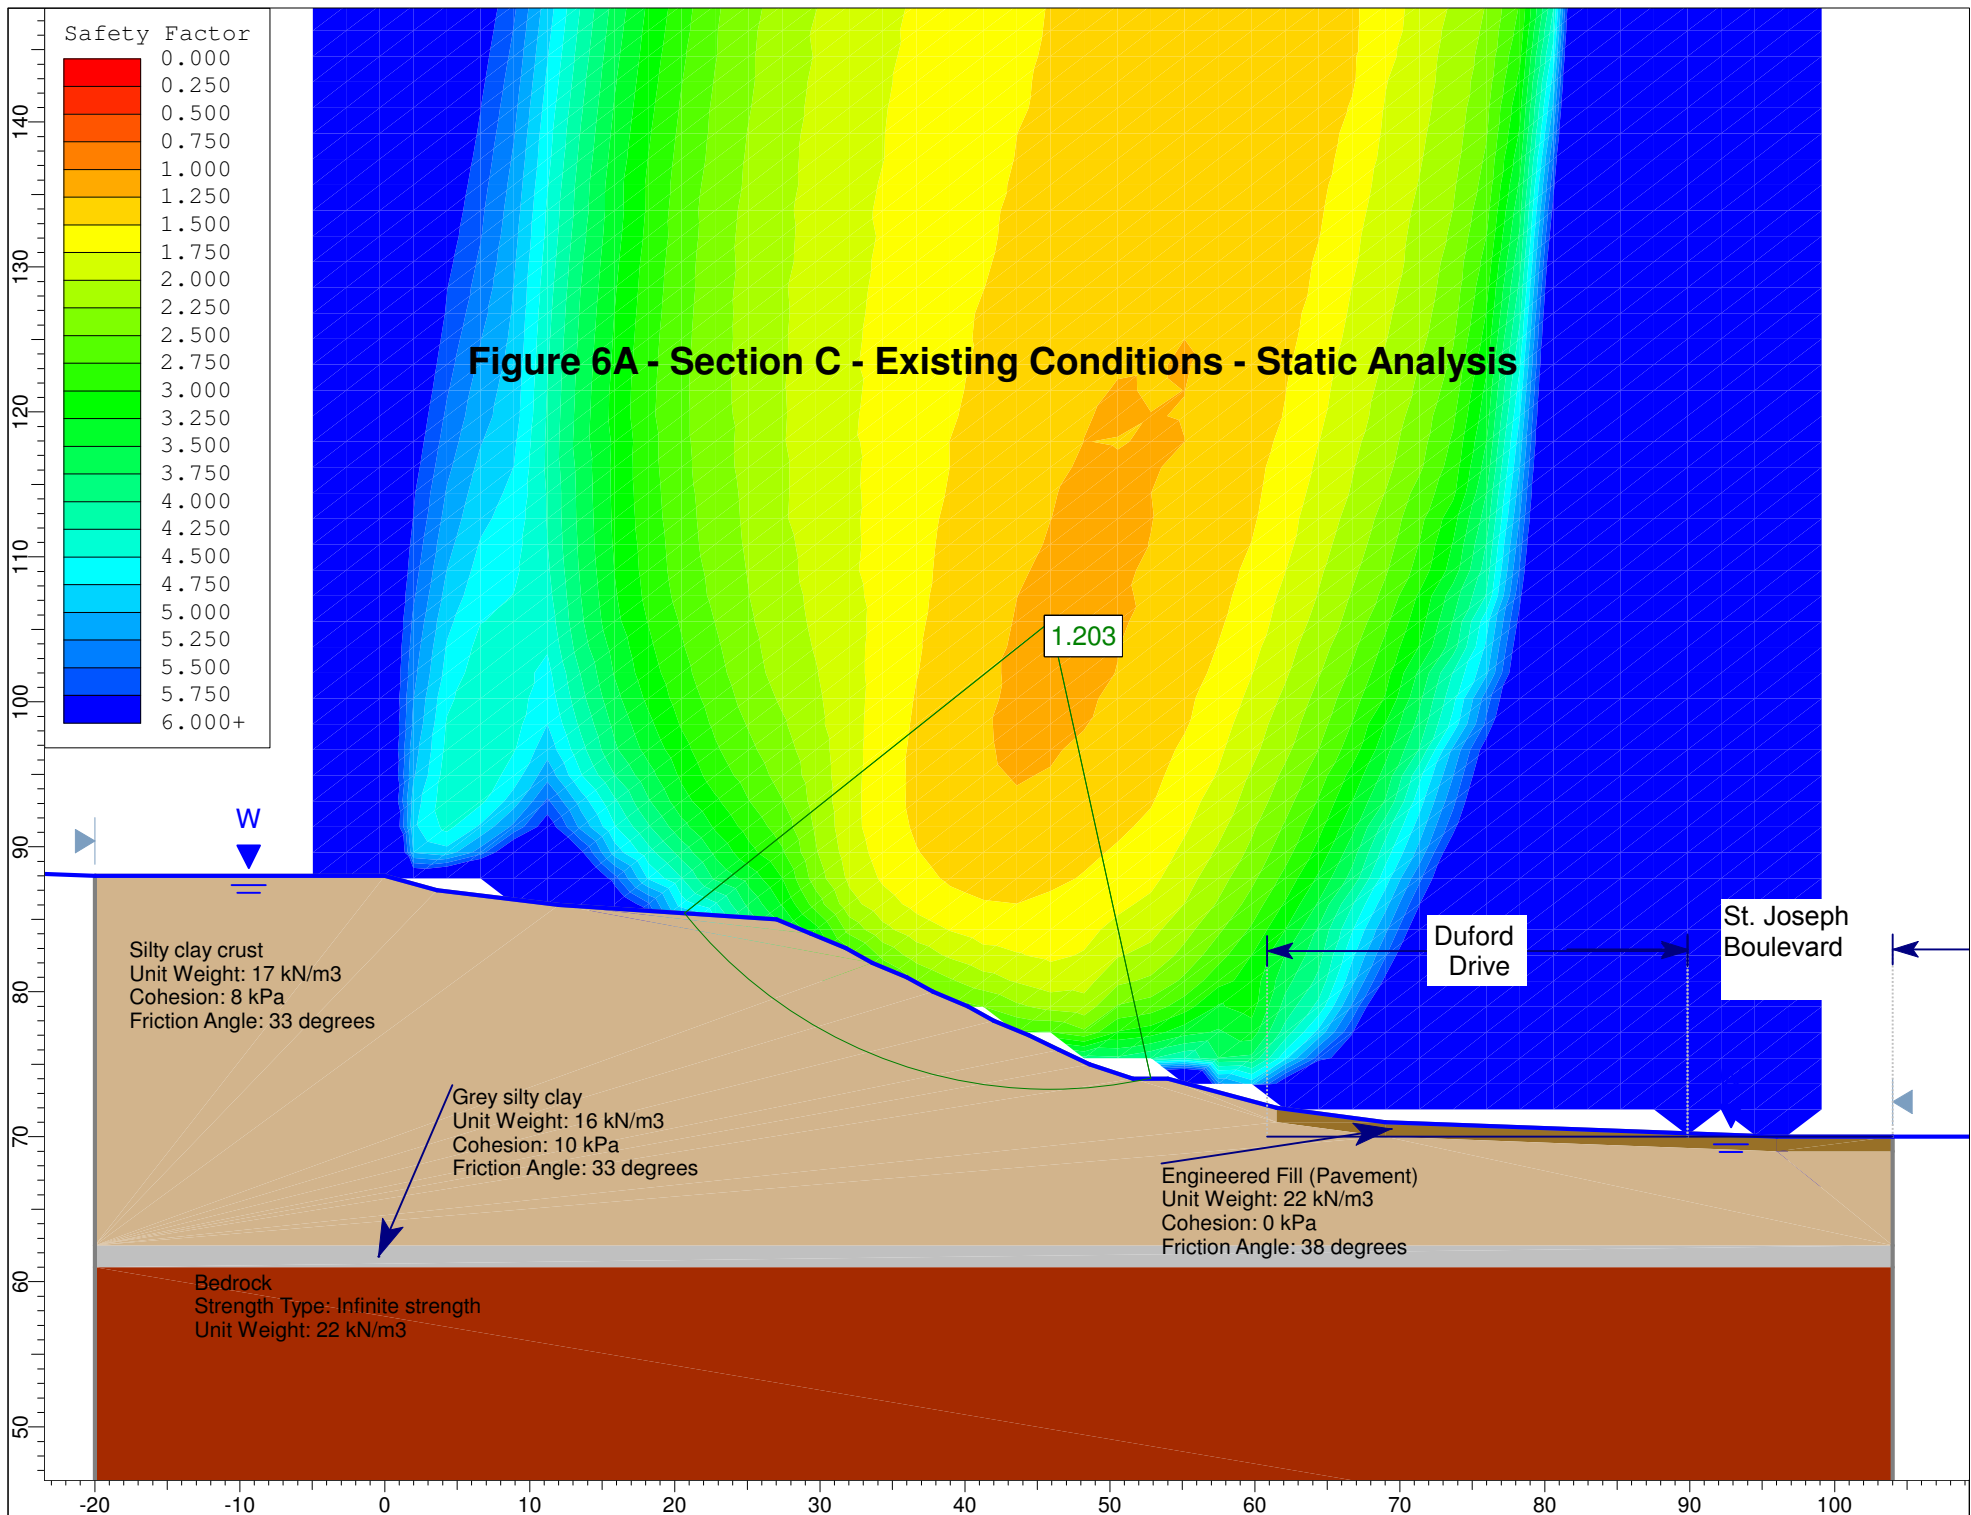
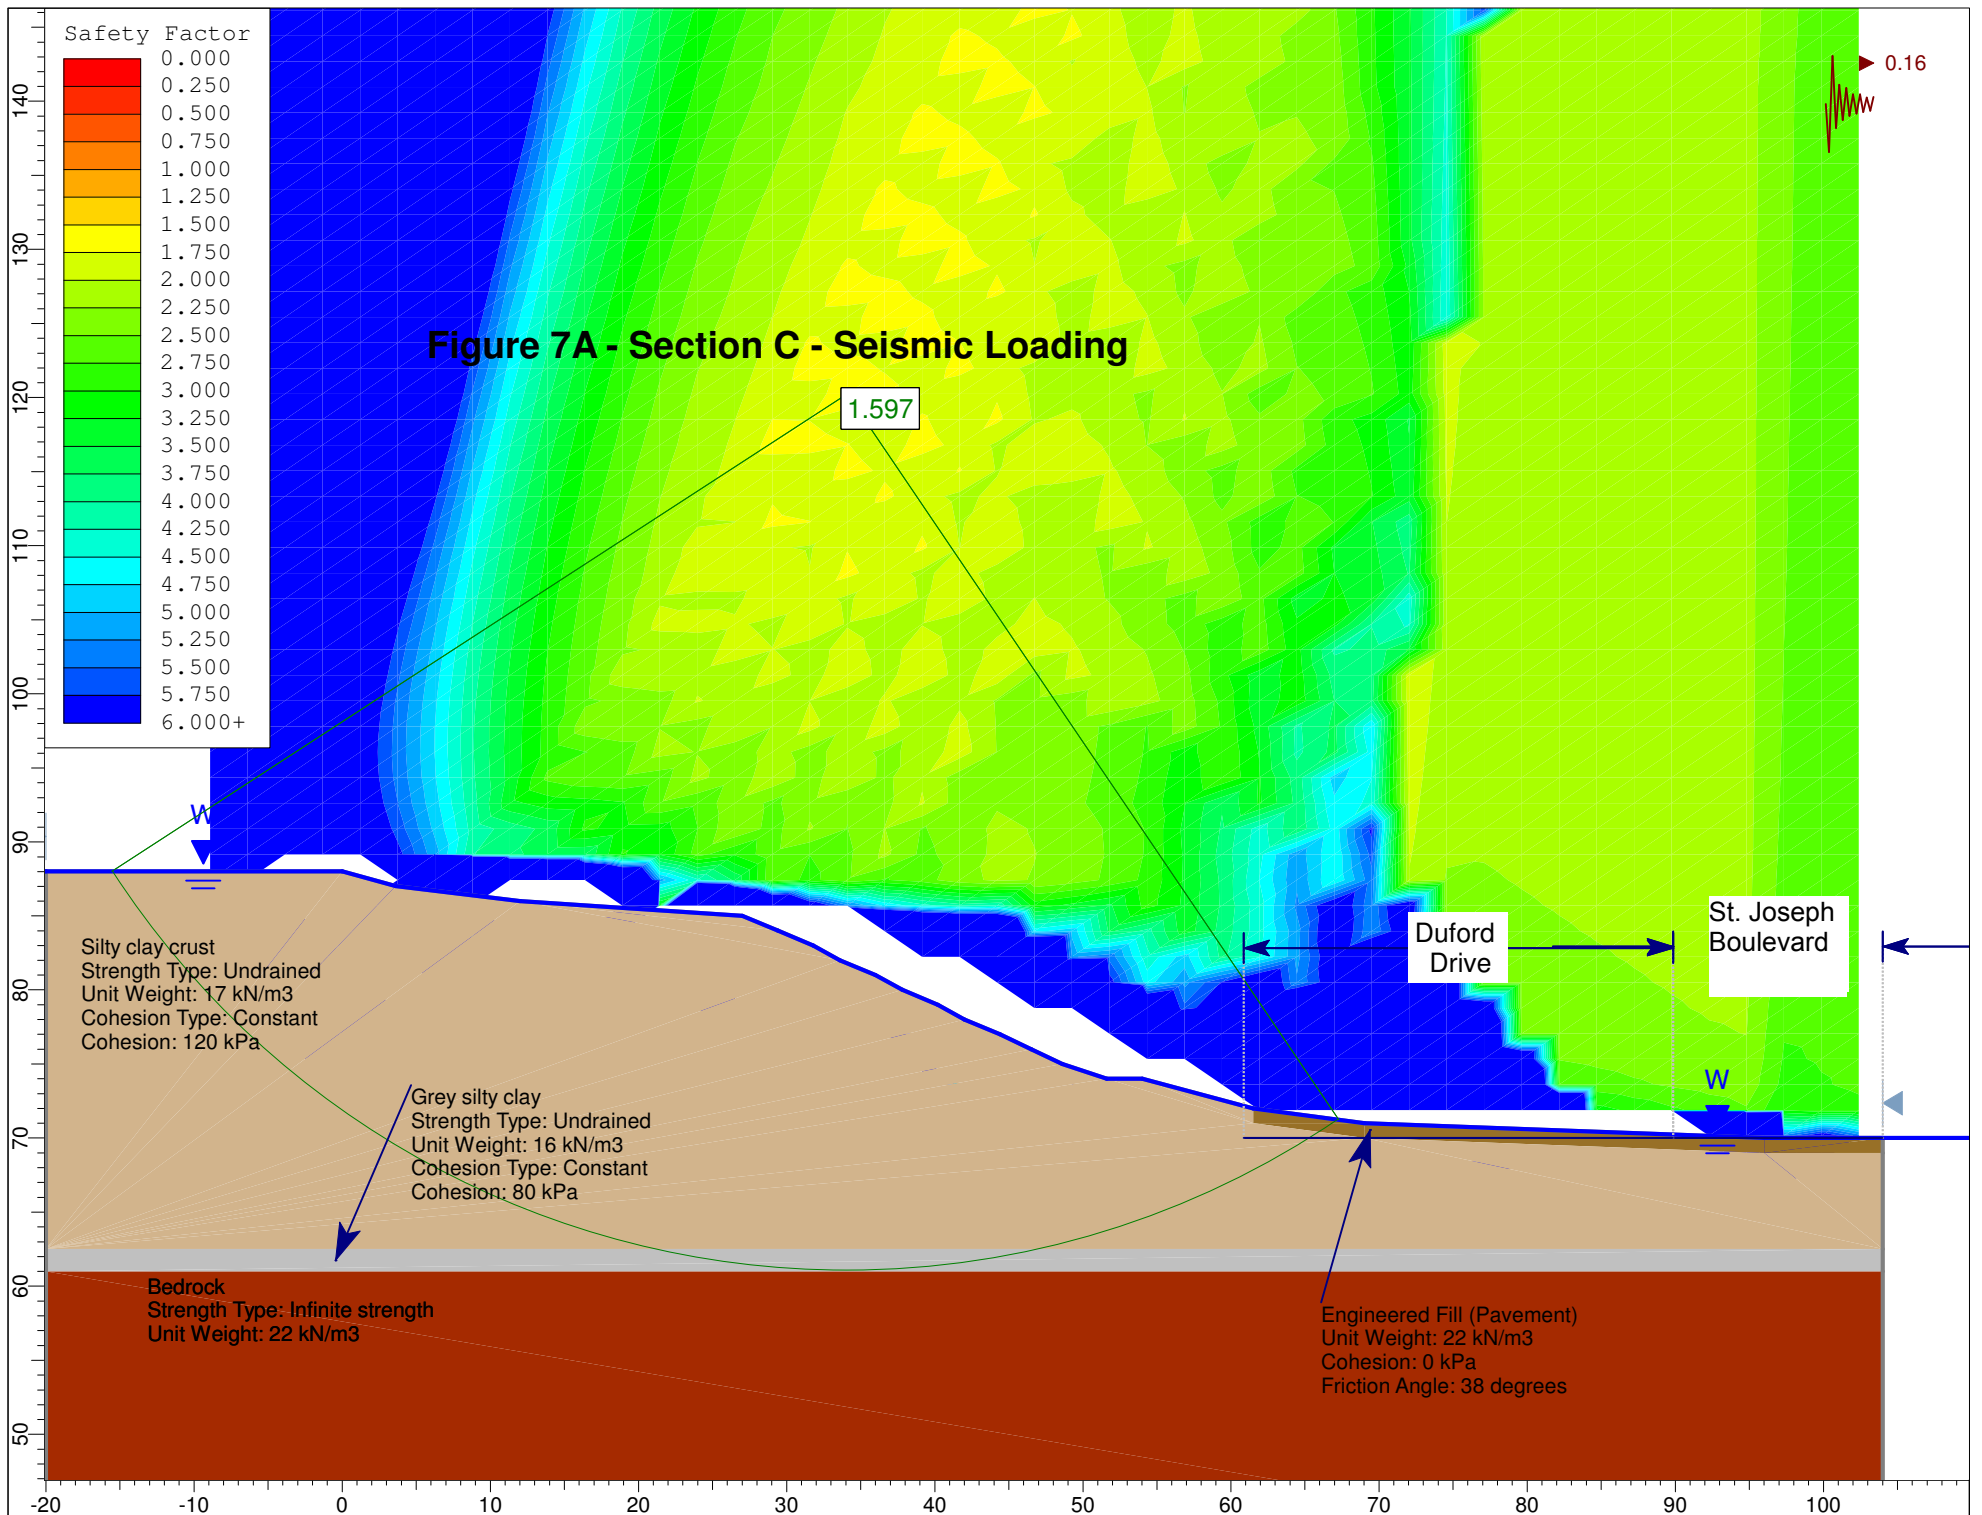
FIGURE 2 to 7 - SLOPE STABILITY ANALYSIS SECTIONS

The results for the existing slope conditions at Section A and Section B are shown in Figure 2 and Figure 4 in Appendix 2. The factor of safety was found to be greater than 1.5 for Section A and B when analyzed under static conditions. It should be noted that a slope stability analysis was completed for Section A due to the steepness of the slope observed, which was considered to be a worst-case scenario for the subject site. Section B was analyzed to include the adjacent slope opposite of Duford Drive. Section C was analyzed considering the upper 2 m of the slope face to be fully saturated and the remainder of the slope is saturated below the long-term groundwater table at the former slope failure location. A global slope stability factor of safety of greater than 1.5 was determined for Section C based on our analysis.
