Project:  
**Gladstone and Loretta**

Drawing:  
**TREE CONSERVATION REPORT**

| 1987-01 | TCR 1.0 |

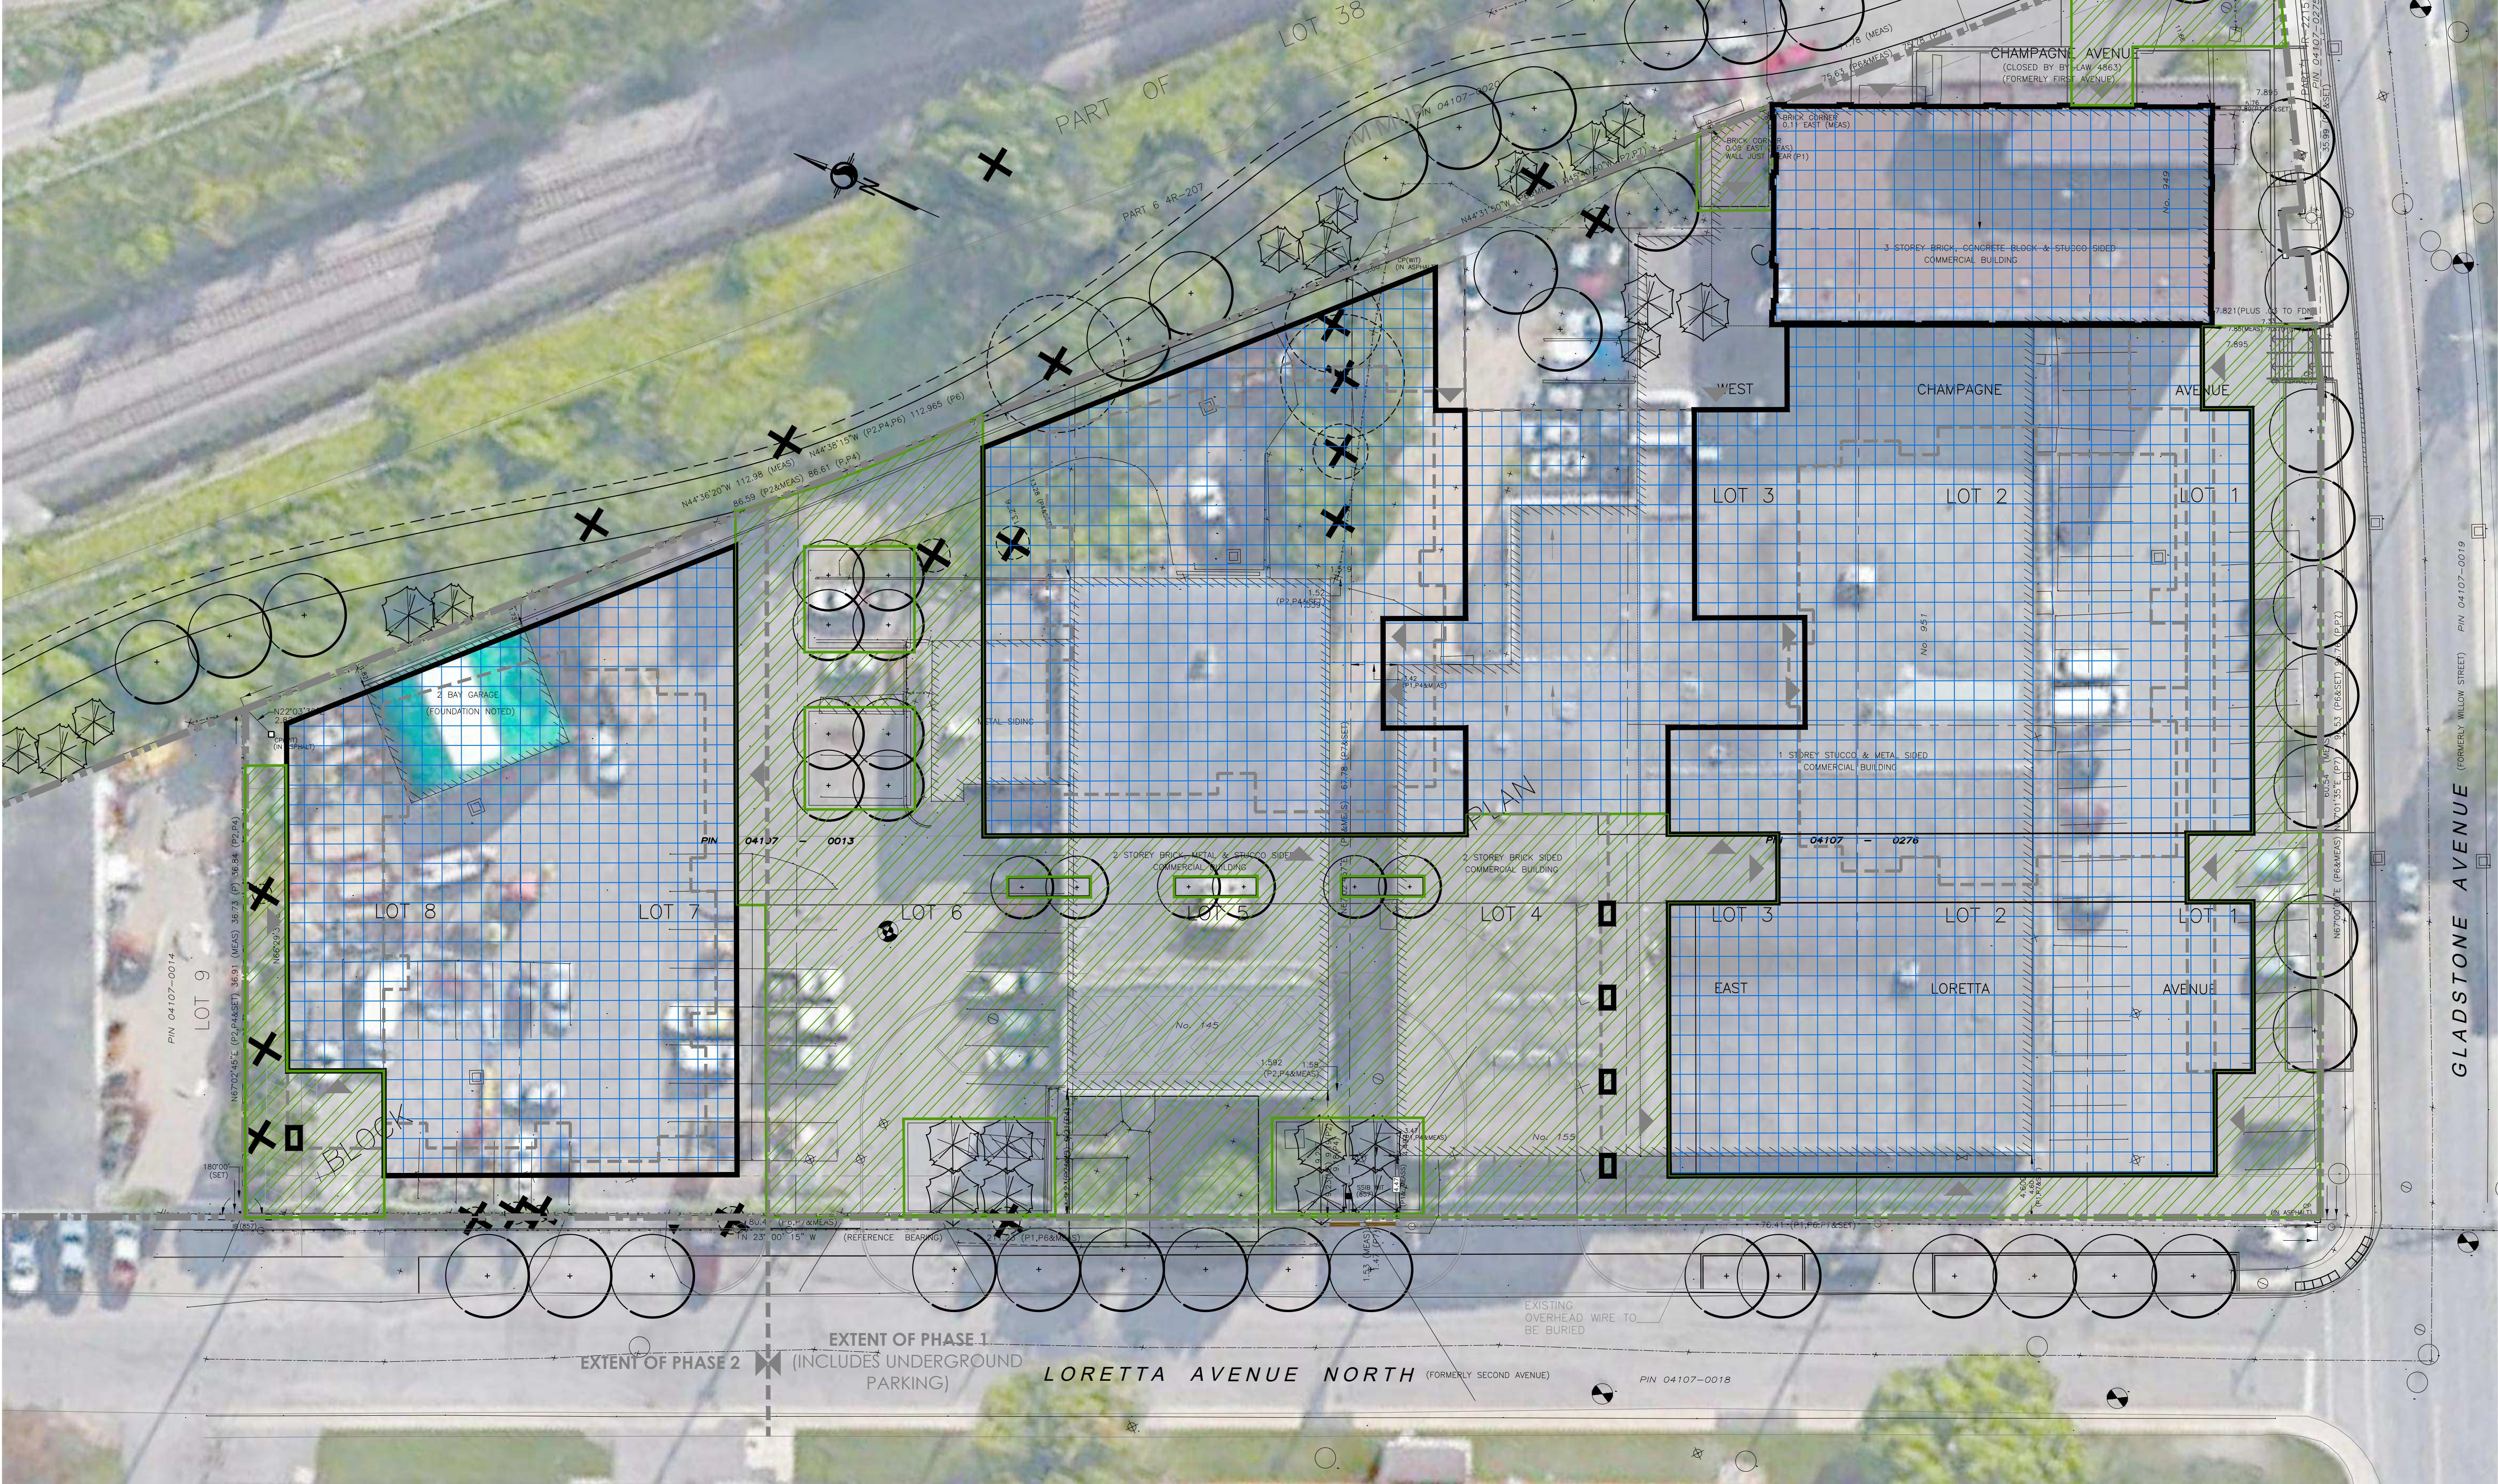
THE LINEAR LANDSCAPE AREA NORTHEAST OF THE SITE RUNS ADJACENT TO THE EXISTING O-TRAIN TRACKS. THIS AREA IS SEPARATED FROM THE COMMERCIAL PROPERTIES WITH CHAIN LINK FENCE AT THE TOP OF A SLOPE. THE AREA IS DENSE WITH INVASIVE PLANTS SUCH AS MANITOBA MAPLE, WILD GRAPE VINE AND VIRGINIA CREEPER. THE AREA HAS A GREAT DEAL OF DEAD TREES AND MISCELLANEOUS DEBRIS MAKING THE AREA DIFFICULT TO ACCESS.

THE SITE LACKS SIGNIFICANT TREES OF VALUE. THE PRESENT TREES OFFER LITTLE BENEFIT TO THE SITE IN TERMS OF ECOLOGY, CHARACTER, OR SHADE VALUE. THE GENERAL CONDITION OF THE SITE'S TREES ARE POOR WITH A DECLINING STATE OF HEALTH.
