Kizell Drain Downstream of 7000 Campeau Drive Geomorphological and Erosion Threshold Assessment

**Kizell Drain
Kanata, Ontario**

May 18, 2021
PN20053

Report Prepared by: GEO Morphix Ltd.
PO Box 205, 36 Main St. N.
Campbellville, ON L0P 1B0

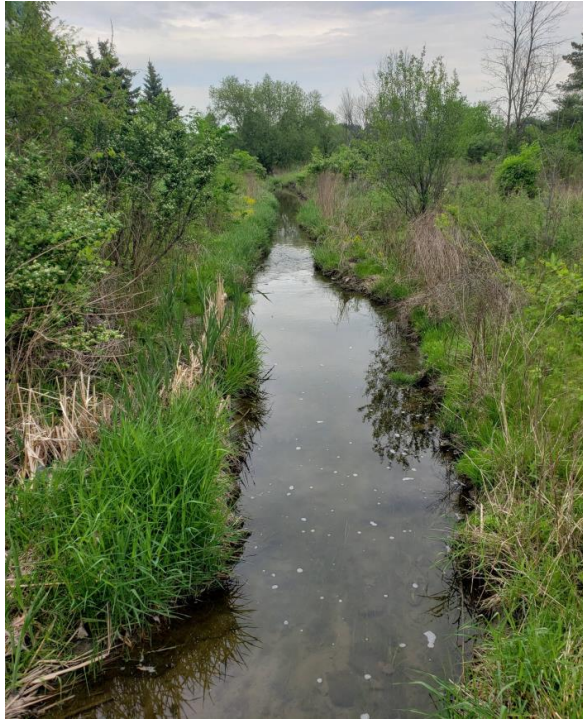
Detailed assessment Site KDR-3 is a channelized watercourse conveying flows through a commercial business park with large parking lots. The channel is unconfined, and at the time of the assessment was backwatered by a beaver dam which exceeded 1 m in height near Legett Drive. The channel had a fragmented, narrow riparian buffer composed of grasses and herbaceous vegetation which occasionally encroached the watercourse, with sparse shade provided from trees. The channel bed was composed of a cohesive clay material, while channel banks were composed of a loamy clay.

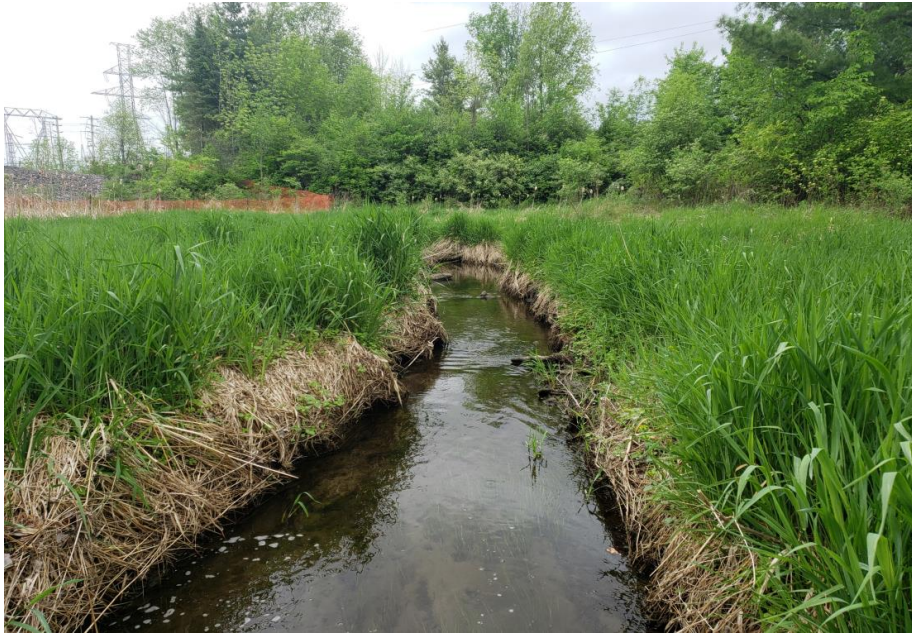
Detailed Assessment Site KDR-4 conveys flows through an unconfined valley, and is surrounded predominantly by residential development. The site has a continuous riparian buffer consisting of a forest in the upstream section of the site, and a meadow in the downstream section. Channel bed materials are composed of dense clay, with overlying sand, gravels and small cobbles. Banks are composed of a loamy clay. The channel has a natural sinuous planform, and the specific detailed site is delimited at the upstream extent by a bedrock outcrop and the downstream extent by a wet meadow with poor bank definition.
