CONSERVATION PLAN 359 KENT STREET, 436 & 444 MACLAREN STREET, OTTAWA

March 2023

Application File Number: D02-02-21-0095 [ZBLA] & D01-01- 21-0015 [OPA]

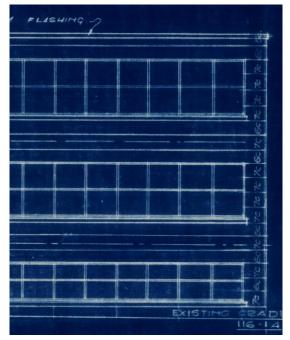
The limestone cladding is supported vertically by steel shelf angles that are in turn attached to the steel frame that is embedded in concrete for fire-rating purposed (see Figure 5). A block back-up wall is constructed between floor slabs and supports the exterior cladding. The stones are secured laterally to the back-up wall with wire ties. There is a 25mm air gap between the inside face of the stone and the back-up wall. The foundation walls are poured concrete construction and there may be instances where the cladding is adhered to the concrete.

Figure 4 (left): Detail section through the walls clad in limestone illustrating the structural frame and materials and their relationships. Note the window sill that is supported on the masonry back-up wall as well as the relationship of the aluminium window sill to the limestone sub-sill. Source: 1955 Architectural Drawing Set A4.

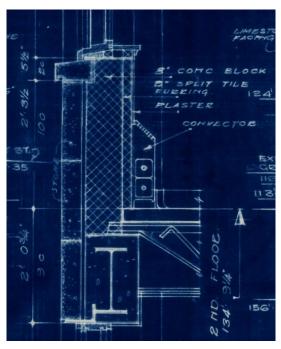
Description: The limestone cladding is 100mm (4") thick, there are two typical coursing heights as illustrated on the Gilmour Street elevation (Figure 4), and the average length is approximately 750mm (30"). The cladding is laid up in a staggered coursed pattern between rows. The stones are mitred at a 45 degree angle on external corners and finished with a 25mm chamfer. The cladding is 40 courses in height and approximately 600 stones form the Gilmour façade for an approximate total of 1200 individual units on the four elevations. There are approximately 115 stones on the Gilmour and Kent Street façades that will not be reinstated and could be used to replace deteriorated units or units damaged during the dismantling process.

Figure 5 (right): Detail of the Gilmour Street façade where the coursing height pattern is noted that vary consistently between two heights (6C and 7C). Source: 1955 Architectural Drawing Set A4.

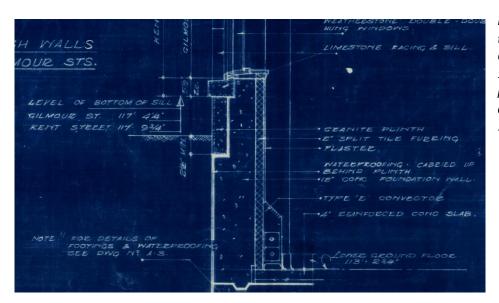
Description: A granite plinth course is located at the base of the Kent and Gilmour Street walls. The material is 100mm in thickness and is bonded to the cast concrete foundation walls. The granite forms a sill evident at the base of the three-storey window on Kent Street. The granite is similar in colour to the limestone cladding panels. The granite is not the same granite that was used to clad the Gilmour entrance walls.

Condition: The granite sill on the Kent Street window is in good condition. The condition of the granite plinth course buried below grade has not been determined.

Figure 17: Detail section through the Kent and Gilmour Street façades. A 100mm thick granite plinth is detailed in the drawing. Source: Original 1955 Drawing Set A4.

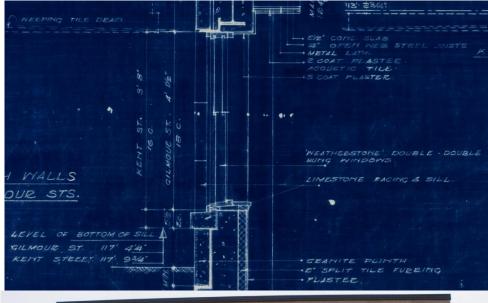
Description Windows: All of the original windows have been replaced with the exception of the three-storey window above the Gilmour Street entrance and the three-storey unit on the Kent Street façade. A character defining feature of the International Style was in the use of metals as a finish, aluminium in this case. The original sash configuration in the horizontal window bands consisted of units with a two-over-two light configuration. The width of the units corresponded with the width of the limestone window sill course units and the coursing width of the limestone cladding panels.

Condition: The existing windows are being replaced with new aluminium thermal units. The original vertical and horizontal division of the lights will be replicated in the three-storey windows on the Kent and Gilmour façades.

Figure 22: Detail section through the Kent and Gilmour Street façades illustrating the horizontal placement of the window assemblies within the exterior walls. The varying window heights between the Kent and Gilmour façades are related to the differing grades. Source: Original 1955 Drawing Set A4.

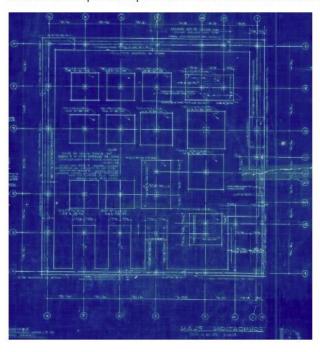
Figure 2. The Legion House Foundation Plan (1955).

The structure is supported on relatively large, spread footings. The underside of the footings is below frost level, constructed approximately 5 feet below exterior grade. A 4" thick concrete slab on grade is located immediately above the spread footings and is approximately 3 feet below grade. There is no dedicated lateral load resisting system but resistance to earthquake loading is aided by the infill masonry walls.

Drawings for the three-storey vertical addition, constructed some 3 years after the original, were not available. We carried out a load review for a typical column footing and found that it is likely that the original footings were sized for the vertical addition and that SLS pressures are in the order of 2000 psf. There is no geotechnical report available but required soil pressures seems to be modest and reasonable.

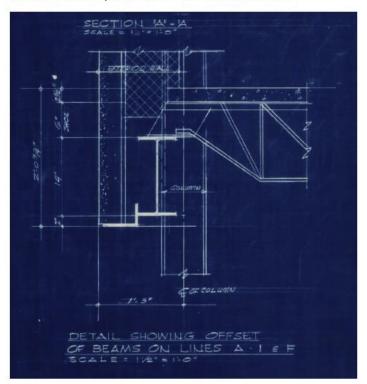
Figure 4. Typical Off-Set Beam Detail at GL 1 and F.

The existing floor joists bear on an offset beam on the gridlines considered for retention. The joist shoe is connected to an offset beam and the beam is cast in concrete for fire proofing purposes. The veneer and back-up masonry block wall bear on this concrete-encased at each floor and induce torsion on the beam (see Figure 4 for the typical detail). The joists brace the beam and provide resistance to the torsion created by the eccentric masonry loads. Removal of the interior joists will require compensating construction to deal with the eccentric loads and this complicates in situ retention of the facade.
