February 7, 2023

File: 64913.01 – R03

**Re: Slope Stability Assessment
5497 Manotick Main Street
Manotick (Ottawa), Ontario**

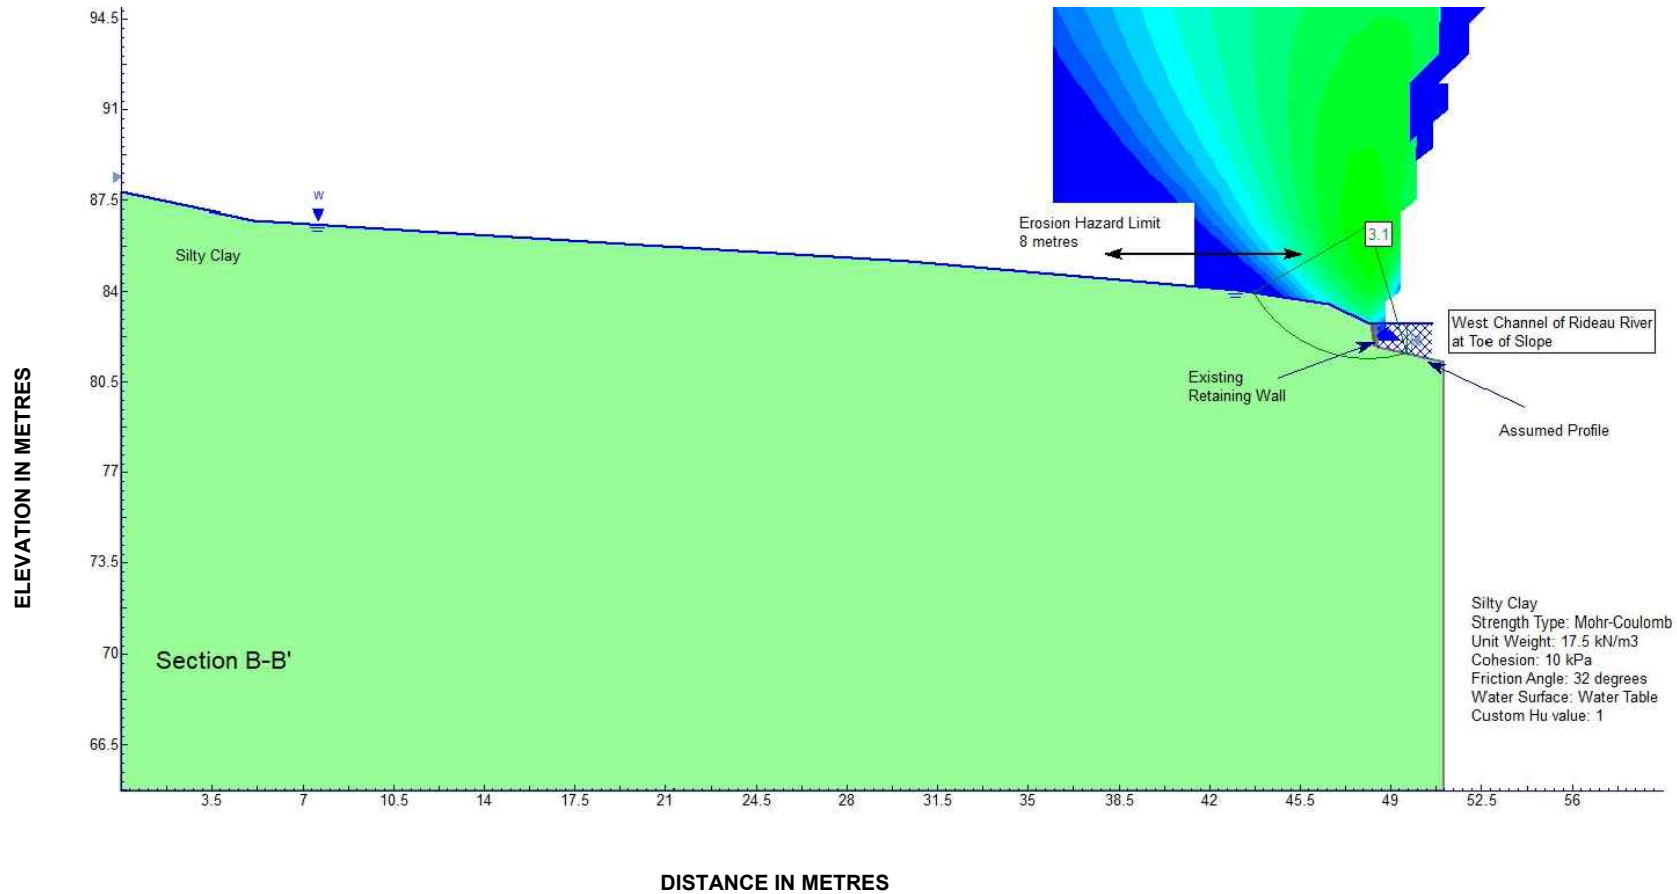
FIGURE A1

The slope stability analyses indicate that the existing slope, in its current configuration, has a factor of safety against overall rotational failure of about 2.1 and 3.1 for Sections A-A' and B-B', respectively. Based on the slope stability analyses, the factors of safety against overall rotational failure for static loading conditions are considered to indicate adequate long-term stability. The results of the stability analyses are provided on Figures A1 and A2 in Attachment A.

Therefore, the Erosion Hazard Limit for the slope at this site is located about 14 metres from the crest of the existing slopes at Sections A-A' and B-B' (refer to Figures A1 and A2). It may be possible to reduce the Toe Erosion Allowance if an additional site visit is carried out when the water levels have receded in order to confirm the state of erosion along the slope toe at the base of the existing retaining wall. However, this may not be warranted, should the proposed development not be impacted by the proposed (conservatively estimated) Erosion Hazard Limit.
