# TREE CONSERVATION REPORT V2.0

**109-115 Dalhousie**

Tree Conservation Report submitted as Partial  
Requirements for a Site Plan Control Application,  
February 16, 2022

**Date:** February 16, 2022

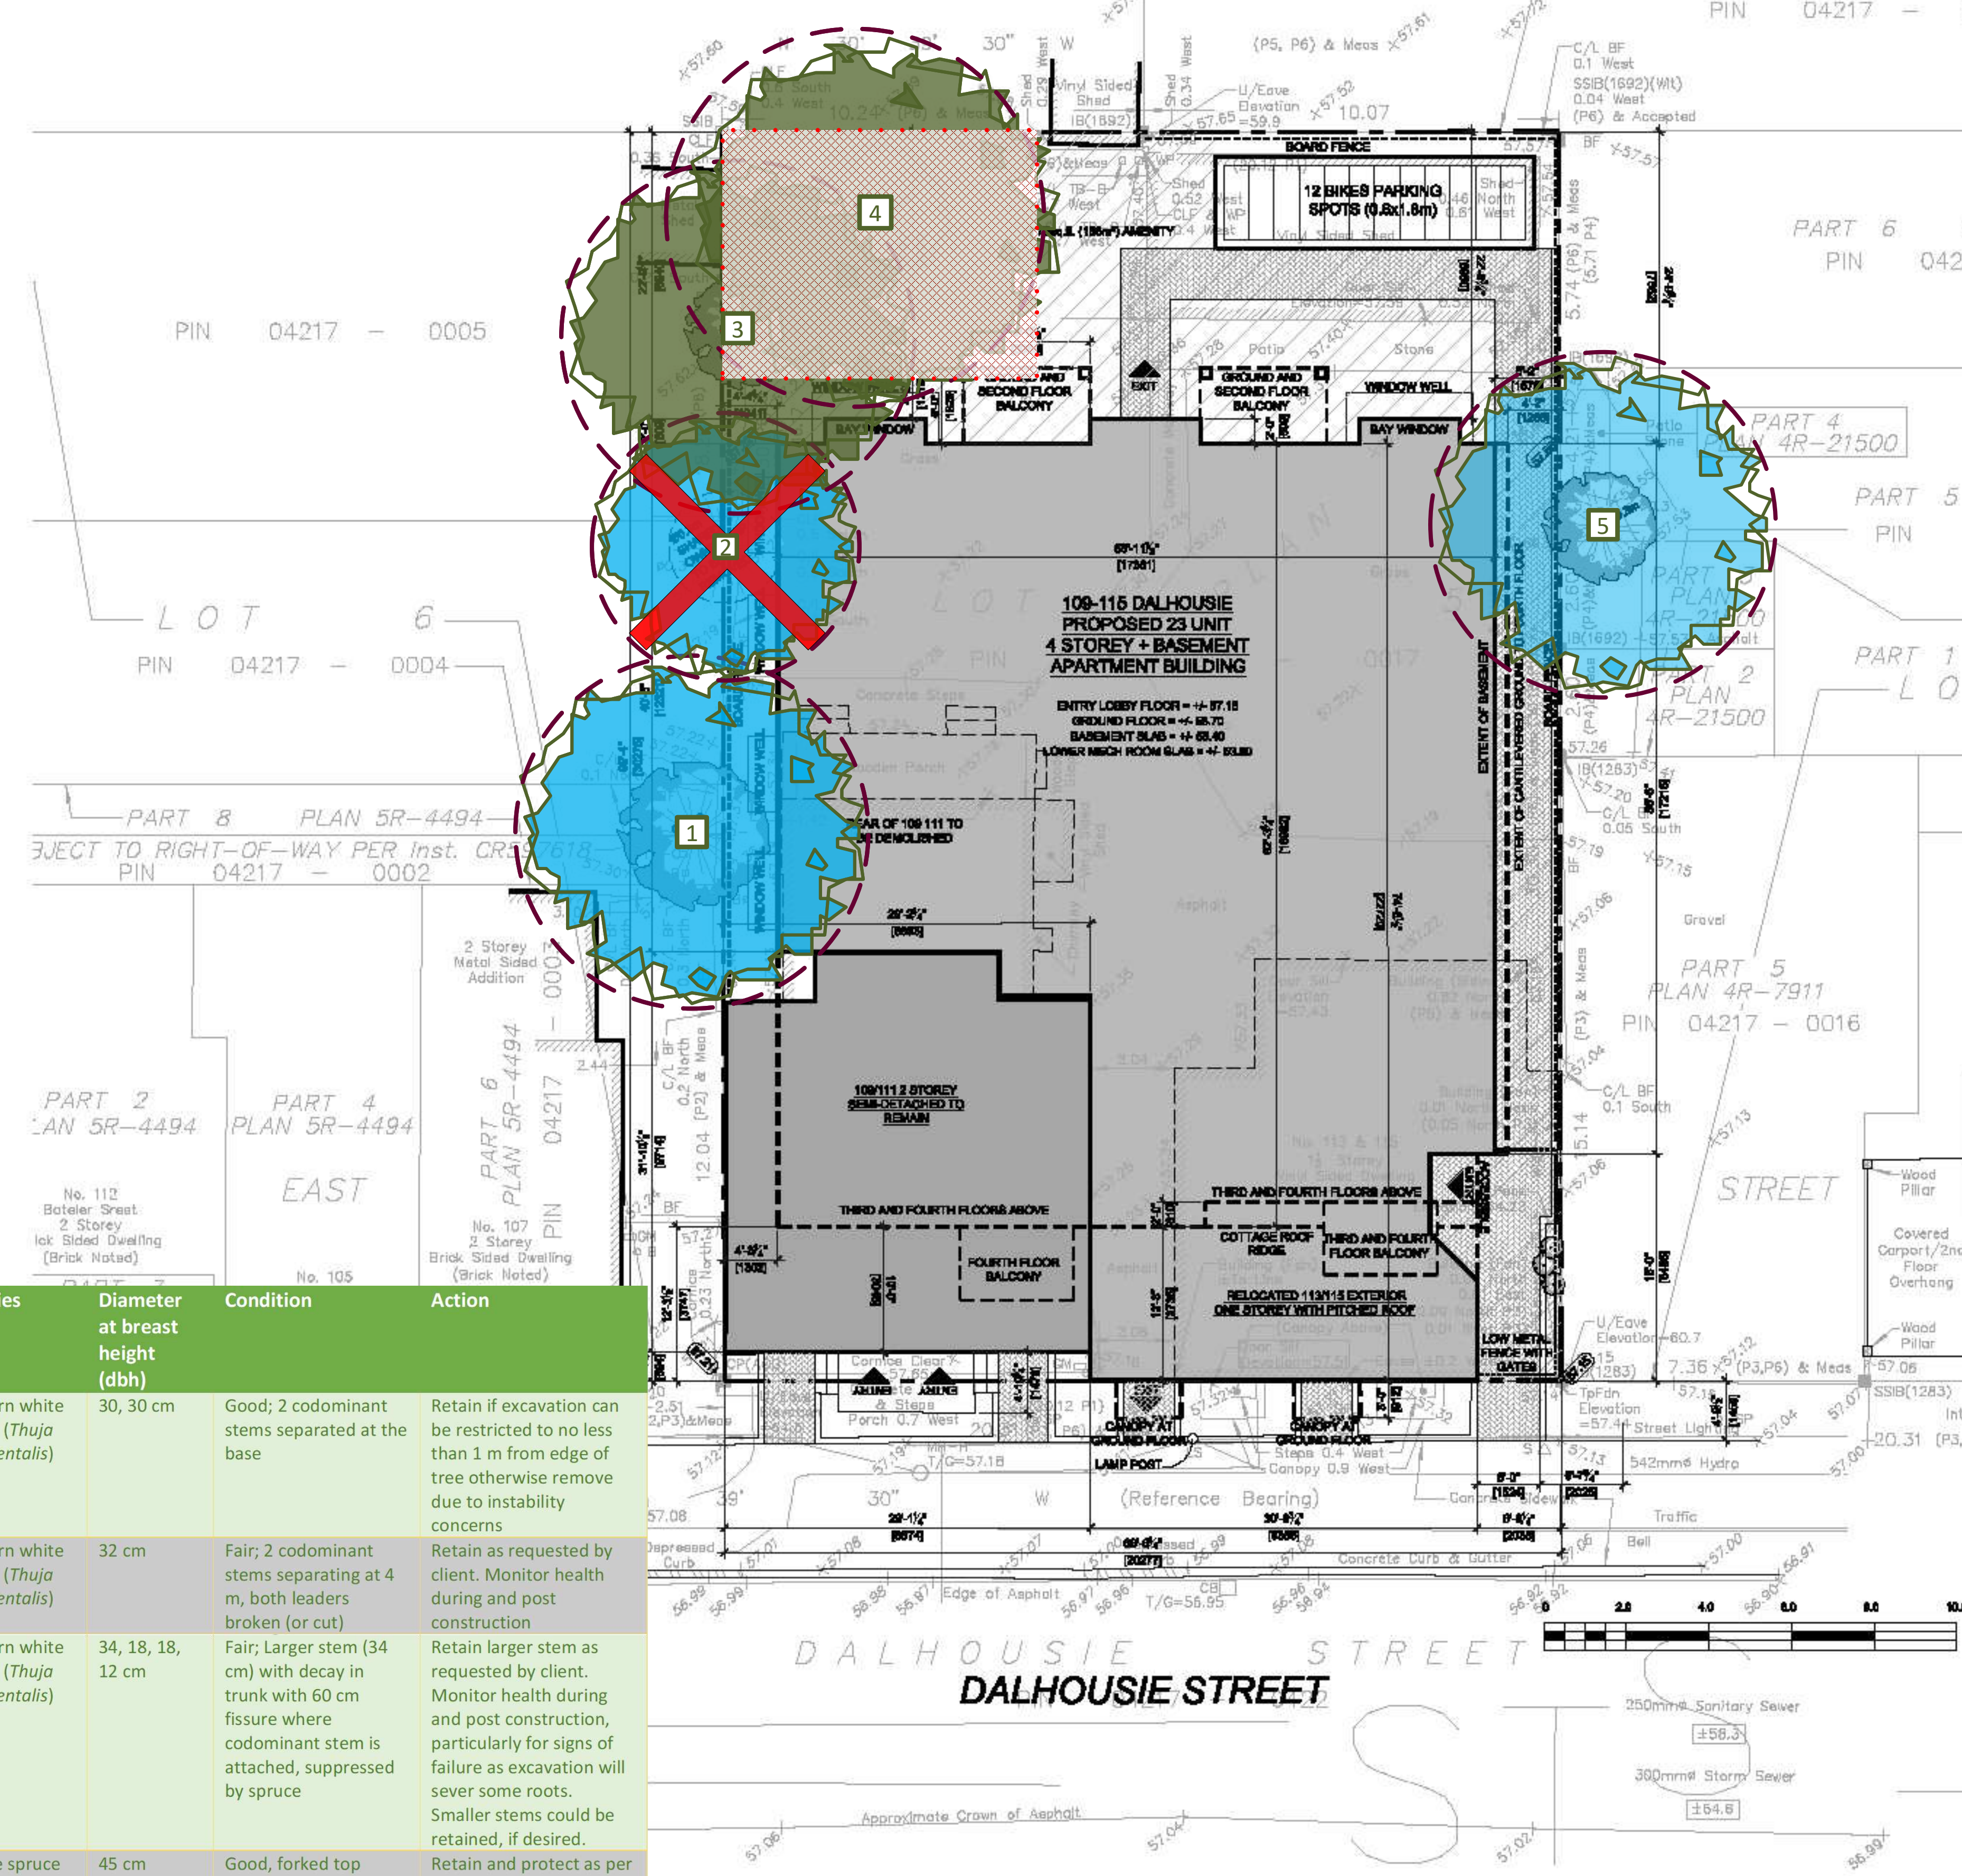
Tree Conservation Report – 109-115 Dalhousie  
 Tree layer prepared by Dendron Forestry Services  
 Version 2.0, February 16, 2022  
 For more information, please contact [info@dendronforestry.ca](mailto:info@dendronforestry.ca)

Tree	Species	Diameter at breast height (dbh)	Condition	Action
1	Eastern white cedar ( <i>Thuja occidentalis</i> )	30, 30 cm	Good; 2 codominant stems separated at the base	Retain if excavation can be restricted to no less than 1 m from edge of tree otherwise remove due to instability concerns
2	Eastern white cedar ( <i>Thuja occidentalis</i> )	32 cm	Fair; 2 codominant stems separating at 4 m, both leaders broken (or cut)	Retain as requested by client. Monitor health during and post construction
3	Eastern white cedar ( <i>Thuja occidentalis</i> )	34, 18, 18, 12 cm	Fair; Larger stem (34 cm) with decay in trunk with 60 cm fissure where codominant stem is attached, suppressed by spruce	Retain larger stem as requested by client. Monitor health during and post construction, particularly for signs of failure as excavation will sever some roots. Smaller stems could be retained, if desired.
4	White spruce ( <i>Picea glauca</i> )	45 cm	Good, forked top	Retain and protect as per protection measures in report

5	Eastern white cedar ( <i>Thuja occidentalis</i> )	42 cm	Good; 2 codominant stems, 20 cm grade higher than subject property	Retain
