Fluvial Geomorphological and Erosion Threshold Assessment, Tributary of Cardinal Creek

1296 and 1400 Old Montreal Road
City of Ottawa, Ontario

Submitted:
November 11, 2024

GEO Morphix Project No. 23076

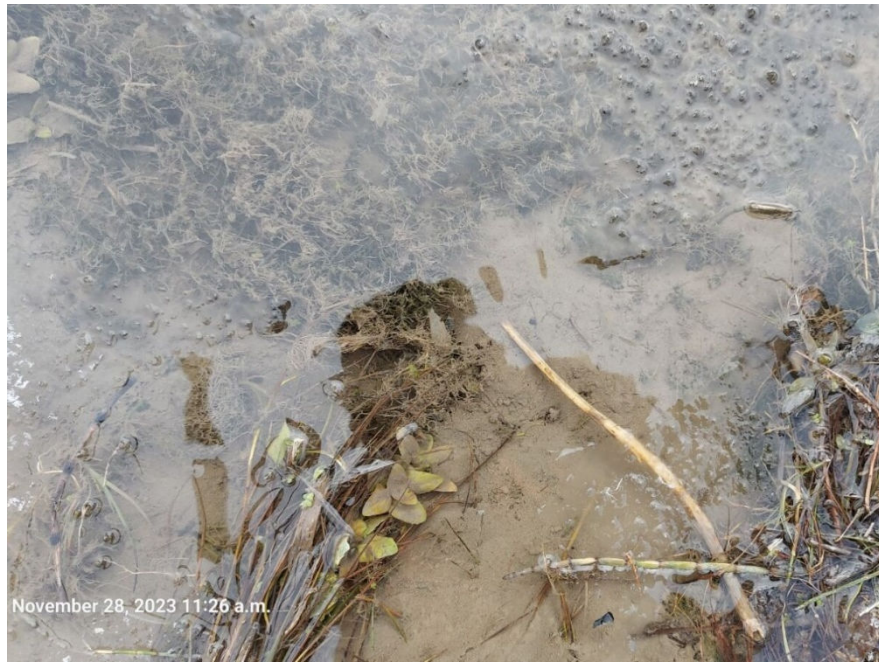
Photo 3
Tributary of Cardinal Creek
Reach: R1

Photograph taken facing the channel bed at **R1**. The bed and banks were composed of compact silt. Instream vegetation covered approximately 60-80% of the reach.

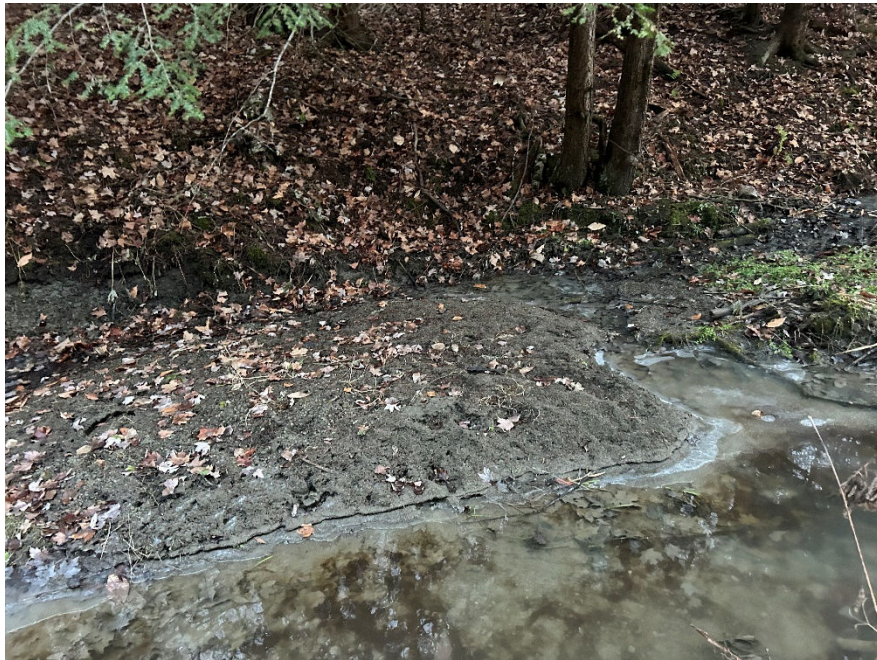
Photo 18
Tributary of Cardinal Creek
Reach: R2A

Photograph taken facing the left bank along **R2A**. Multiple flow paths (2-3) travelled within the valley walls and through the historic beaver meadow.

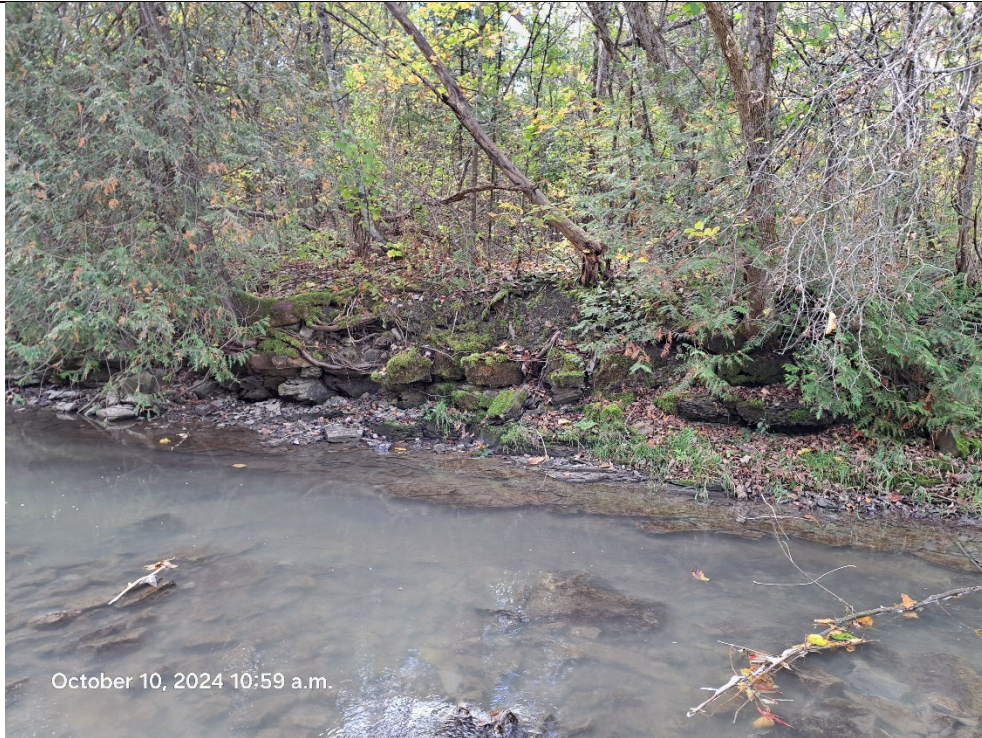
Photo 42
Tributary of Cardinal Creek
Reach: C10

Photograph taken facing the left bank near cross-section 6. Bank materials consisted of clayey and sandy soils containing gravel deposits, with exposed local calciferous bedrock.

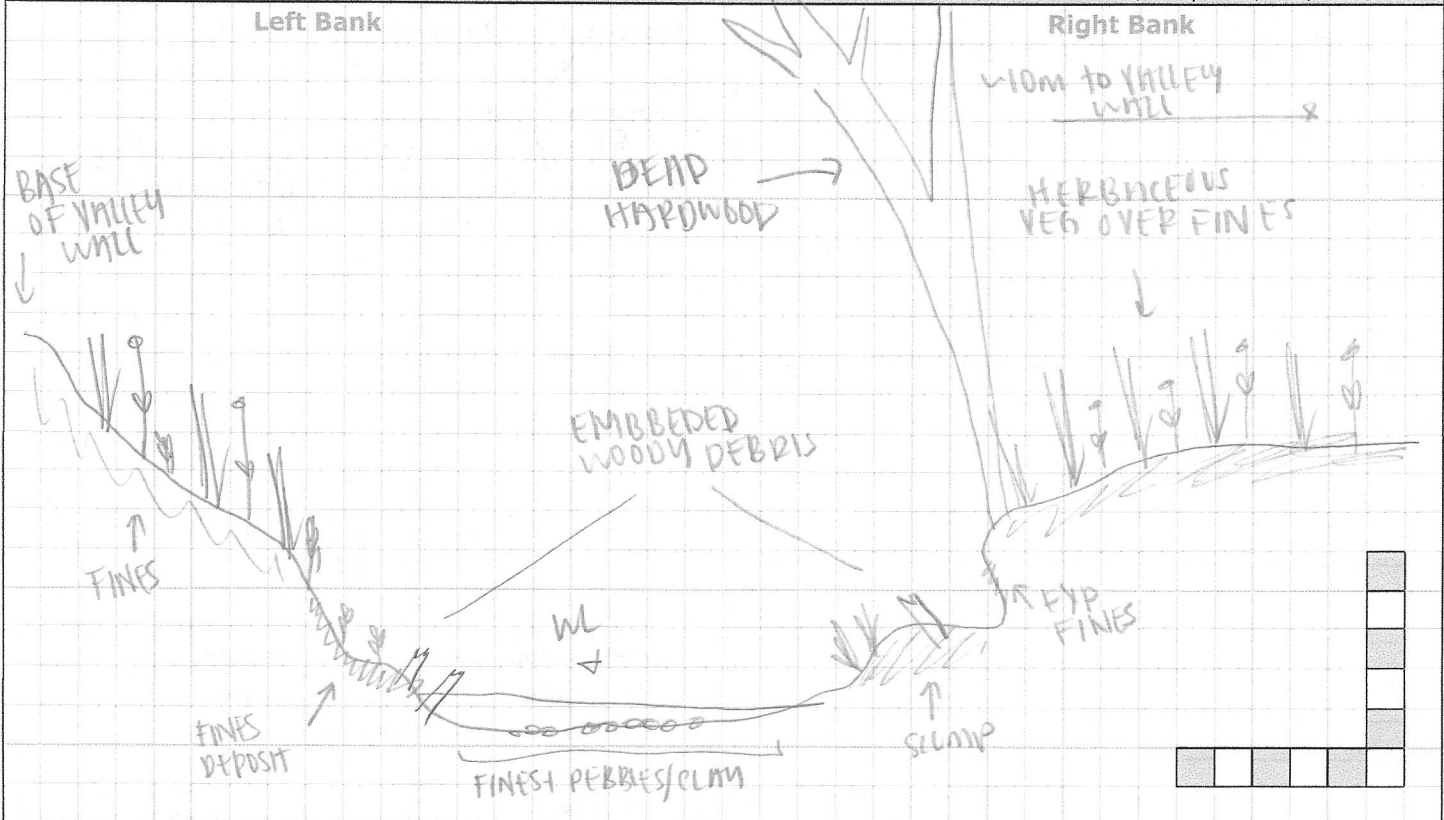
Date:	<u>2024-08-06</u>	Cross-section:	<u>XS3</u>
Time:	<u>11:46am</u>	Reach:	<u>R3</u>
Weather:	<u>SUN 25°C</u>	Location:	<u>ORLEANS</u>
Field Staff:	<u>KM HM</u>	Watershed/Subwatershed:	<u>CARDINAL CREEK</u>

Left Bank Materials			Features		Right Bank Materials		
<input type="checkbox"/> Bedrock	<input type="checkbox"/> Gravel			Station location	<input type="checkbox"/> Bedrock	<input type="checkbox"/> Gravel	
<input type="checkbox"/> Till	<input type="checkbox"/> Small Cobble			Monumented XS	<input type="checkbox"/> Till	<input type="checkbox"/> Small Cobble	
<input checked="" type="checkbox"/> Clay	<input type="checkbox"/> Large Cobble			Monumented photo	<input type="checkbox"/> Clay	<input type="checkbox"/> Large Cobble	
<input type="checkbox"/> Silt	<input type="checkbox"/> Small Boulder			Undercut bank	<input type="checkbox"/> Silt	<input type="checkbox"/> Small Boulder	
<input type="checkbox"/> Sand	<input type="checkbox"/> Large Boulder			Eroded bank/slope	<input type="checkbox"/> Sand	<input type="checkbox"/> Large Boulder	
Bank Height: <u>0.85</u> m				Bank stabilization	Bank Height: <u>0.55</u> m

Bank Angle: <u>30</u> °				Fence	Bank Angle: <u>25</u> °		
Root Depth: <u>0.07</u> m				Grasses	Root Depth: <u>0.11</u> m		
Root Density: <u>10</u> %				Leaning tree	Root Density: <u>30</u> %		
Undercut: <u>NO</u> m				Tree	Undercut: <u>0.28</u> m		
Erosion Pin: <u>N/A</u> m				Woody Debris	Erosion Pin: <u>N/A</u> m		
Torvane: <u>0.50</u> kg/cm ²				Sediment sample	Torvane: <u>0</u> kg/cm ²		
Penetrometer: <u>0.75</u> kg/cm ²				Erosion pin	Penetrometer: _____ kg/cm ²		
Foot Used: <input type="checkbox"/> Yes <input checked="" type="checkbox"/> No				Scour/bed chain	Foot Used: <input type="checkbox"/> Yes <input type="checkbox"/> No

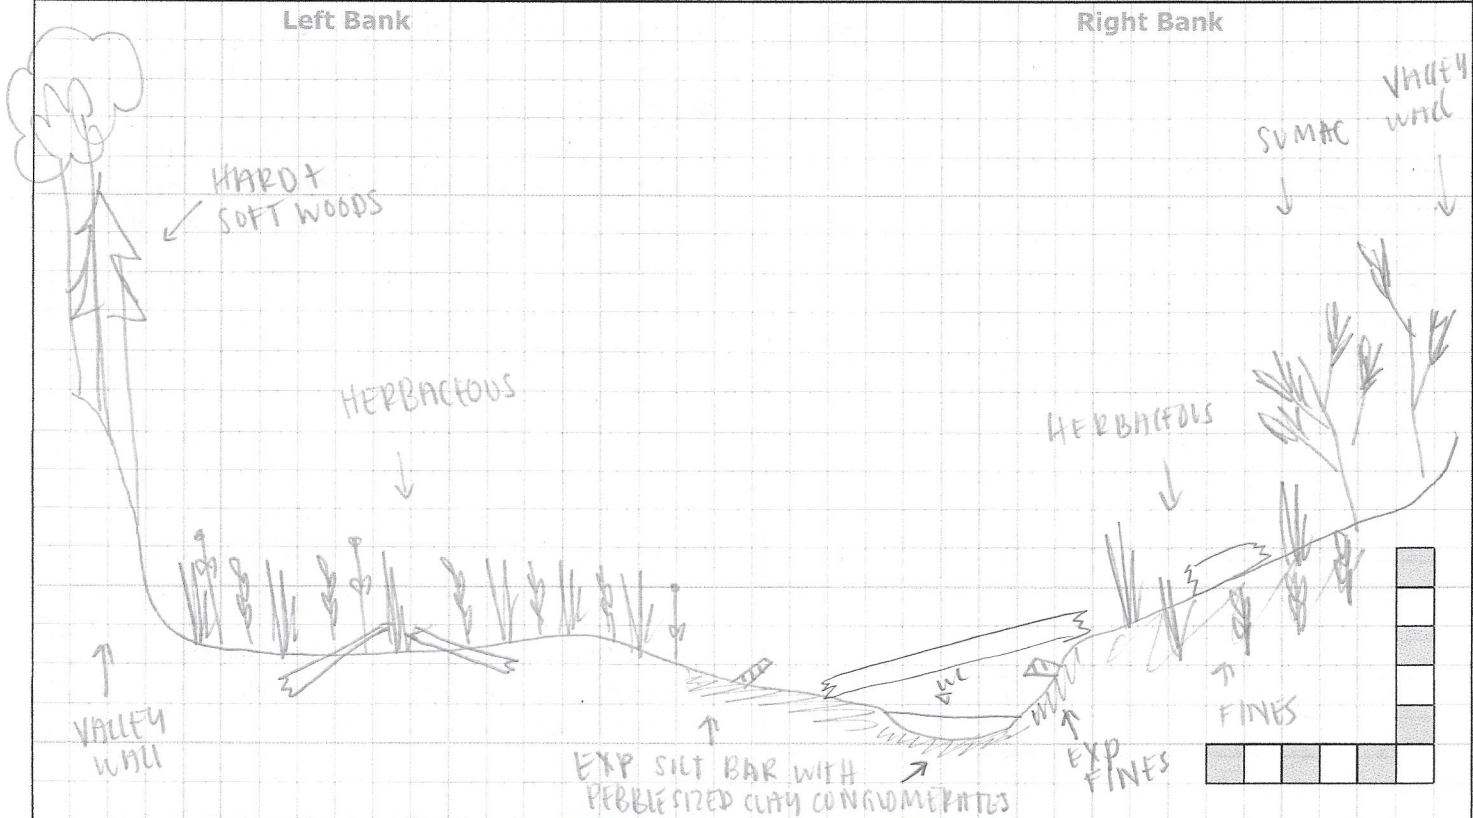
Date:	2024-08-06	Cross-section:	XSS-M
Time:	12:09 pm	Reach:	R3
Weather:	SUN 25°C	Location:	DREHNS
Field Staff:	KM HM	Watershed/Subwatershed:	CARDINAL CREEK

Left Bank Materials		Features		Right Bank Materials	
<input type="checkbox"/> Bedrock	<input type="checkbox"/> Gravel	Station location		<input type="checkbox"/> Bedrock	<input type="checkbox"/> Gravel
<input type="checkbox"/> Till	<input type="checkbox"/> Small Cobble	Monumented XS		<input type="checkbox"/> Till	<input type="checkbox"/> Small Cobble
<input checked="" type="checkbox"/> Clay	<input type="checkbox"/> Large Cobble	Monumented photo		<input checked="" type="checkbox"/> Clay	<input type="checkbox"/> Large Cobble
<input checked="" type="checkbox"/> Silt	<input type="checkbox"/> Small Boulder	Undercut bank		<input checked="" type="checkbox"/> Silt	<input type="checkbox"/> Small Boulder
<input type="checkbox"/> Sand	<input type="checkbox"/> Large Boulder	Eroded bank/slope		<input type="checkbox"/> Sand	<input type="checkbox"/> Large Boulder
Bank Height: <u>0.162</u> m		Bank stabilization		Bank Height: <u>0.52</u> m

Bank Angle: <u>15</u> °		Fence		Bank Angle: <u>40</u> °	
Root Depth: <u>0.06</u> m		Grasses		Root Depth: <u>0.16</u> m	
Root Density: <u>20</u> %		Leaning tree		Root Density: <u>20</u> %	
Undercut: <u>0.03</u> m		Tree		Undercut: <u>0.13</u> m	
Erosion Pin: <u>0.28</u> m		Woody Debris		Erosion Pin: <u>0.26</u> m	
Torvane: <u>0.75</u> kg/cm ²		Sediment sample		Torvane: <u>0.75</u> kg/cm ²	
Penetrometer: <u>0.50</u> kg/cm ²		Erosion pin		Penetrometer: <u>0.50</u> kg/cm ²	
Foot Used: <input type="checkbox"/> Yes <input checked="" type="checkbox"/> No		Scour/bed chain		Foot Used: <input type="checkbox"/> Yes <input checked="" type="checkbox"/> No

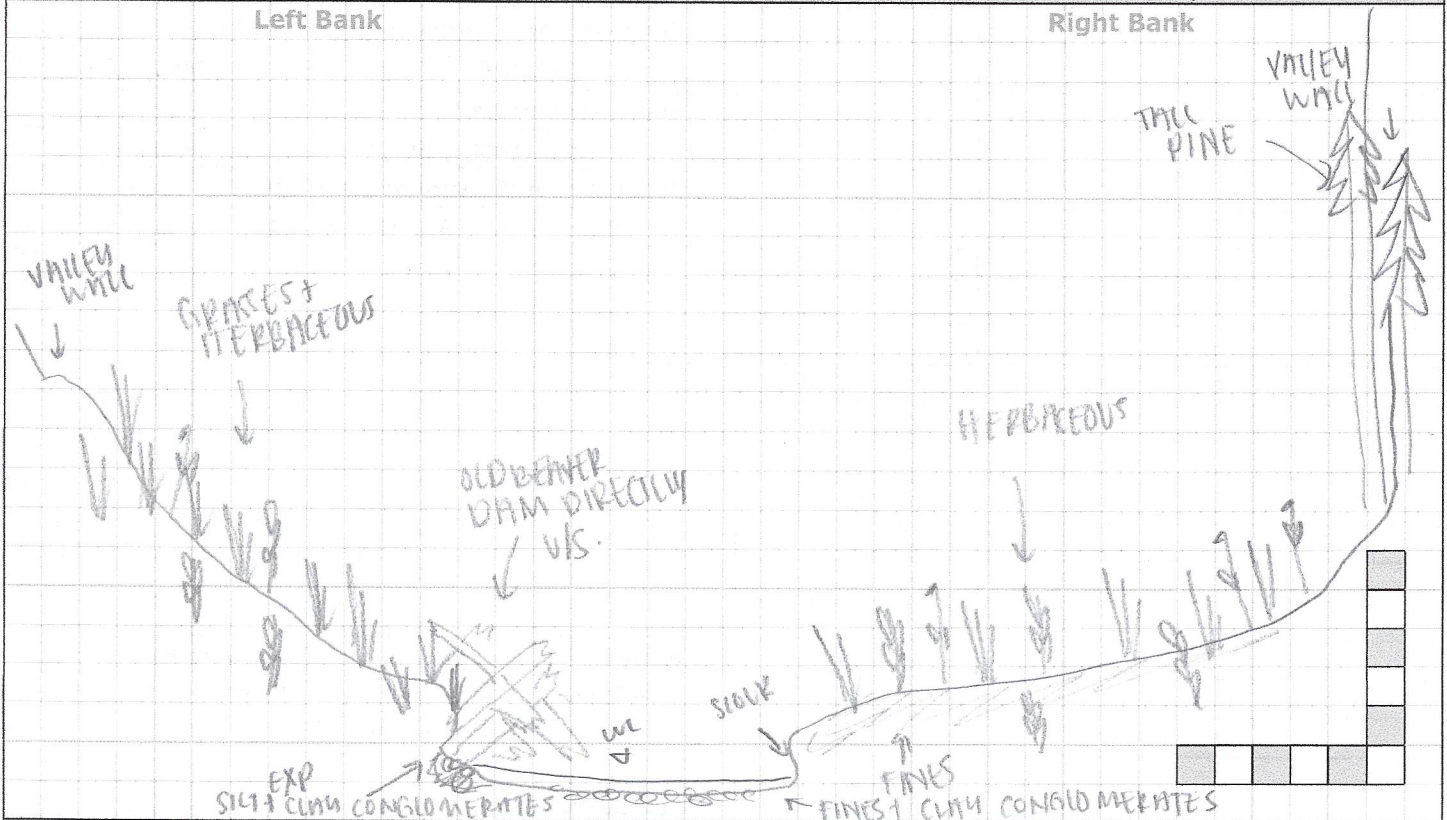
Date:	2024-08-06	Cross-section:	XS10
Time:	12:25pm	Reach:	R3
Weather:	SUN 25°C	Location:	ORLEANS
Field Staff:	KM HM	Watershed/Subwatershed:	CARDINAL CREEK

Left Bank Materials		Features		Right Bank Materials	
<input type="checkbox"/> Bedrock	<input type="checkbox"/> Gravel	Station location		<input type="checkbox"/> Bedrock	<input type="checkbox"/> Gravel
<input type="checkbox"/> Till	<input type="checkbox"/> Small Cobble	Monumented XS		<input type="checkbox"/> Till	<input type="checkbox"/> Small Cobble
<input checked="" type="checkbox"/> Clay	<input type="checkbox"/> Large Cobble	Monumented photo		<input checked="" type="checkbox"/> Clay	<input type="checkbox"/> Large Cobble
<input checked="" type="checkbox"/> Silt	<input type="checkbox"/> Small Boulder	Undercut bank		<input checked="" type="checkbox"/> Silt	<input type="checkbox"/> Small Boulder
<input type="checkbox"/> Sand	<input type="checkbox"/> Large Boulder	Eroded bank/slope		<input type="checkbox"/> Sand	<input type="checkbox"/> Large Boulder
Bank Height: <u>0.60</u> m		Bank stabilization		Bank Height: <u>0.50</u> m

Bank Angle: <u>50</u> °		Fence		Bank Angle: <u>45</u> °	
Root Depth: <u>0.09</u> m		Grasses		Root Depth: <u>0.13</u> m	
Root Density: <u>10</u> %		Leaning tree		Root Density: <u>10</u> %	
Undercut: <u>0.05</u> m		Tree		Undercut: <u>0.02</u> m	
Erosion Pin: <u>N/A</u> m		Woody Debris		Erosion Pin: <u>N/A</u> m	
Torvane: <u>0</u> kg/cm ²		Sediment sample		Torvane: <u>1.00</u> kg/cm ²	
Penetrometer: <u>0.50</u> kg/cm ²		Erosion pin		Penetrometer: <u>0.50</u> kg/cm ²	
Foot Used: <input type="checkbox"/> Yes <input checked="" type="checkbox"/> No		Scour/bed chain		Foot Used: <input type="checkbox"/> Yes <input checked="" type="checkbox"/> No

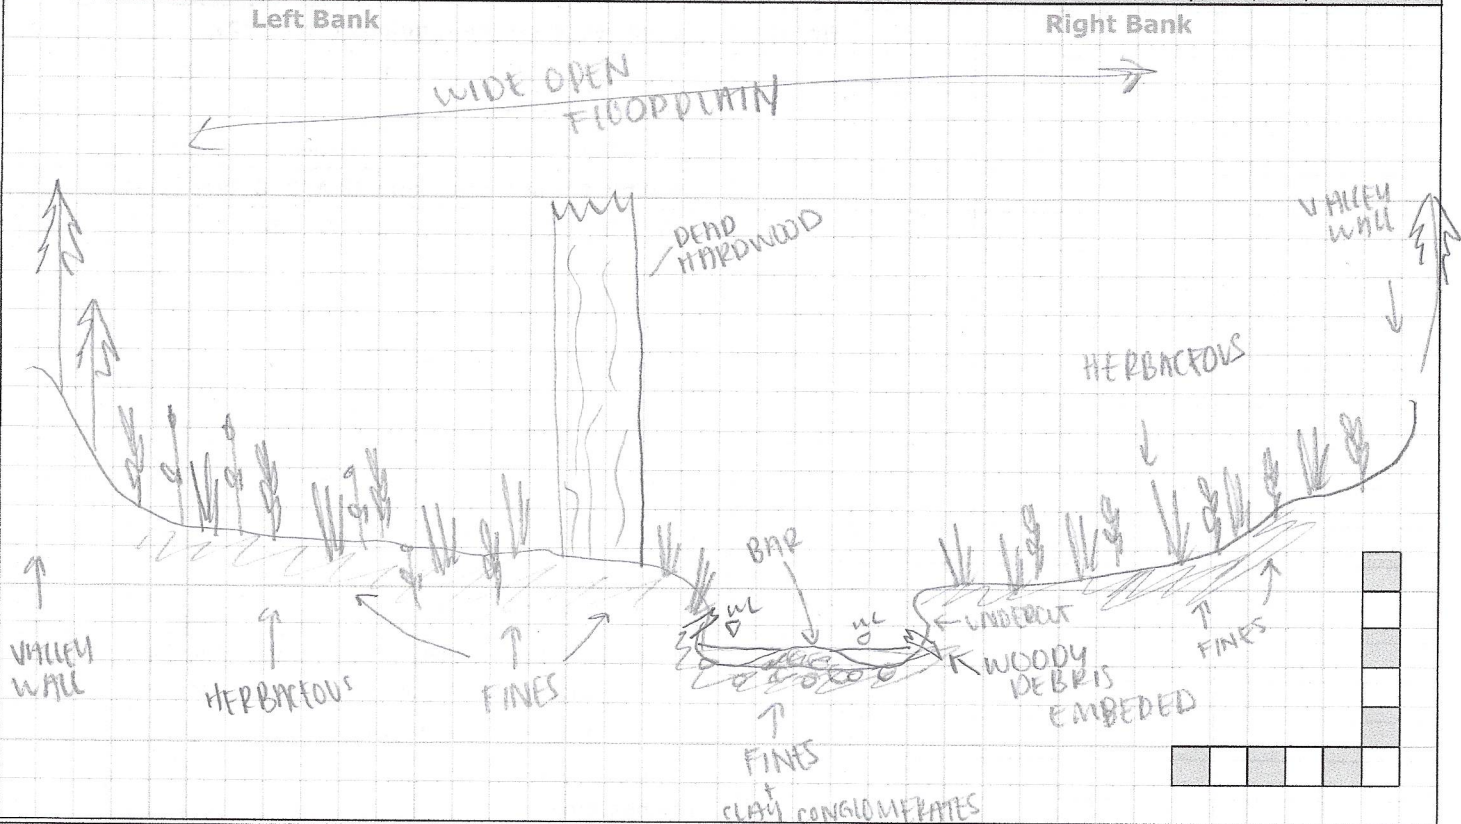
Date:	2024-08-06	Cross-section:	XS 7
Time:	12:41pm	Reach:	R3
Weather:	SUN 25°C	Location:	ORLEANS
Field Staff:	KM HM	Watershed/Subwatershed:	CARDINAL CREEK

Left Bank Materials	
<input type="checkbox"/> Bedrock	<input type="checkbox"/> Gravel
<input type="checkbox"/> Till	<input type="checkbox"/> Small Cobble
<input checked="" type="checkbox"/> Clay	<input type="checkbox"/> Large Cobble
<input checked="" type="checkbox"/> Silt	<input type="checkbox"/> Small Boulder
<input type="checkbox"/> Sand	<input type="checkbox"/> Large Boulder
Bank Height:	0.100 m
Bank Angle:	25 °
Root Depth:	0.10 m
Root Density:	15 %
Undercut:	NO m
Erosion Pin:	N/A m
Torvane:	0.50 kg/cm ²
Penetrometer:	0.50 kg/cm ²
Foot Used:	<input type="checkbox"/> Yes <input type="checkbox"/> No

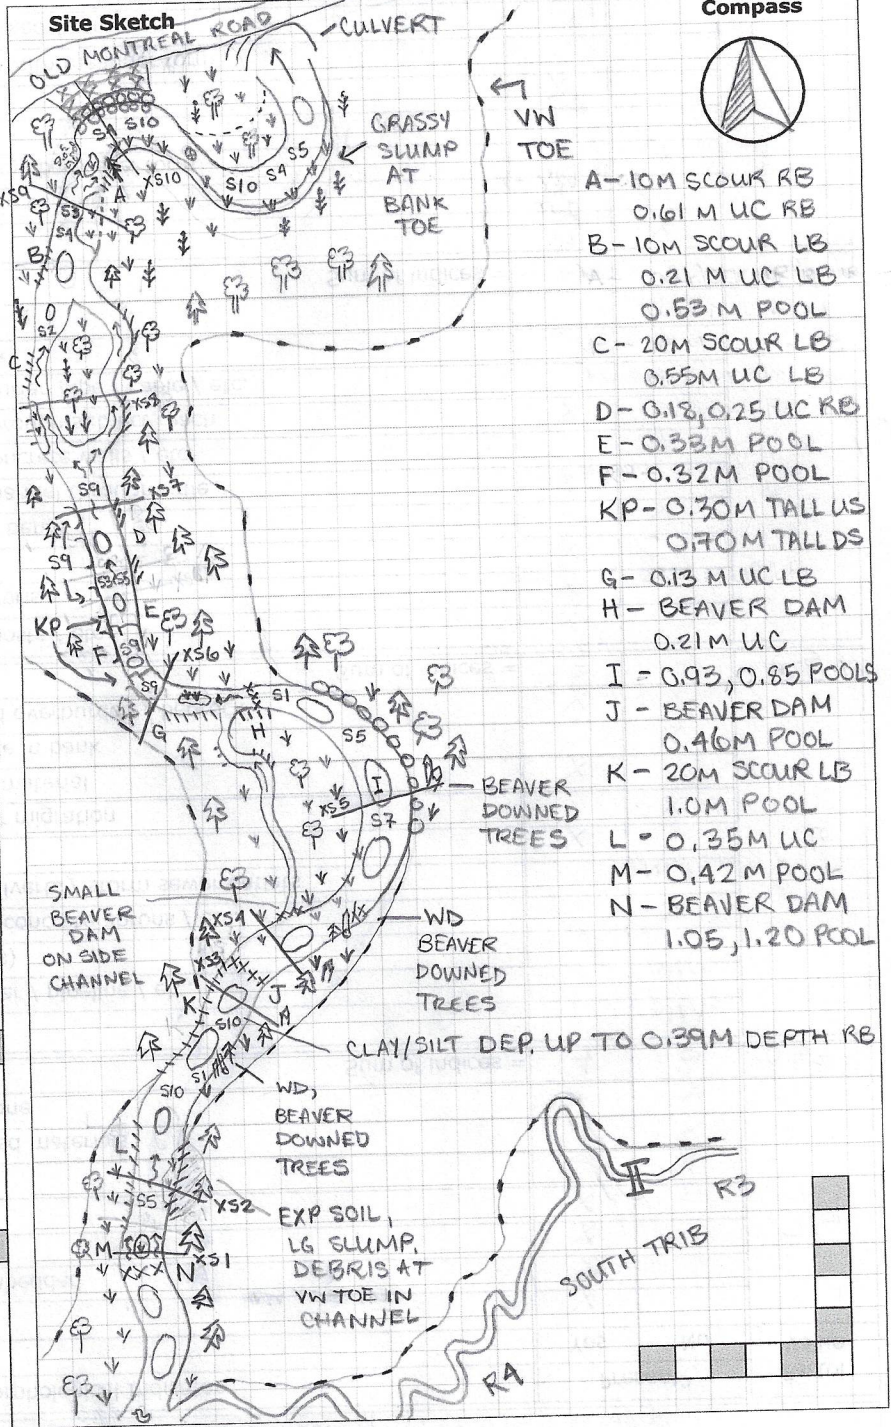
Notes: ISLANDS W/ TREES IN 2 LOCATIONS, ISLANDS

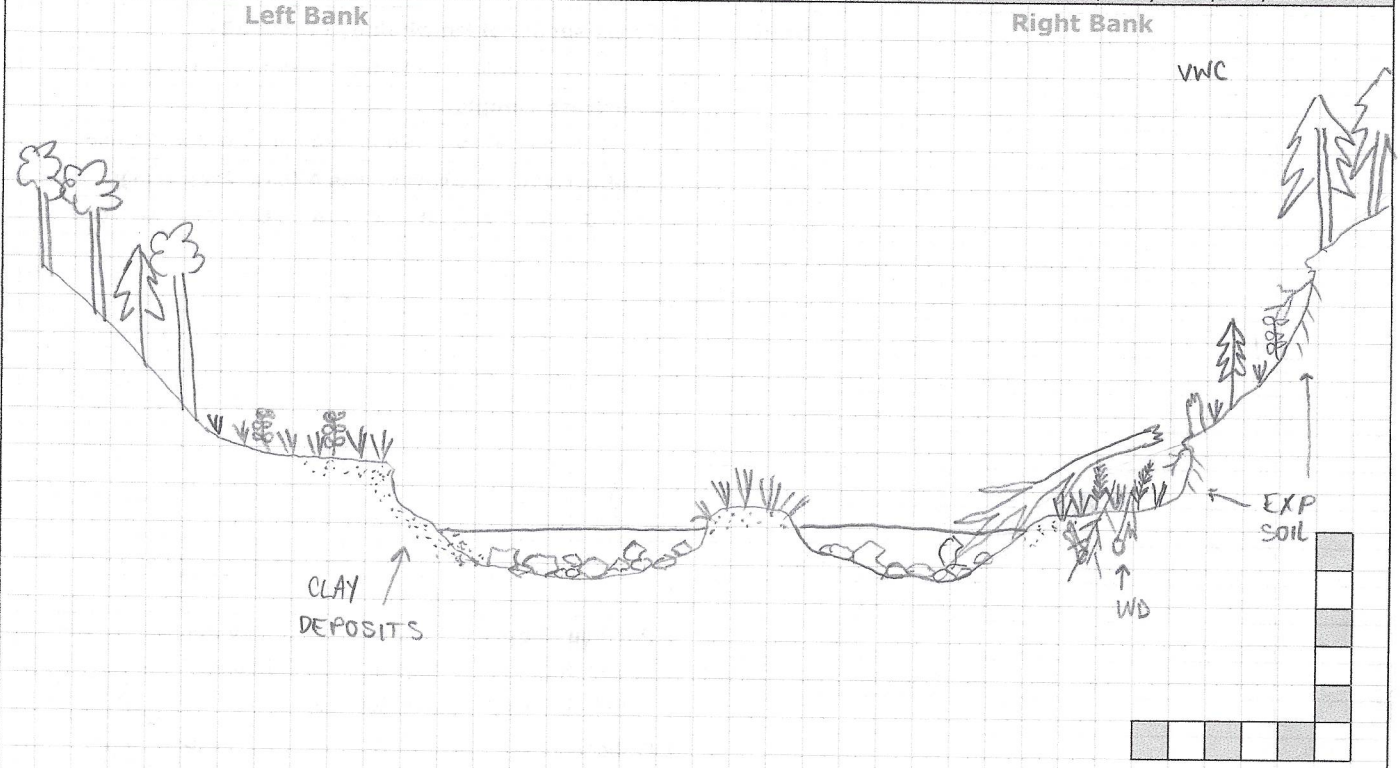
Date:	10-10-24	Cross-section:	XSI
Time:	12:00	Reach:	C10
Weather:	10°C SUN/CLOUD	Location:	CARDINAL CREEK
Field Staff:	KS CM MK	Watershed/Subwatershed:	OTTAWA RIVER

Left Bank Materials	
<input type="checkbox"/> Bedrock	<input type="checkbox"/> Gravel
<input type="checkbox"/> Till	<input type="checkbox"/> Small Cobble
<input checked="" type="checkbox"/> Clay	<input type="checkbox"/> Large Cobble
<input type="checkbox"/> Silt	<input type="checkbox"/> Small Boulder
<input type="checkbox"/> Sand	<input type="checkbox"/> Large Boulder
Bank Height:	<u>0.75</u> m
Bank Angle:	<u>55</u> °
Root Depth:	<u>0.20</u> m
Root Density:	<u>10</u> %
Undercut:	<u>0</u> m
Erosion Pin:	<u>—</u> m
Torvane:	<u>1.0</u> kg/cm ²
Penetrometer:	<u>0.75</u> kg/cm ²
Foot Used:	<input type="checkbox"/> Yes <input checked="" type="checkbox"/> No

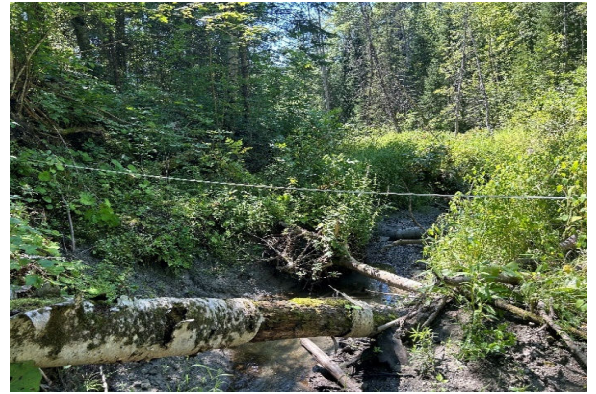
Photograph at cross section 1 (looking downstream)

Reach **R3** was characterized by a sinuous channel set within a confined, wooded valley. The valley floor was previously inundated due to beaver activity and had since drained to reveal accumulated fine sediment deposits (e.g. clay to sand sized particles). Short grasses and herbaceous vegetation are populating the deposits, forming a beaver meadow. At the time of inspection, a channel was forming within the meadow and actively reworking the deposits of fine sediments. The channel bed morphology consisted of alternating riffle-pool sequences comprised primarily of fine sediments. A small proportion of the channel sediments were gravel sized and were generally limited to riffle features. The channel banks were vegetated but were relatively soft in composition and thus sensitive to erosion (e.g. slumping). The channel exhibited evidence of systematic aggradation and widening. For example, channel banks were generally unstable and in-channel bars/fine sediment deposits were common.
