FLUVIAL GEOMORPHIC AND EROSION HAZARD ASSESSMENT
STINSON LANDS
OTTAWA, ONTARIO

Prepared for:
NOVATECH ENGINEERING AND CONSULTANTS LTD.

Prepared by:
MATRIX SOLUTIONS INC.

Version 1.0
November 2022
Guelph, Ontario

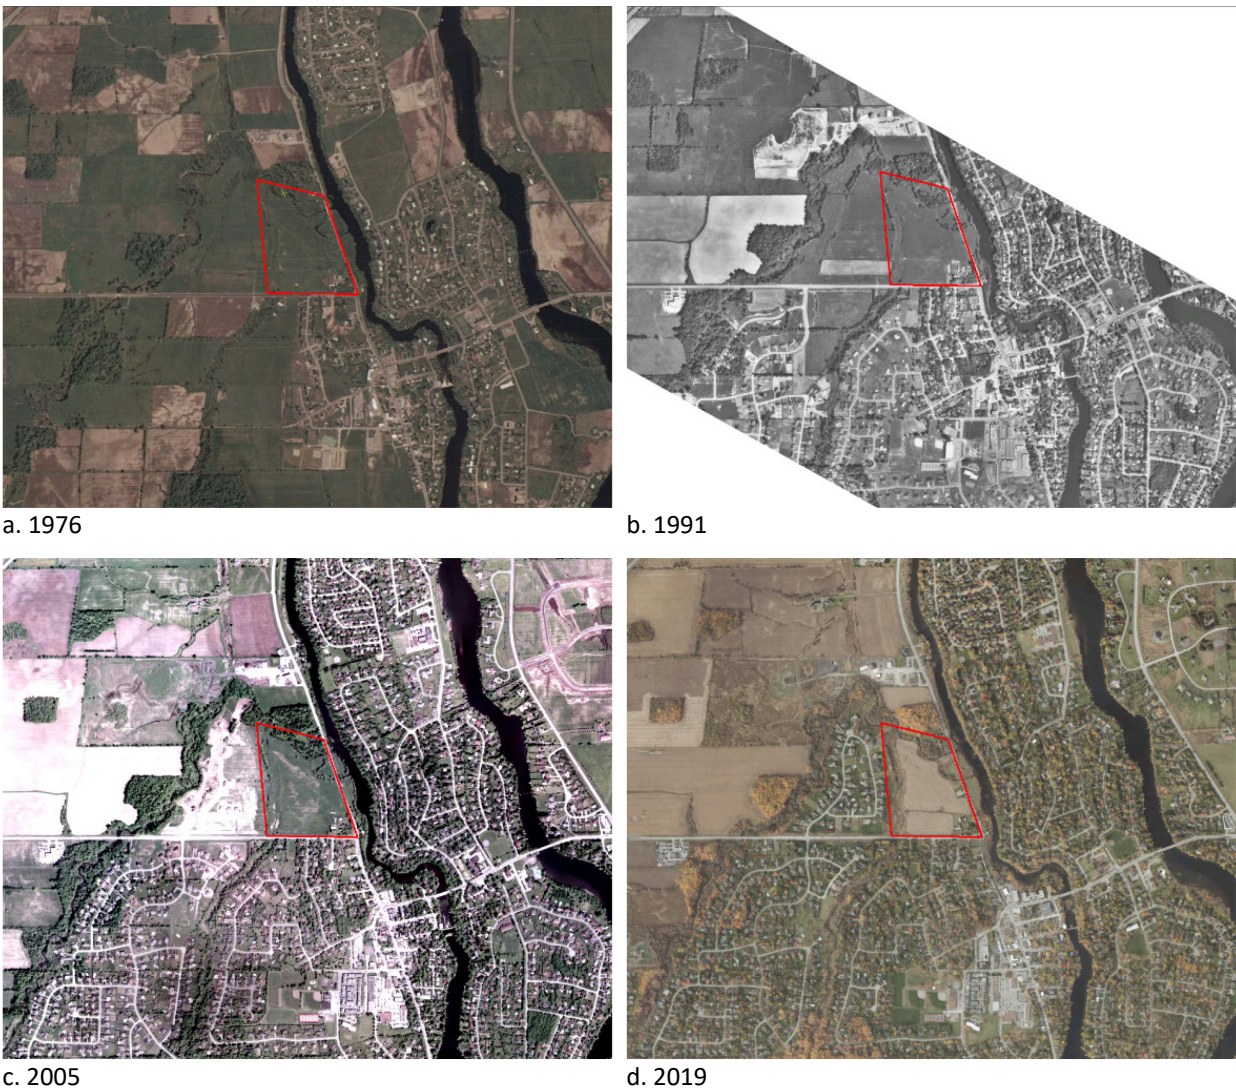
FIGURE 3 Historic Land Use and Development Expansion Around the Stinson Lands Study Site

In 1954, land use surrounding the study area consisted of vacant open land, agricultural fields, and wood lots. Mud Creek exhibited a sinuous planform with well-established meanders, some woody vegetation along the northern valley slope, and a wide floodplain bound by valley walls. However, it is apparent that some channelization likely happened prior to 1954 as the planform straightens on approach to the Rideau River. As a result, there is a cutoff feature (oxbow) in the floodplain to the south of the main channel. This cutoff was not visible in 1954 but can be seen in the remainder of the available air photographs and has been confirmed through field surveys. The Wilson-Cowan Drain was also sinuous, set within a small

valley with a well-defined, narrow floodplain but with sparse woody vegetation. Aerial photographs from 1976 reveal that no major changes had occurred to the area surrounding Mud Creek or the Wilson-Cowan Drain immediately upstream of Stinson Lands. By 1991, significant urbanization had occurred south of the study site, with the town of Manotick bordering the Stinson Lands and multiple developments encroaching on Mud Creek to the north and south; however, there is no indication of the creek being modified. Air photographs from 2002 show minimal adjustment in the planform of each creek, as it maintains well-vegetated riparian areas in most of the surrounding area. Construction of a subdivision along the west side of the Wilson-Cowan Drain began in 2005, set back from the valley top. This development area is visible in the 2015 photograph; however, limited development expansion was evident in 2019, and planform adjustment revealed little to no change.

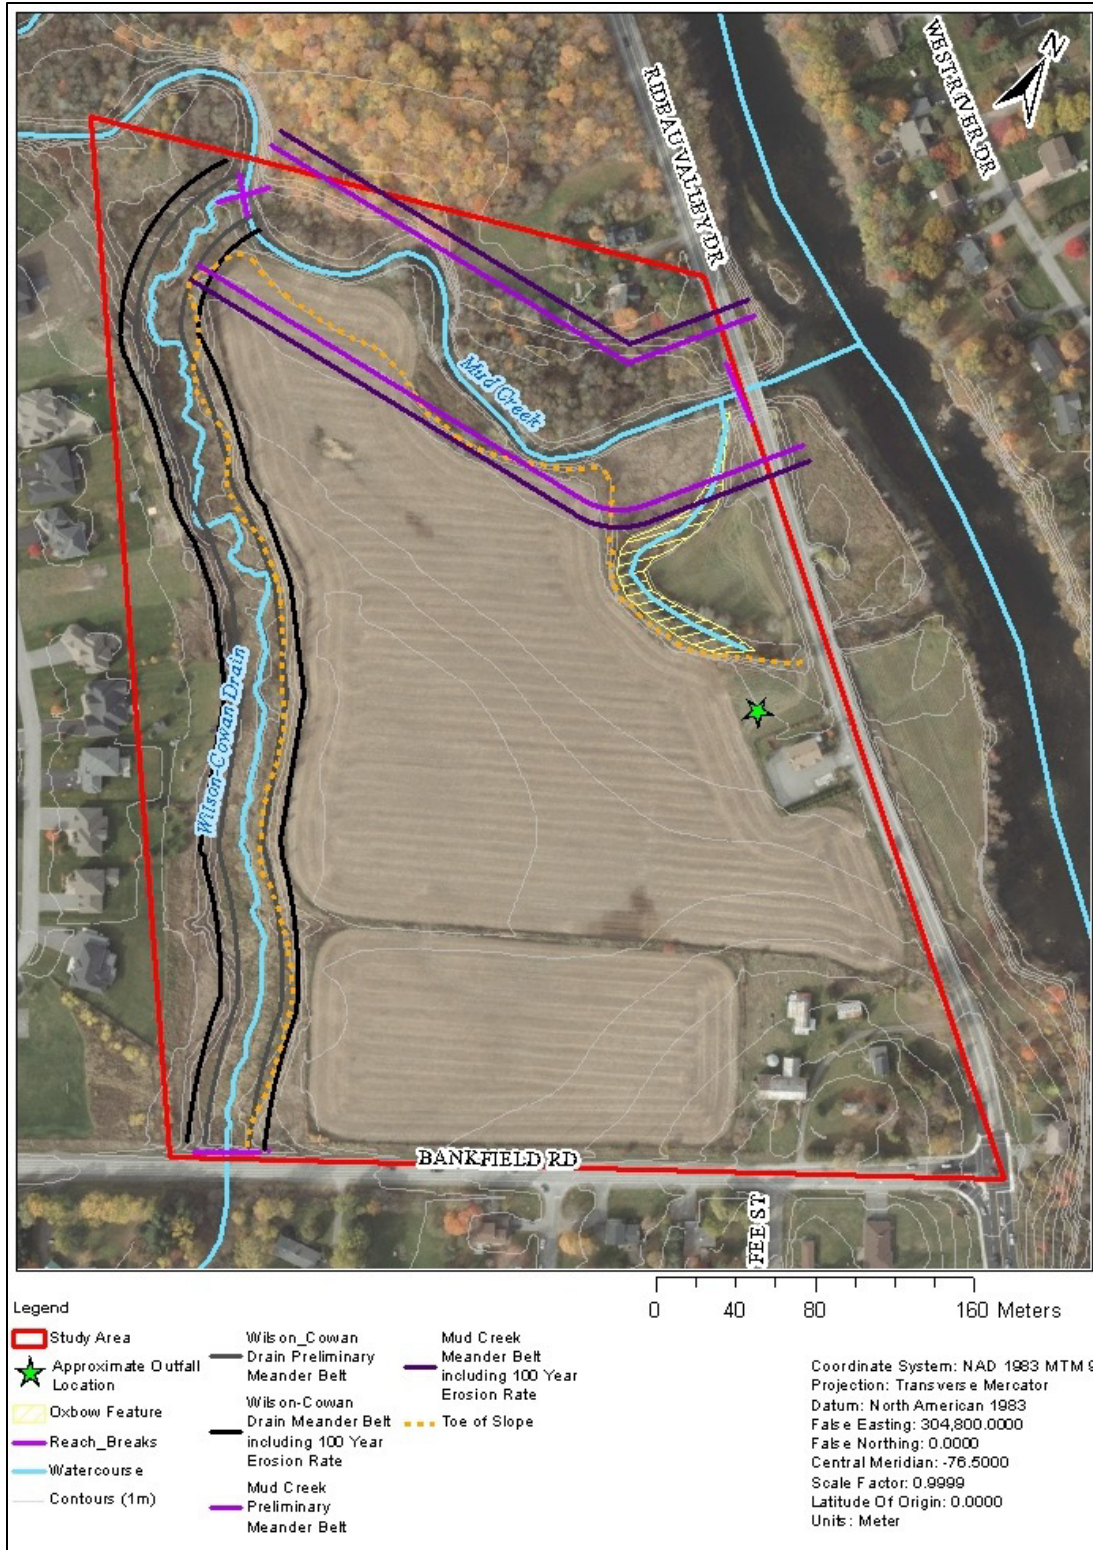
FIGURE 6 Meander Belt Delineation

The confinement of the two channels varied can be seen in Figure 6, meaning the greater hazard of the two approaches was used to provide a final hazard limit. Clay-silt was noted as the dominant substrate during the field investigations, and due to evidence of erosion noted within both channels, a toe erosion allowance of 5 m was selected using the Technical Guide (MNR 2002b) for areas where the watercourse was within 15 m of the valley toe. This value of 5 m also agrees with the findings and recommendations of the Paterson Group Inc. (2021), which applied a 5 m toe erosion allowance to Mud Creek due to its soil type and erosion activity. The 5 m toe erosion allowance was also applied to the Wilson-Cowan Drain due to the observed soil type and the active erosion noted during the field investigations. This value differs from the 1 m toe erosion allowance reported in the Paterson (2021) geotechnical study, as they had not observed active erosion.

Mud Creek and the Wilson-Cowan Drain can be considered confined channels, as their meander belt widths with 100-year erosion rates extend beyond the toe of slope.

The preliminary meander belt width derived for the unconfined portion of Mud Creek is 60 m, as determined from the maximum meander amplitude offset from the meander axis. A 100-year erosion rate of 0.2 m/year (or 20 m per 100 years) was calculated, resulting in a final meander belt width of 80 m. For Wilson-Cowan Drain, the preliminary meander belt was determined to be 22 m in width. The final meander belt was determined by adding a 100-year erosion rate of 17 m as a factor of safety, resulting in a 38 m corridor (Figure 6). In this instance, the meander belt extends beyond the toe and top-of-slope within this confined valley setting.

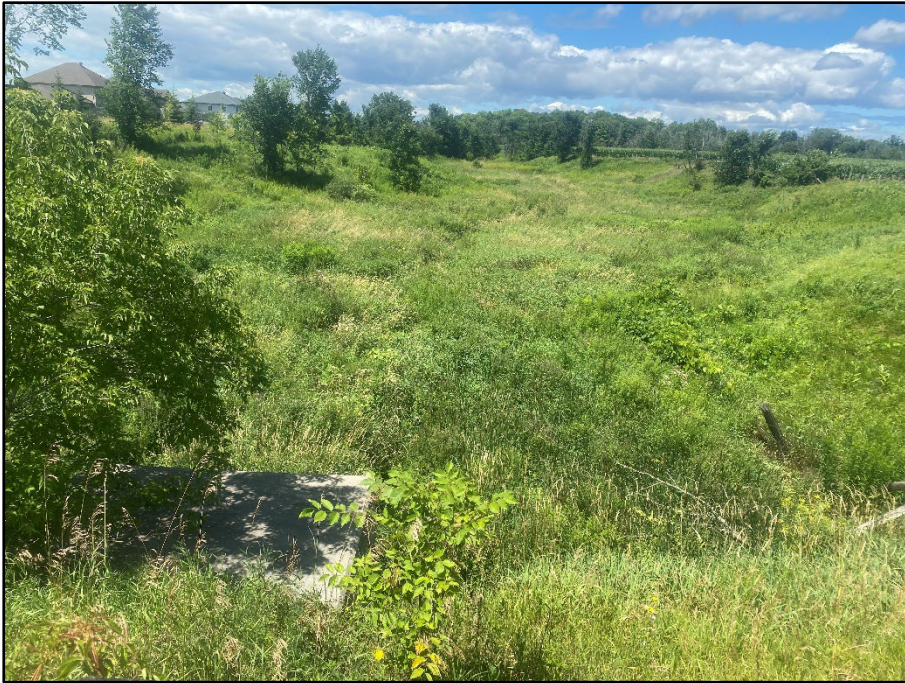
1. Wilson Cowan Drain - Facing downstream, Wilson-Cowan Drain and valley from Bankfield Road

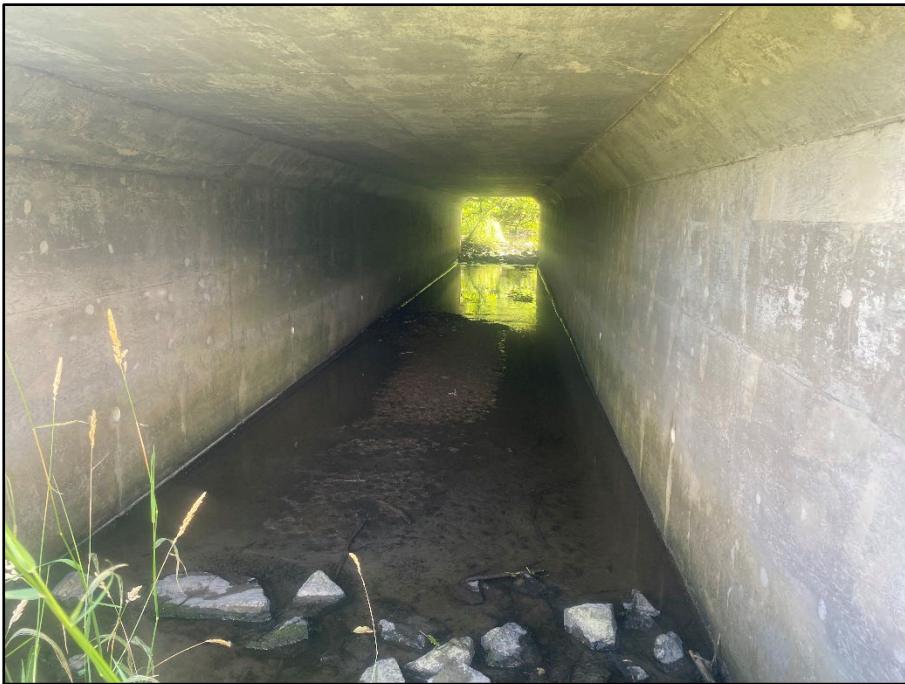
2. Wilson Cowan Drain - Facing upstream from outlet of culvert passing under Bankfield Road

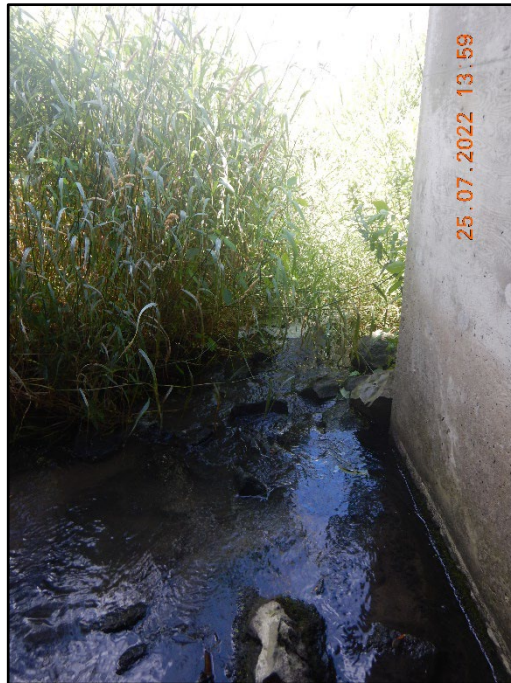
3. Wilson Cowan Drain - Facing downstream from inside culvert, the flow path is to the right side of the culvert flowing into a defined channel

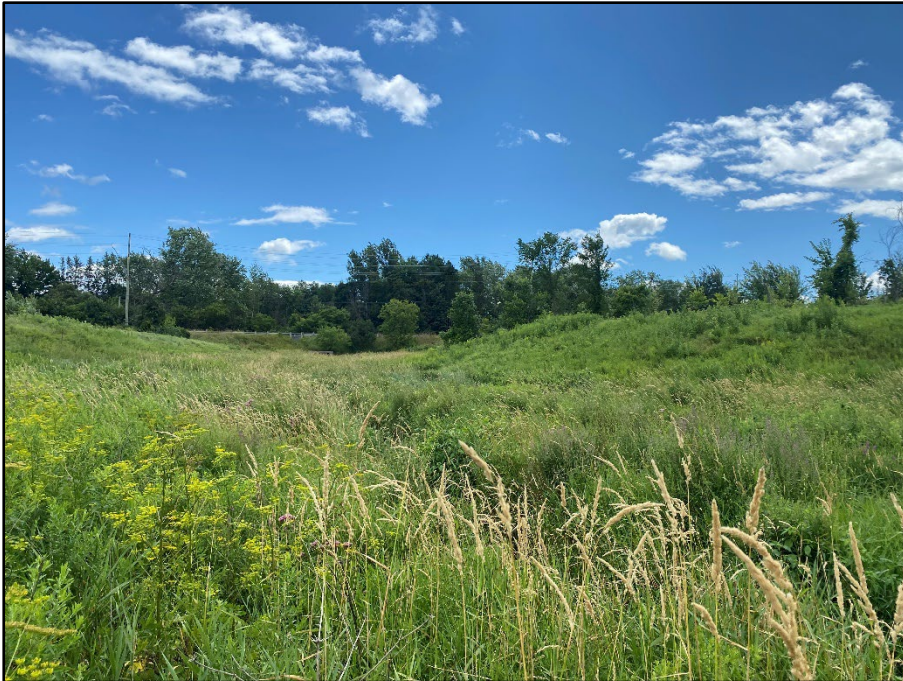
Results of the rapid assessments classified this section of the Wilson-Cowan Drain as In Regime or stable (RGA) and of Moderate stream health (RSAT) with scores of 0.093 and 27, respectively (Tables 3 and 4). Very few geomorphic indicators were observed, and solely those indicative of channel widening, including basal scour along most of the reach and fracture lines on the top-of-bank. It is likely that channel widening will continue to occur as a lot of the banks lack well-rooted vegetation.

5. Wilson Cowan Drain - Looking upstream, despite being well vegetated, the channel maintains it's definition along the reach

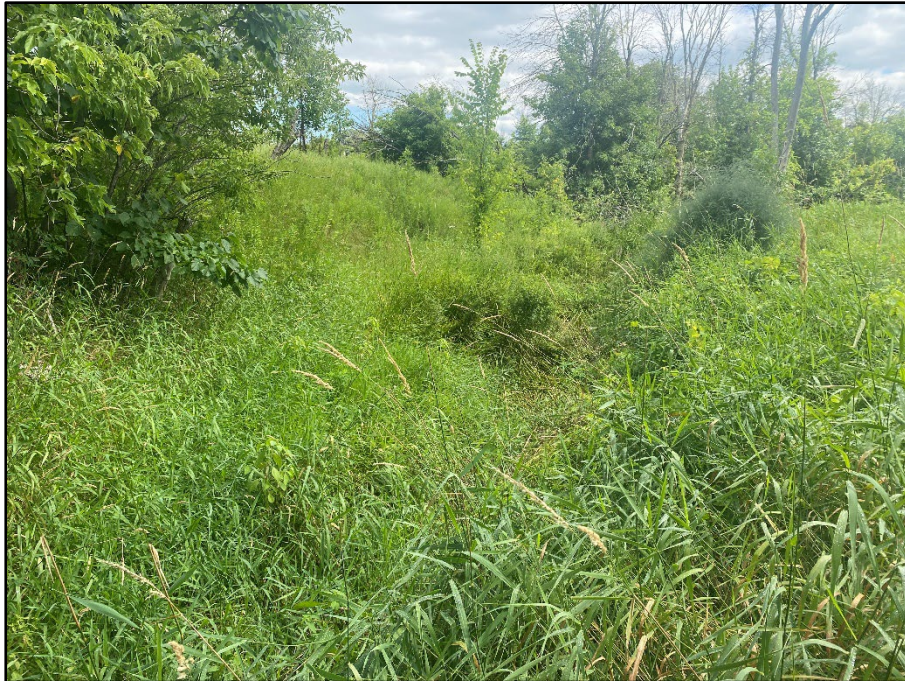
11. Oxbow Feature— Facing upstream from confluence with Mud Creek, feature is a defined valley that's heavily vegetated with grasses and reeds

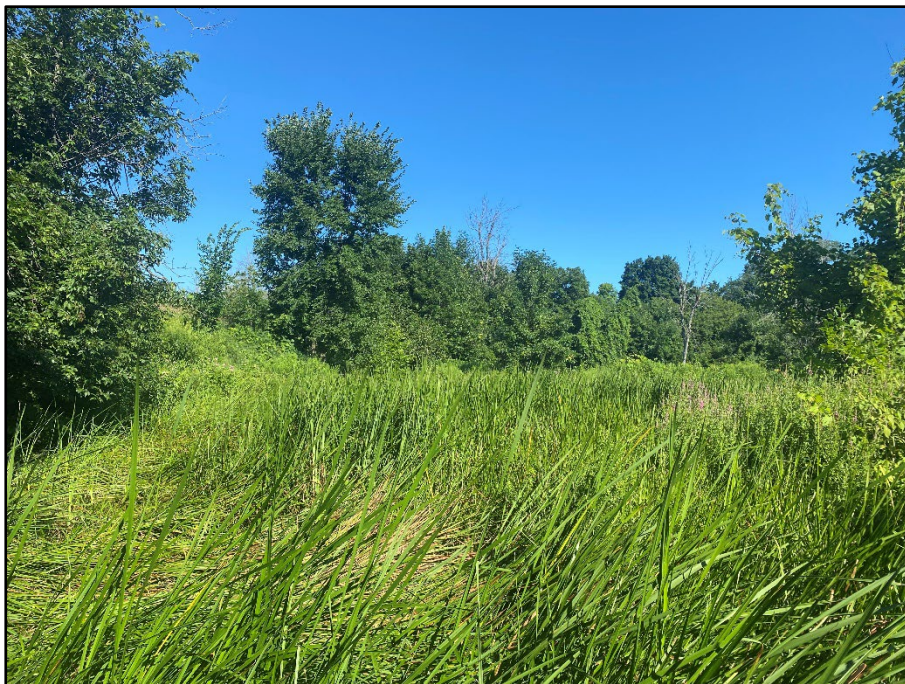
Creek, with detailed surveys of profile and cross-sections being completed for a portion from the apex extending across Mud Creek (Figure 4). Standing water was observed within the feature during the field assessment, with depths exceeding 1.5 m, having a thick layer of unconsolidated silts. The outer banks of the oxbow were well-defined and exhibited signs of previous erosion. The oxbow is currently situated between cropped land to the north and the densely vegetated valley contact to the south. Where defined, widths ranged between 2 and 4 m, while depths ranged between 0.07 and 0.15 m. The entire oxbow is well-vegetated with reeds and cattails. The water depth increases toward the bend in the oxbow with standing water and saturated ground, allowing for survey rods to sink upwards of 0.5 m deep into the sediment. The oxbow becomes shallower in water depth approaching Mud Creek. Evidence of erosion was noted around the confluence with Mud Creek as a result of water flowing over the bank; however, no water was actively flowing from the oxbow into Mud Creek at the time of the site visit and is assumed to occur following precipitation/melt events.

14. Oxbow Feature– Facing downstream, between the define banks, the feature is heavily grasses but maintains water
