# **Geotechnical Investigation**

## **Proposed Residential Development**

4386 Rideau Valley Drive  
Ottawa, Ontario

Report PG5828-1 Revision 4 dated April 4, 2024

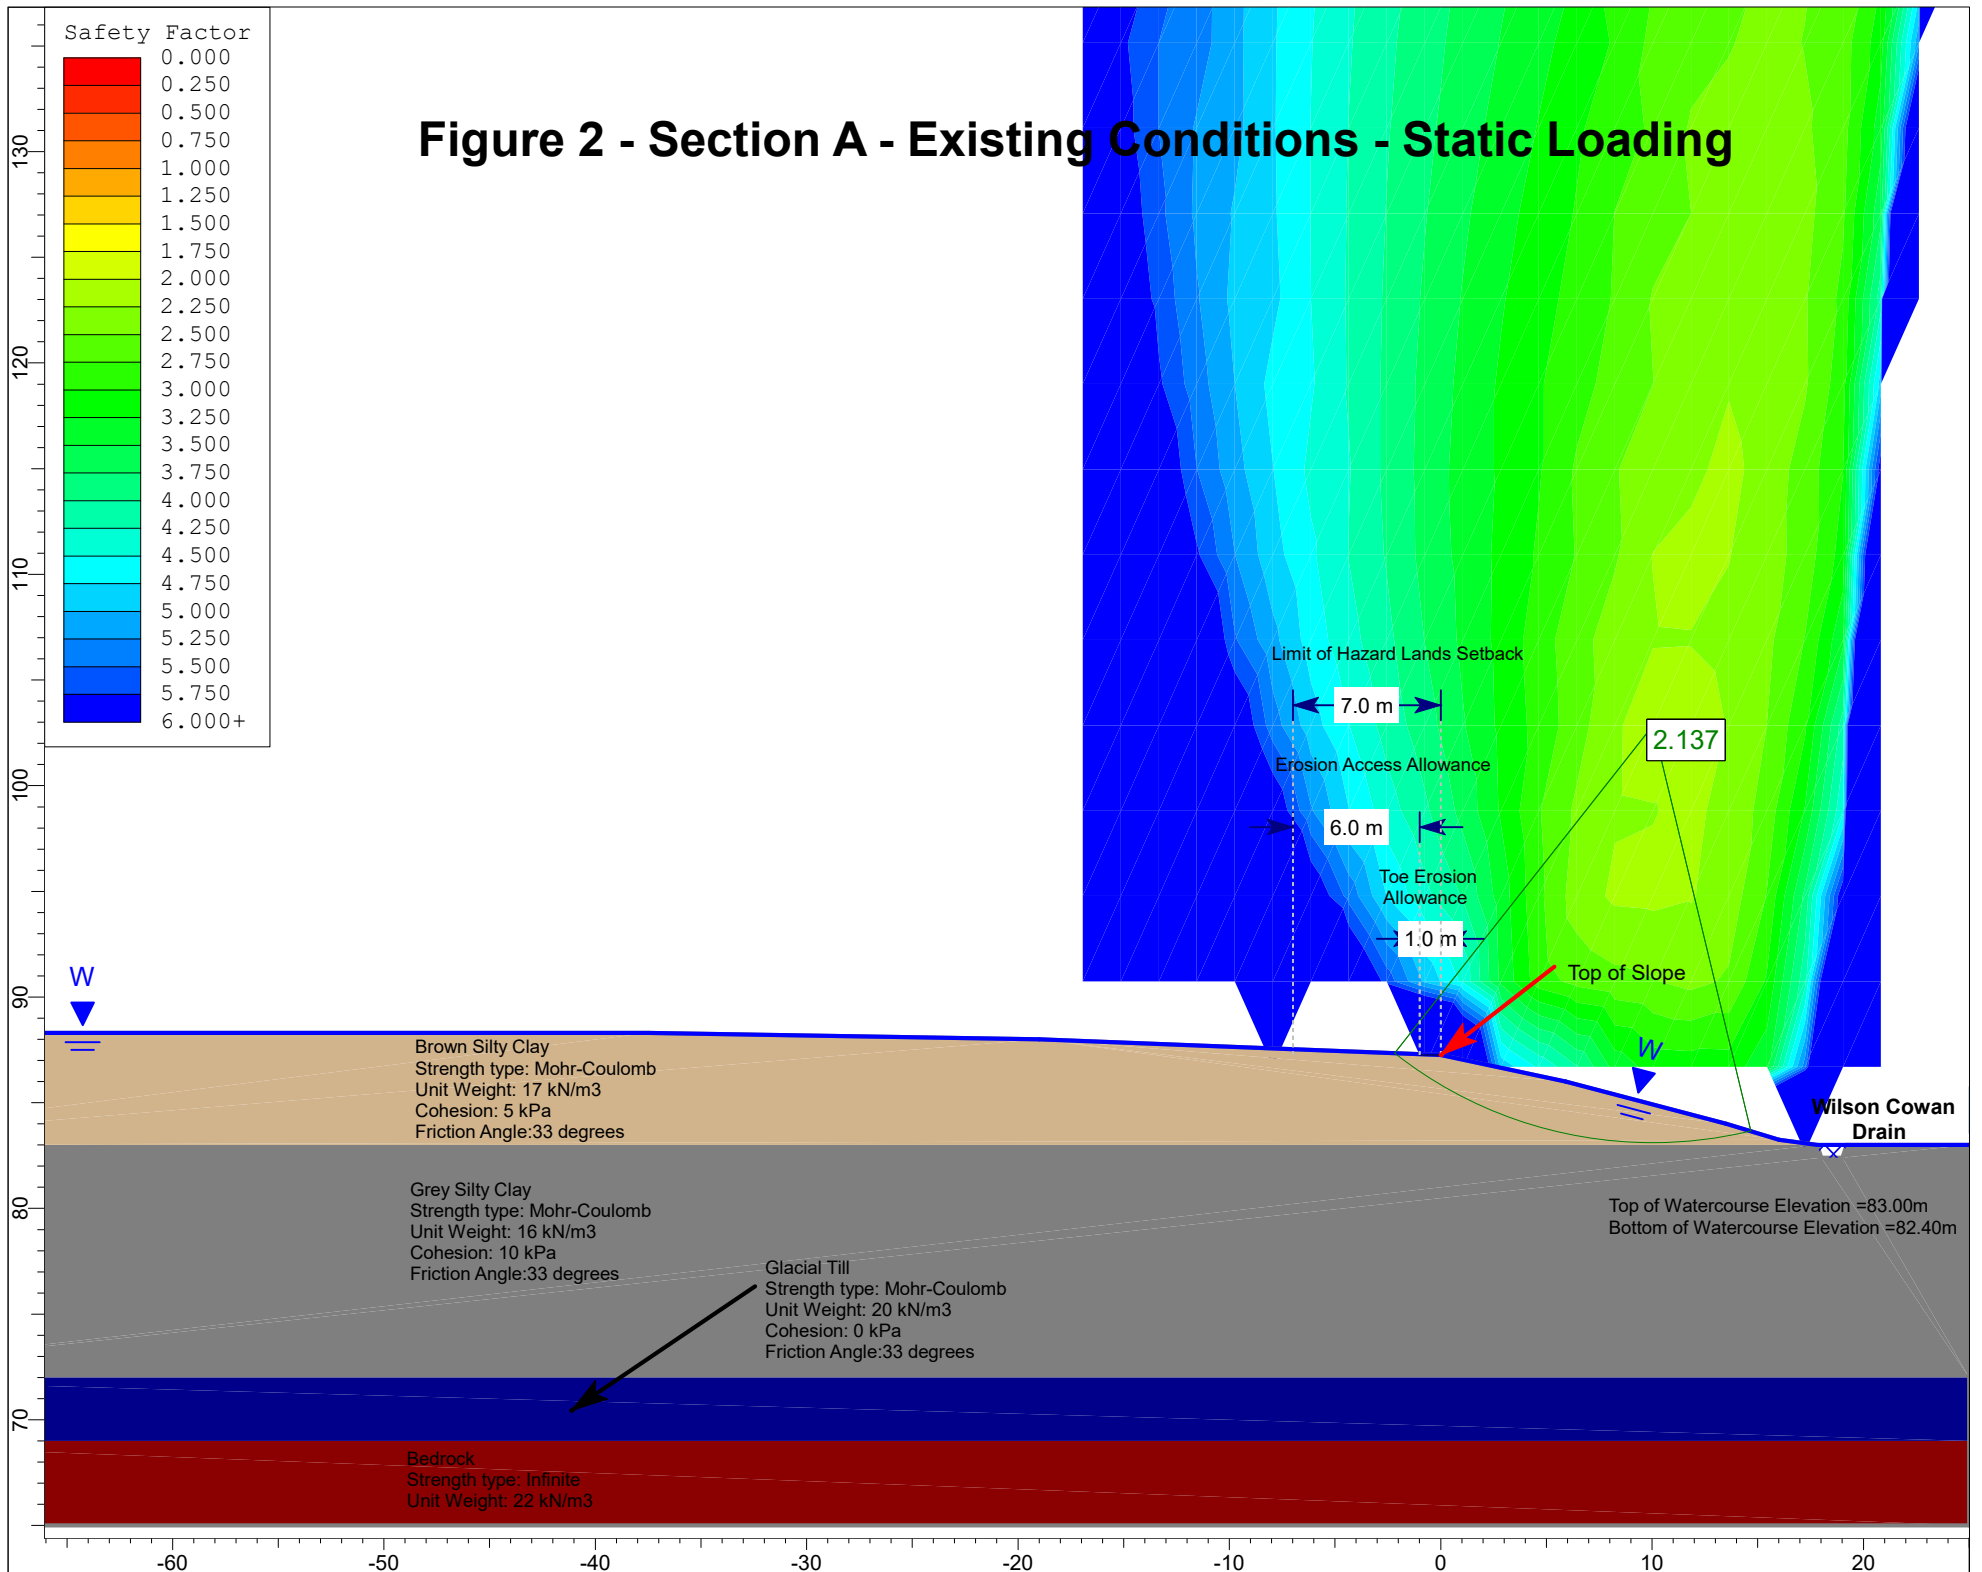
# Figure 2 - Section A - Existing Conditions - Static Loading

The results are shown in Figures 2, 4, 6, 8, 10, 12, 14, & 16 in Appendix 2. The results indicate a slope with a factor of safety of 2.1 and 2.4 at Section A and Section B, respectively. The results also indicate slopes with factors of safety less than 1.5 beyond the top of slope at Section C and D. Based on these results, a stable slope setback varying between 1.3 and 5.3 m from the top of the slope are required to achieve a factor of safety of 1.5 for the limit of the hazard lands in the area of Sections C and D.

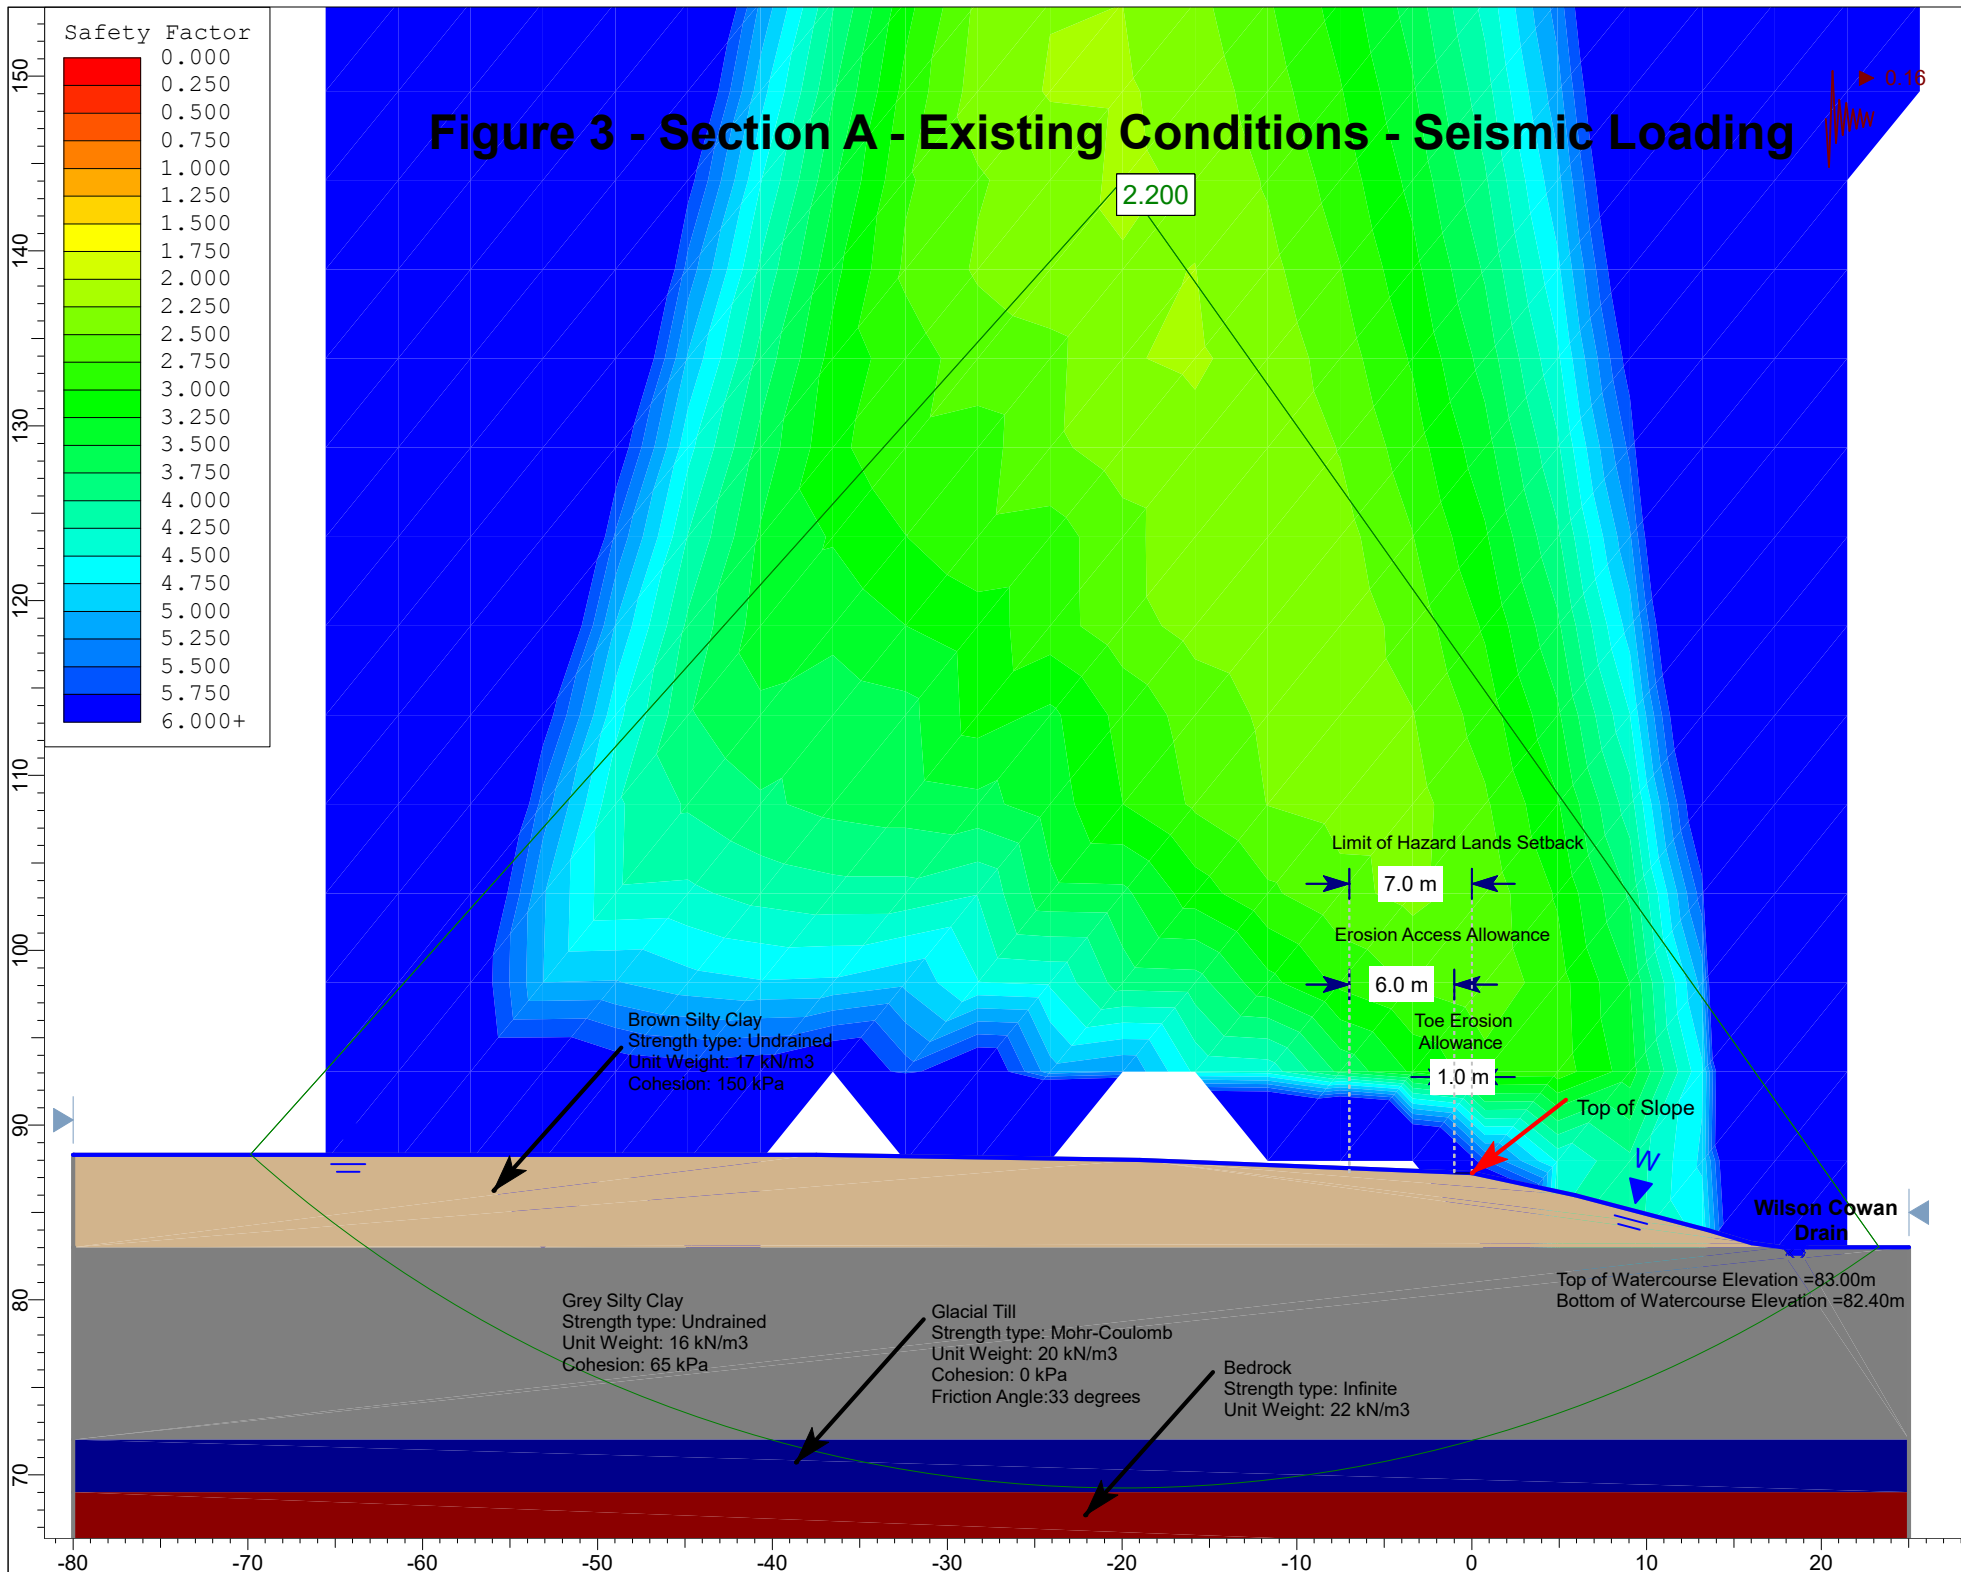
# Figure 3 - Section A - Existing Conditions - Seismic Loading

The results of the analyses including seismic loading are shown in Figures 3, 5, 7, 9, 11, 13, 15, and 17 in Appendix 2. The results indicate a slope with a factor of safety greater than 1.1 at all sections. However, it should be noted that the stable slope setback associated with our static loading analysis governs the required stable slope setback required for static conditions.

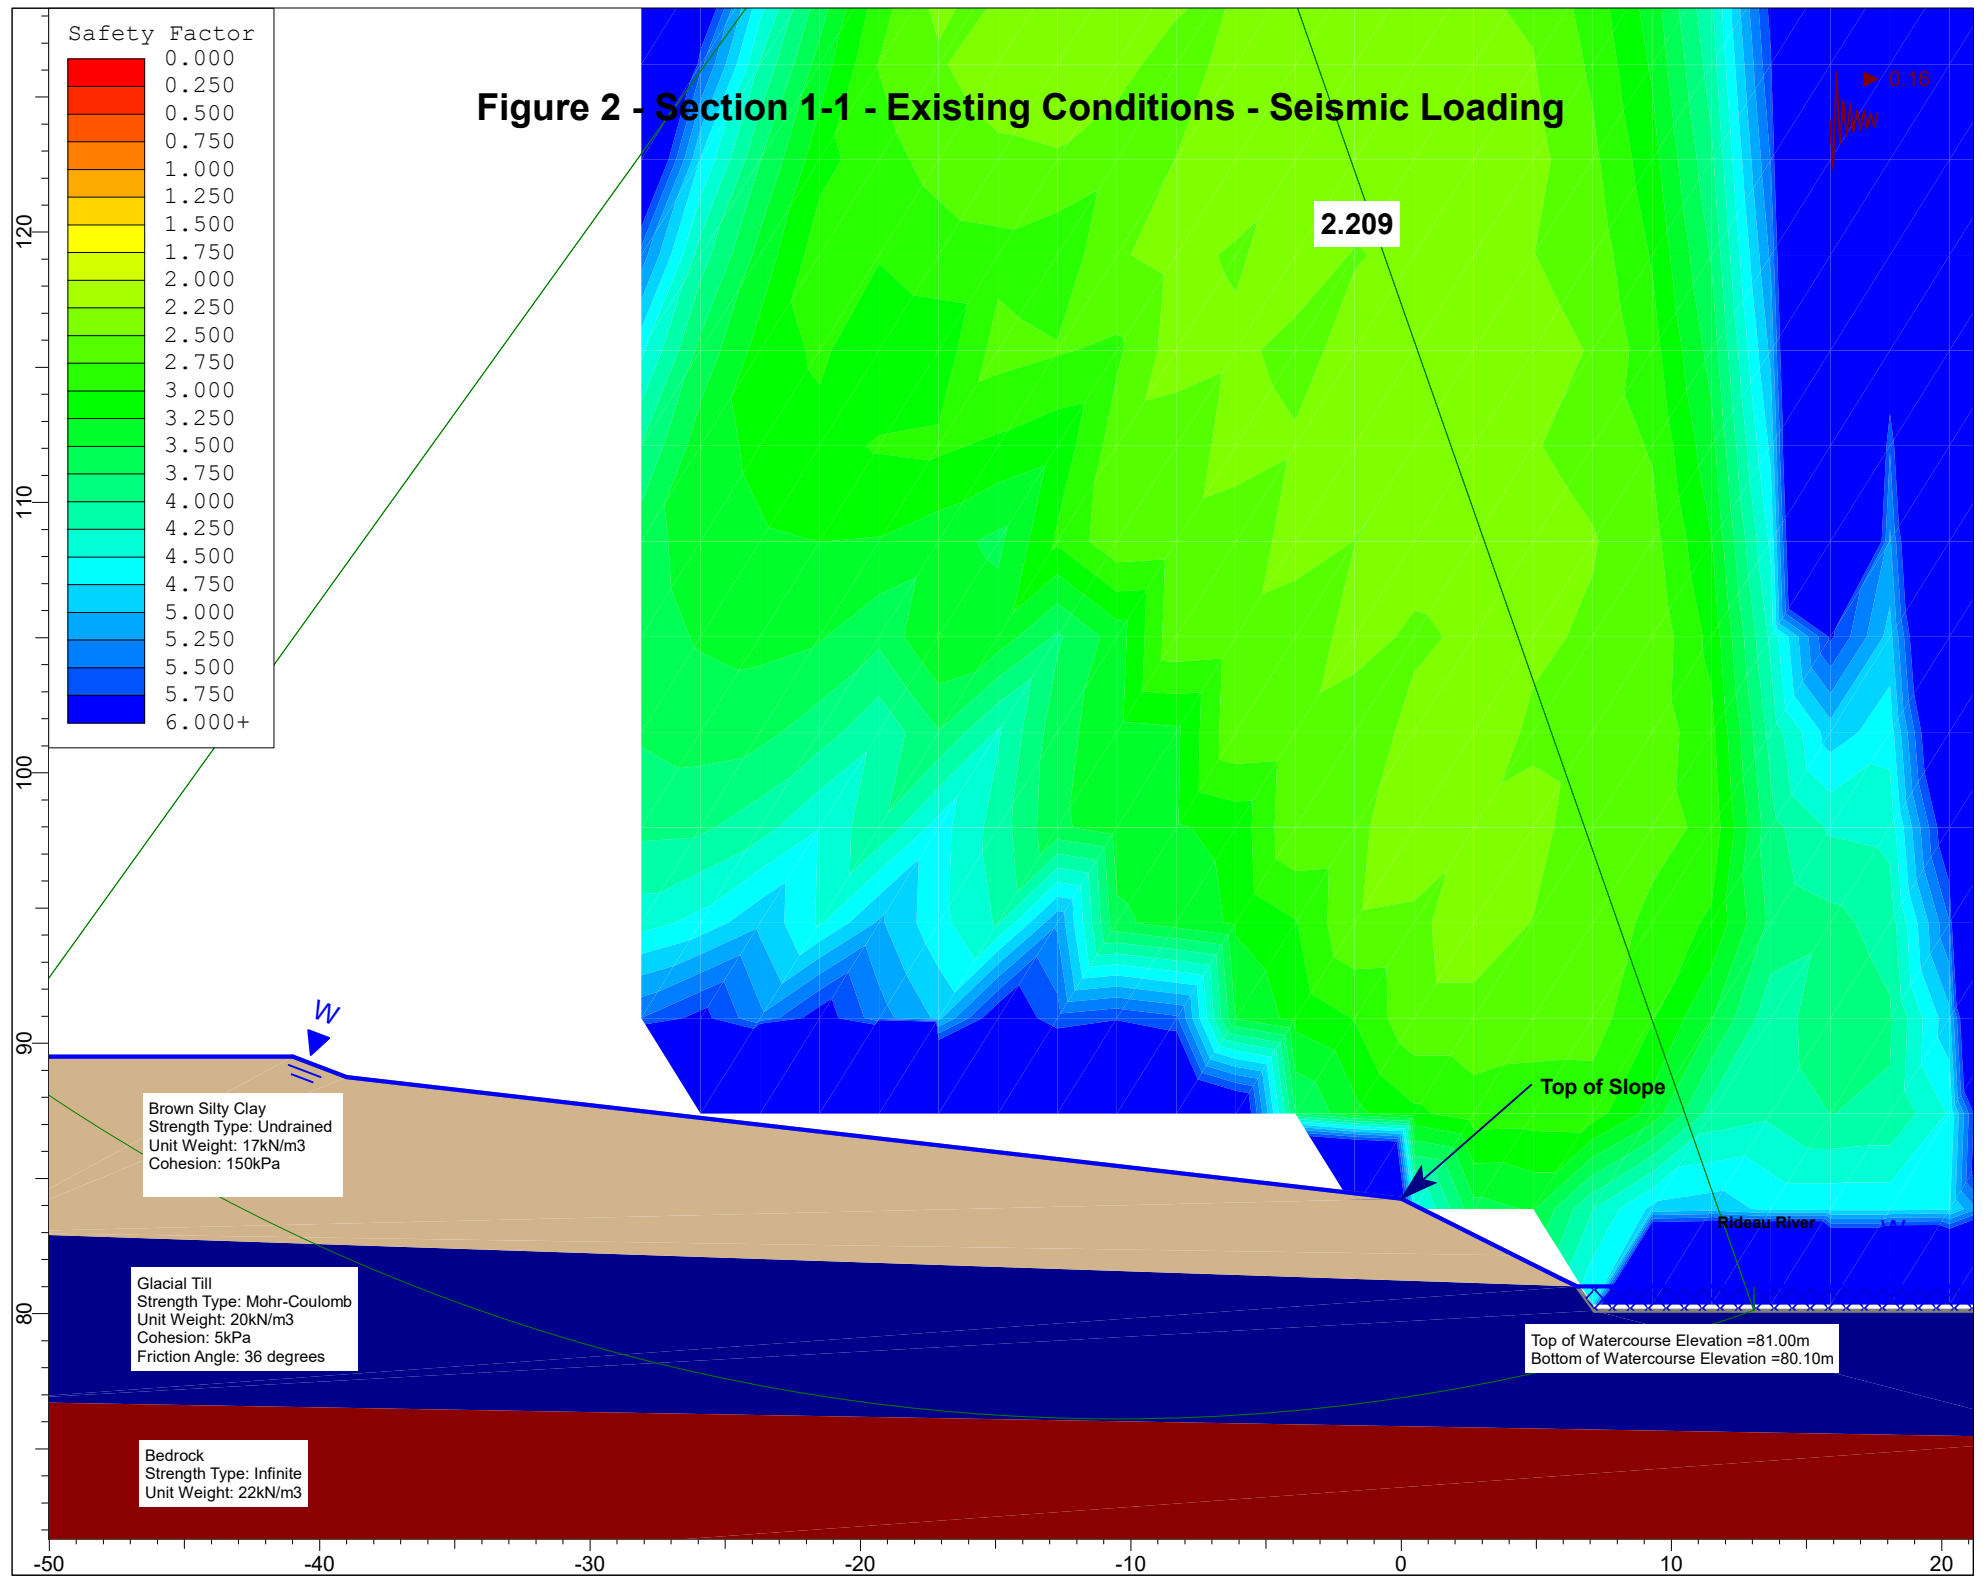
**Figure 2 - Section 1-1 - Existing Conditions - Seismic Loading**

An analysis considering seismic loading and the groundwater at ground surface was also completed. A horizontal acceleration of 0.16g was considered for all slopes. A factor of safety of 1.1 is considered to be satisfactory for stability analyses including seismic loading. The results of the analyses including seismic loading are shown in Figures 2, 4, and 6. The results indicate a slope with a factor of safety greater than 1.1 at all sections. However, it should be noted that the stable slope setback associated with our static loading analysis governs the required stable slope setback required for static conditions.

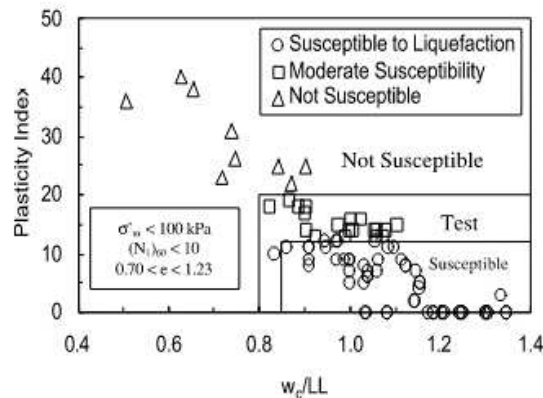
The soils encountered at the subject site consist of silty clays, which are cohesive in nature. These soils were evaluated for liquefaction susceptibility in accordance with the criteria prepared by Bray et al. 2004 which determines that all soils with a plasticity index exceeding 20% are not liquifiable (Figure 1). In general, the plasticity index results completed on samples taken from the silty clay layer were found to be above 20. Therefore, the encountered soils are not susceptible to liquefaction. Reference should be made to subsection 5.4- Design for Earthquakes in the abovementioned revised geotechnical report, for further details on liquefaction susceptibility at the subject site.

Figure 1. Criteria for evaluating liquefaction susceptibility of fine-grained soils (Bray et al. 2004).
