ADDENDUM #1

211-231 BANK STREET CONSERVATION PLAN

Applications D02-02-22-0127 / D07-12-22-0188 and plan number 18910

August 2024

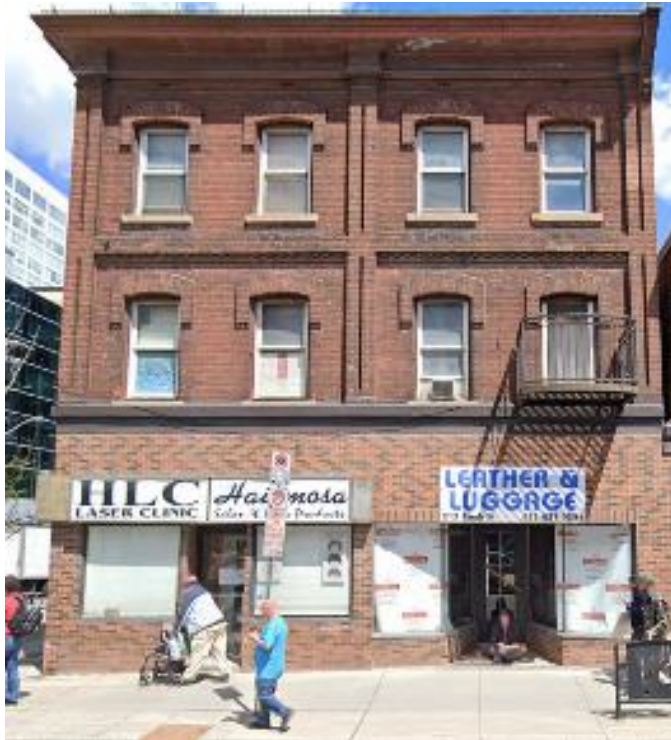
Figure 6. West Elevation

The building's footprint and upper storeys have not changed since the Nepean addition c.1922. The upper floors continue as residential apartments. The building appears to be in fair to good condition requiring cleaning and repointing of masonry, some repairs to the metal cornice, and the renewal of windows. The ground floor commercial storefronts have been completely altered, with original features lost. The existing frontage replaced with a variegated brick infill, the shopfront's glazed transoms and large commercial glazing removed along with the ground floor cornice.

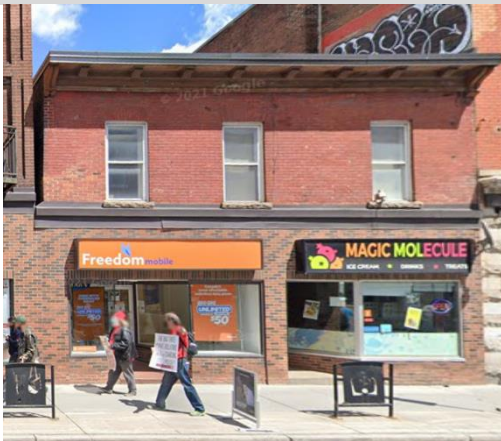
215-217 BANK ST.

The upper storey is intact with replacement windows. The original signboard, historic transom, and display windows have been removed and the brick piers reclad with a variegated brick siding.

1. Repair as necessary the elaborate metal cornice at the roofline.
2. Chemical wash to remove paint from the upper level.
3. Install the ground floor cornice set just below the second-floor windowsills.
4. Selective replacement of damaged/spalling brick, repointing of brick facade, and replacing sills.
5. Replace the 3 second-floor windows with new one-over-one units.
6. Restore the ground floor brick piers at either edge of the building and framing the retail entrance.
7. Insert large glazed commercial storefront into the two bays with recessed flared entrance.
8. Introduce commercial cornice with signboard, knee wall at base, recessed flared entrances. See comparative illustrations.
