# Fluvial Geomorphology and Erosion Hazard Assessment

**1086 Antochi Lane  
Manotick, Ontario**

June 22, 2023  
PN23057

Project Number: PN23057  
Status: Final  
Version: 1.0  
First Submission Date: June 22, 2023

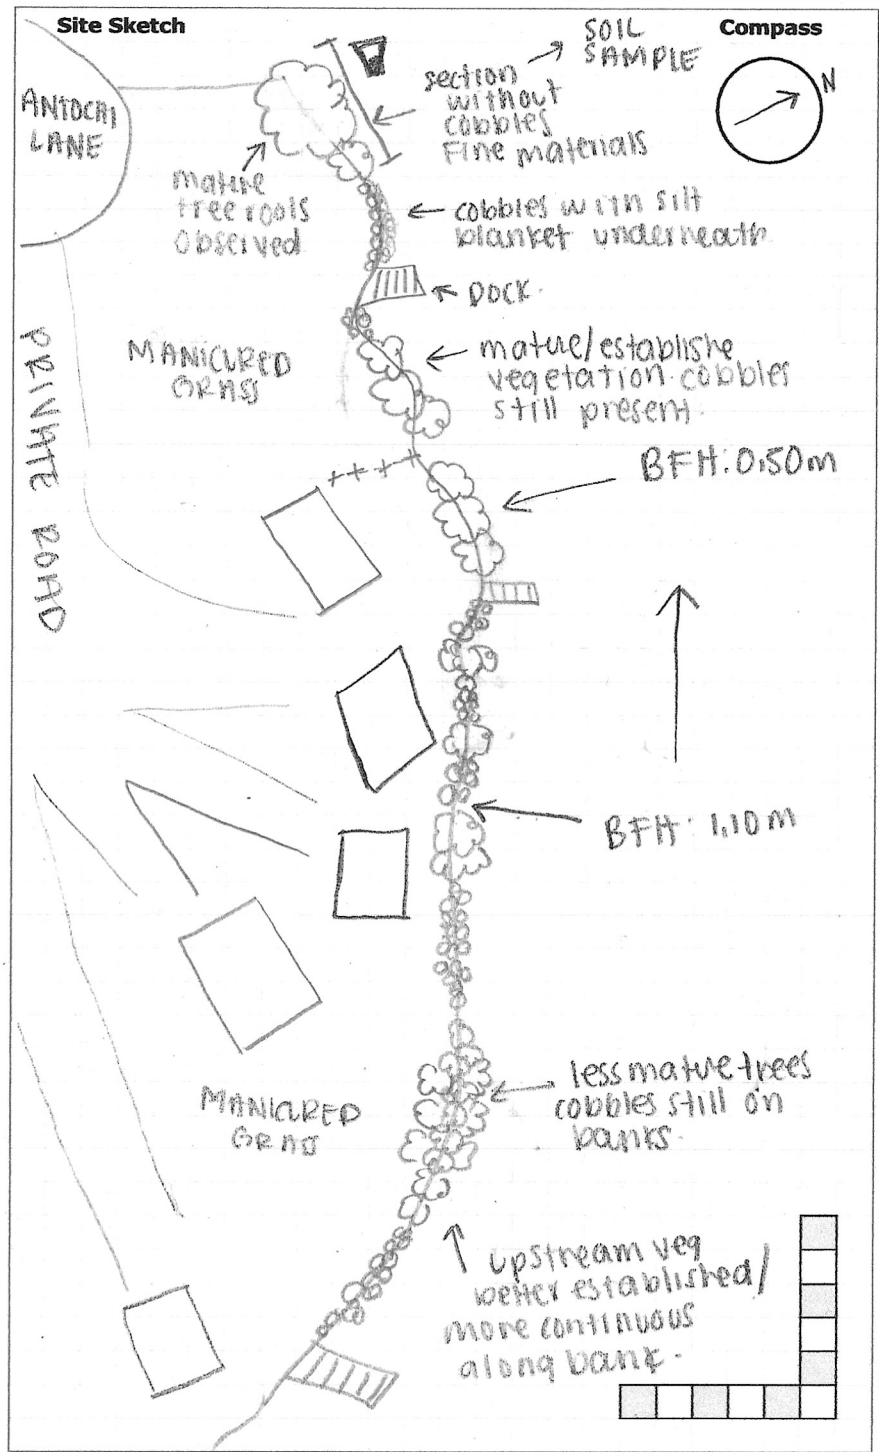
**Notes:** Entire shoreline composed of angular cobbles (10-20cm diameter). Bank vegetation well established where present. No signs of active erosion.
