HERITAGE IMPACT ASSESSMENT & CONSERVATION PLAN*

168 -174 MURRAY STREET, OTTAWA

Owner: David Yoo
Address: 168 – 174 Murray Street, Ottawa, Ontario

Revised March 2025

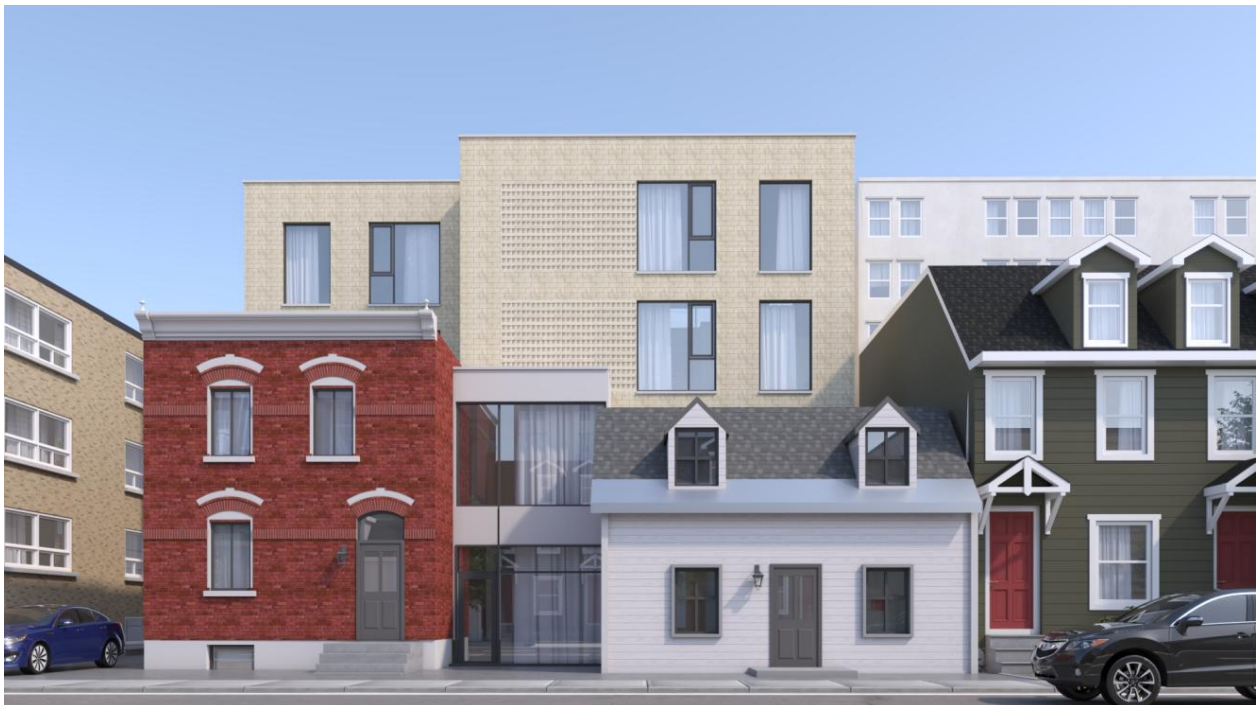
Figure 36: Elevations of the two heritage buildings being retained, with the planned 4-storey apartment setback and entered between the buildings. The two buildings have been recorded by Redline Architecture Inc. 2025.

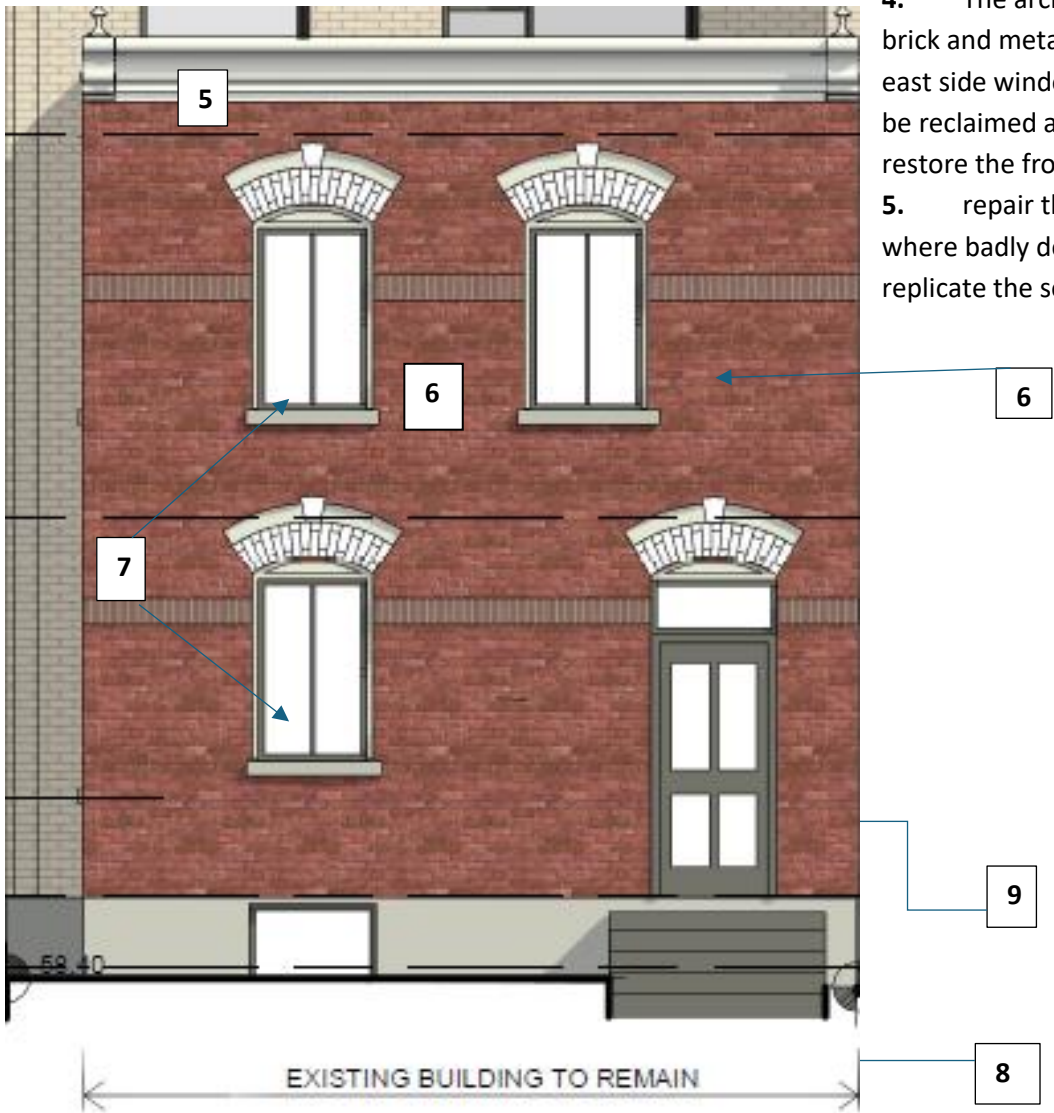
Figure 45: As -found image with areas requiring repair and restoration highlighted in white.

- 1. Undertake a structural assessment of the foundation, realign the foundation at the west corner, undertake jacking for levelling the floors and setting the building on a repaired foundation.
- 2. Engage a brick mason with expertise in conservation to assess the condition of the brick.
- 3. Undertake a program of removals followed by an assessment. As part of demolition of the rear additions, salvage brick as matching replacement for masonry at the front.

- 4. The arched segmented brick and metal hood from the east side window of 174 can be reclaimed and used to restore the front entry.
- 5. repair the cornice and, where badly deteriorated, replicate the section.

- 6. Dismantle the section of brick on the second floor where there is bulging and potential separation of brick from the backing wall. Repair and repoint façade, as necessary.
- 7. Casement windows will be retained and painted.
- 8. Install a new stoop to provide access to the new front door
- 9. Undertake brick dismantling and replacing the salvaged decorative hood and segmented brick header over the front door, replace the brick between the door and the west corner and repoint, as necessary.

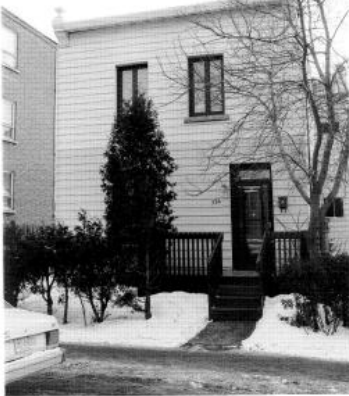
ARCHITECTURAL INTEGRITY (ALTERATIONS)
aluminum siding; original window replaced with casement windows;
porch and canopy

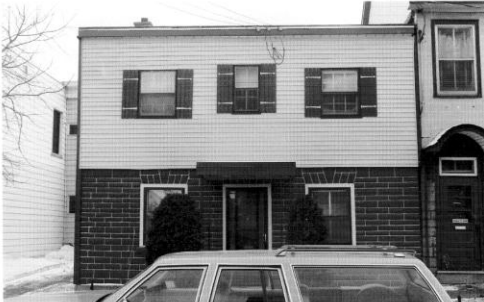
ARCHITECTURAL INTEGRITY (ALTERATIONS)
alum. iron siding and angelstone over original sheathing; original windows and door replaced.
