ADDENDUM #1: CONSERVATION PLAN

John Stewart Commonwealth
June 20, 2024

1.0 CONSERVATION PLAN FOR 168 & 174 MURRAY STREET

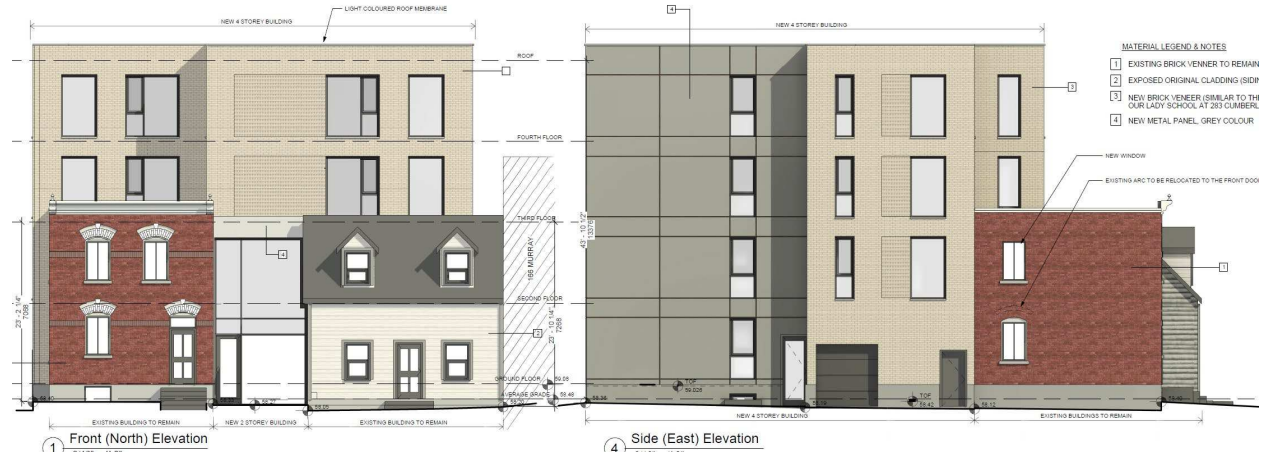
Figure 1: Elevations of the two heritage buildings being retained, with the planned 4-storey apartment setback and entered between the buildings. The two buildings have been recorded by Redline Architecture Inc.
