# TREE CONSERVATION REPORT

**168-174 Murray Street**

**Tree Conservation Report  
submitted as Partial  
Requirements for a Site Plan  
Control Application, March 30,  
2022**

**Dendron Forestry Services**

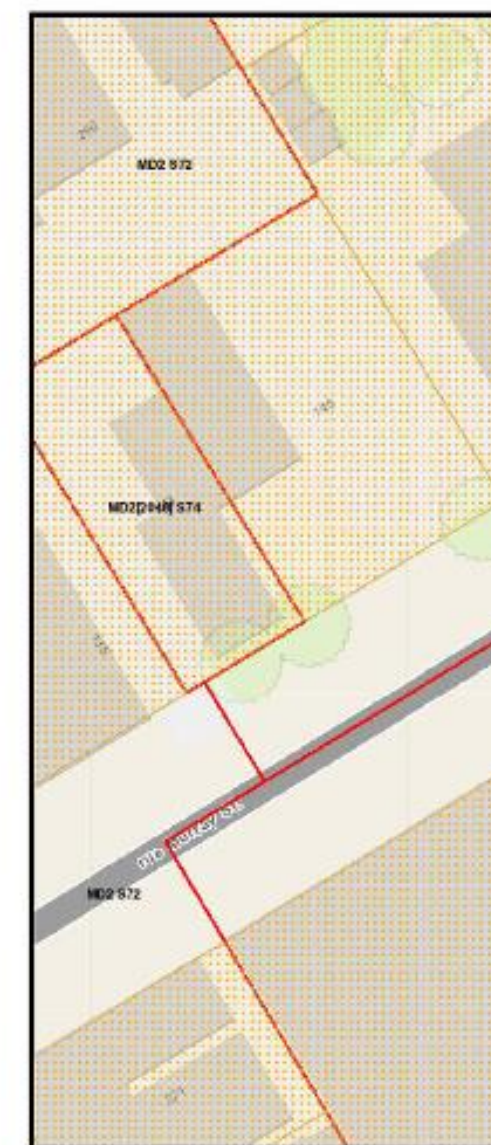
Tree <sup>1</sup>	Species	Diameter at breast height (dbh)	Condition	Action
1	Manitoba maple ( <i>Acer negundo</i> )	88 cm	Poor; extensive crown dieback throughout, decay at base and at junction of two stems, risk of branches and/or stem failing onto road	Remove prior to any site works; Tree Permit required for removal or request removal by City Forestry department
2 <sup>3</sup>	Manitoba maple ( <i>Acer negundo</i> )	40, 40 cm (estimate)	Poor, extreme lean over garage, possibly relying on garage for support, significant fissure on upper side of one stem	Remove prior to any site works, particularly garage demolition; Tree Permit required for removal
