Report

Trail Road Battery Energy Storage System (BESS)  
Fluvial Geomorphology Assessment

H375035-0000-2B0-066-0001

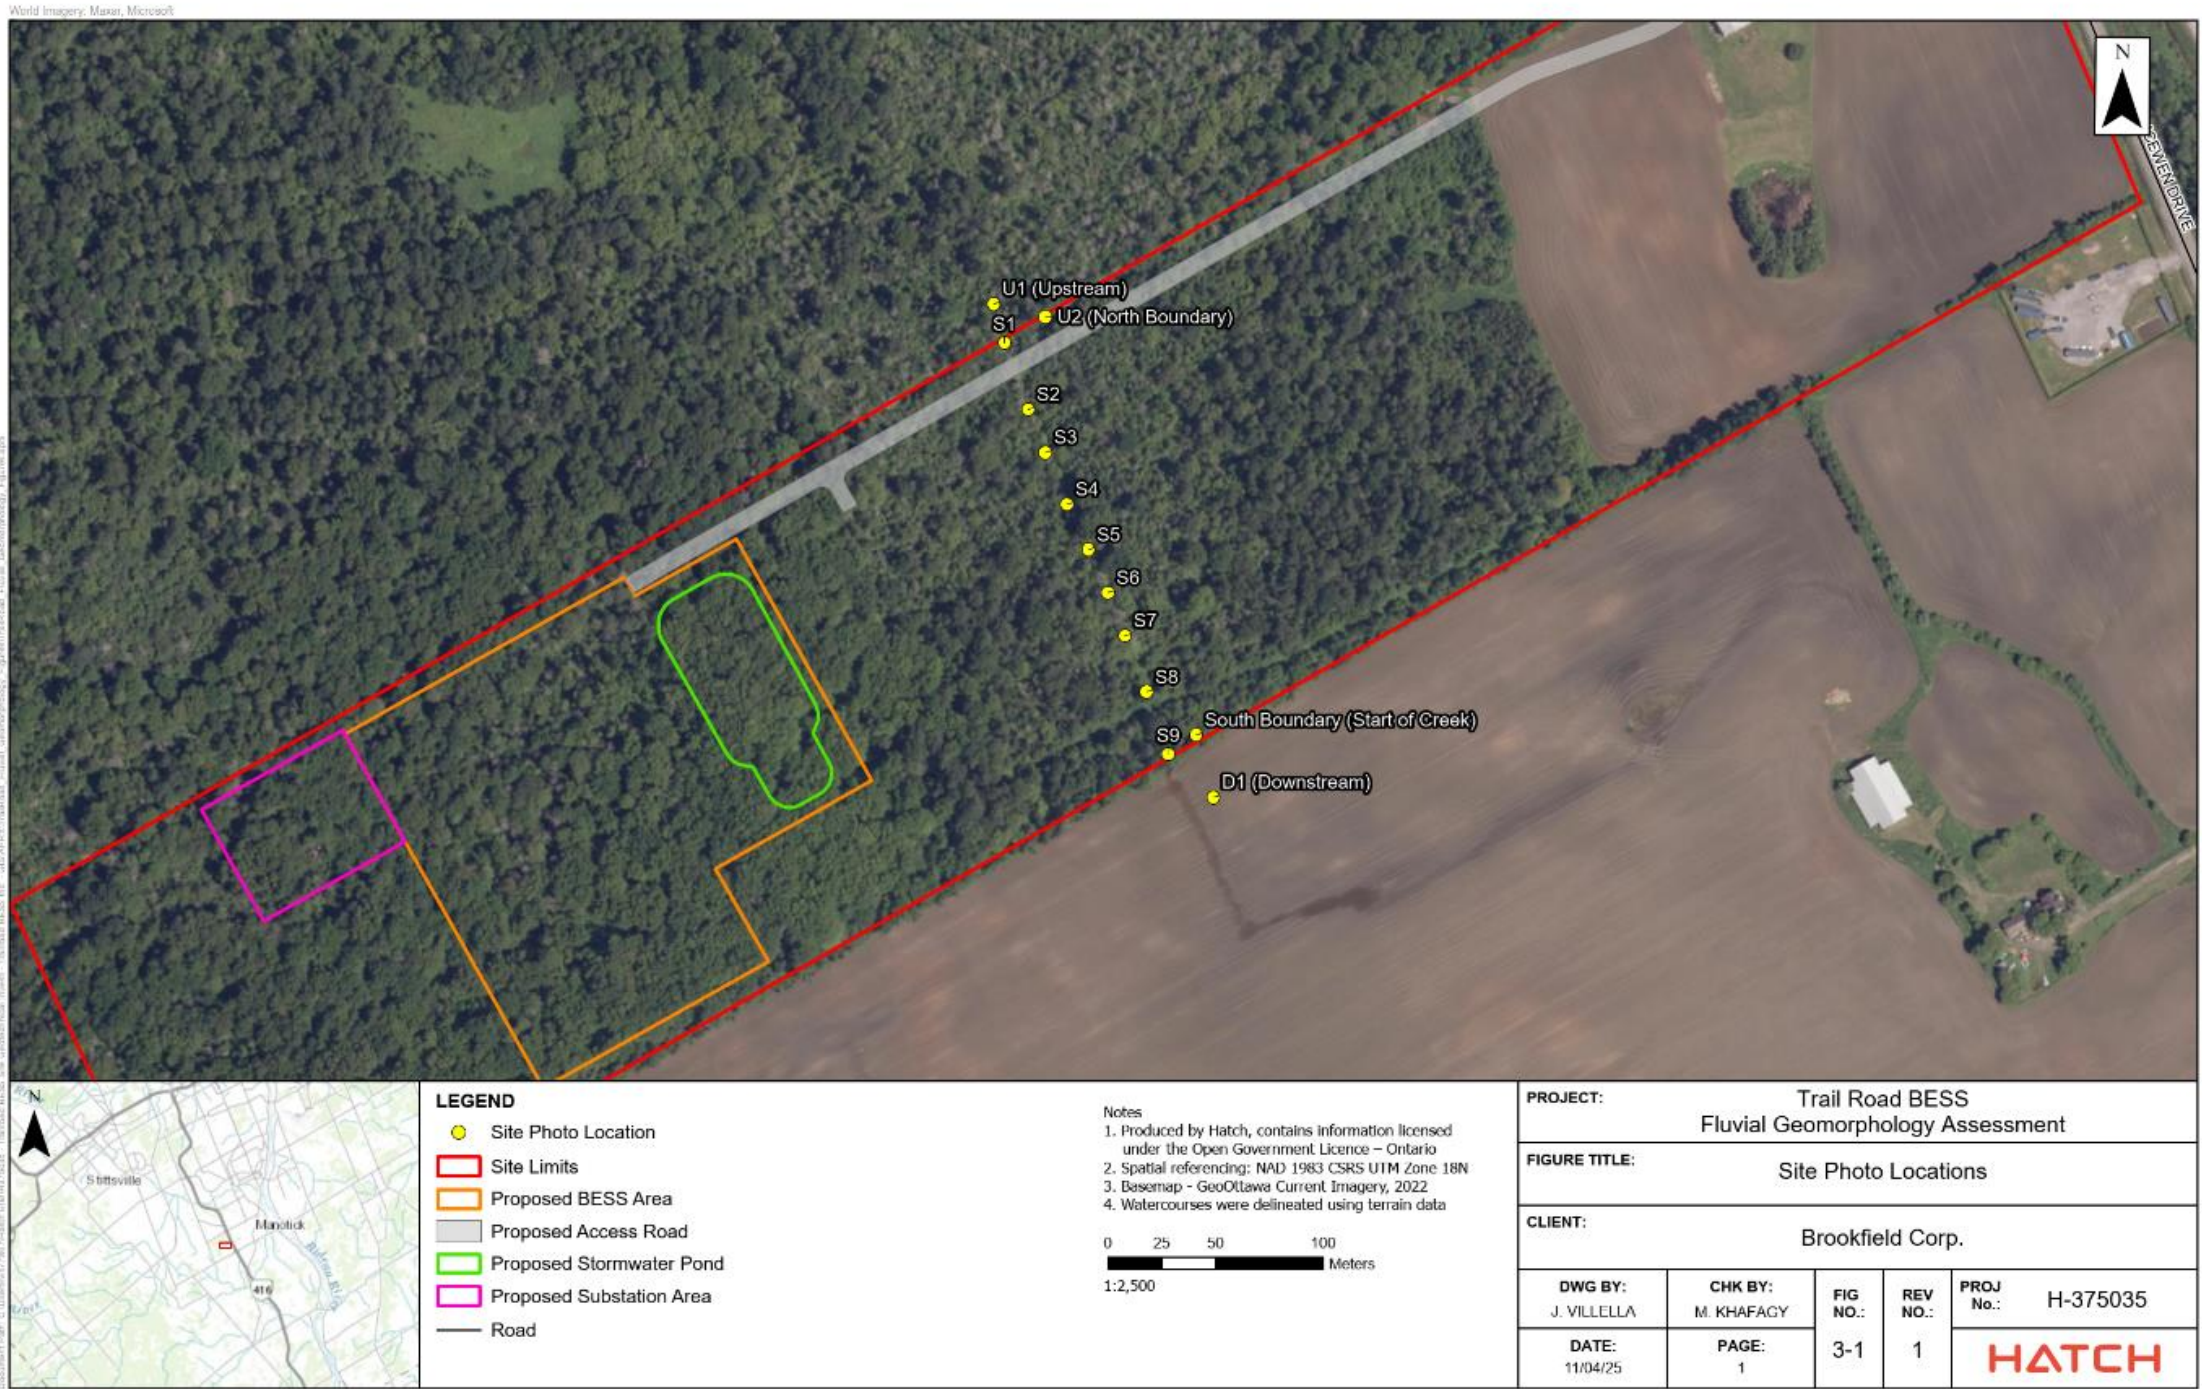
Figure 3-1: Locations of Field Photographs

A field investigation was conducted on April 7, 2025, to assess the fluvial and geomorphic conditions of the Creek within the Project boundaries. Given the small scale of the watercourse and the proximity of adjacent private properties, observations were collected from the east bank of the Creek. The watercourse was observed to be narrow and situated in an unconfined setting, with an average surface width of approximately 2 m and a shallow depth of around 15 cm. Active flow was present during the site visit, with water observed moving along the channel and pooling in low-lying sections. Field observations are supplemented by representative photographs (Photos 1 to 24), the geographic locations of which are shown in Figure 3-1, and included in Appendix B.

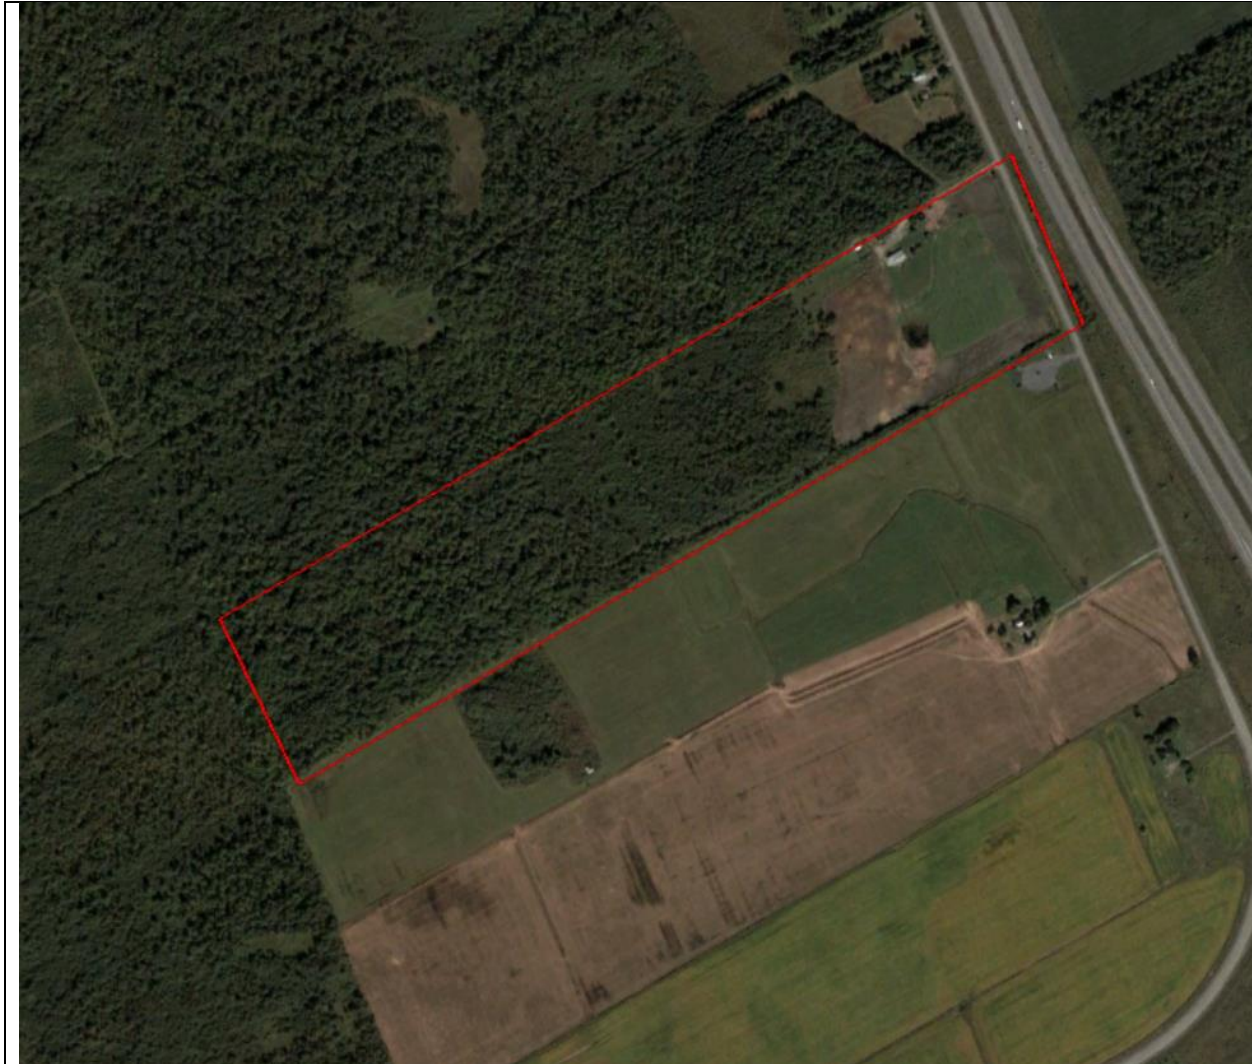
Between 2002 and 2004, the watercourse is present in good condition, with no observable changes compared to the 1954 aerial photography. The surrounding land use appears unchanged.

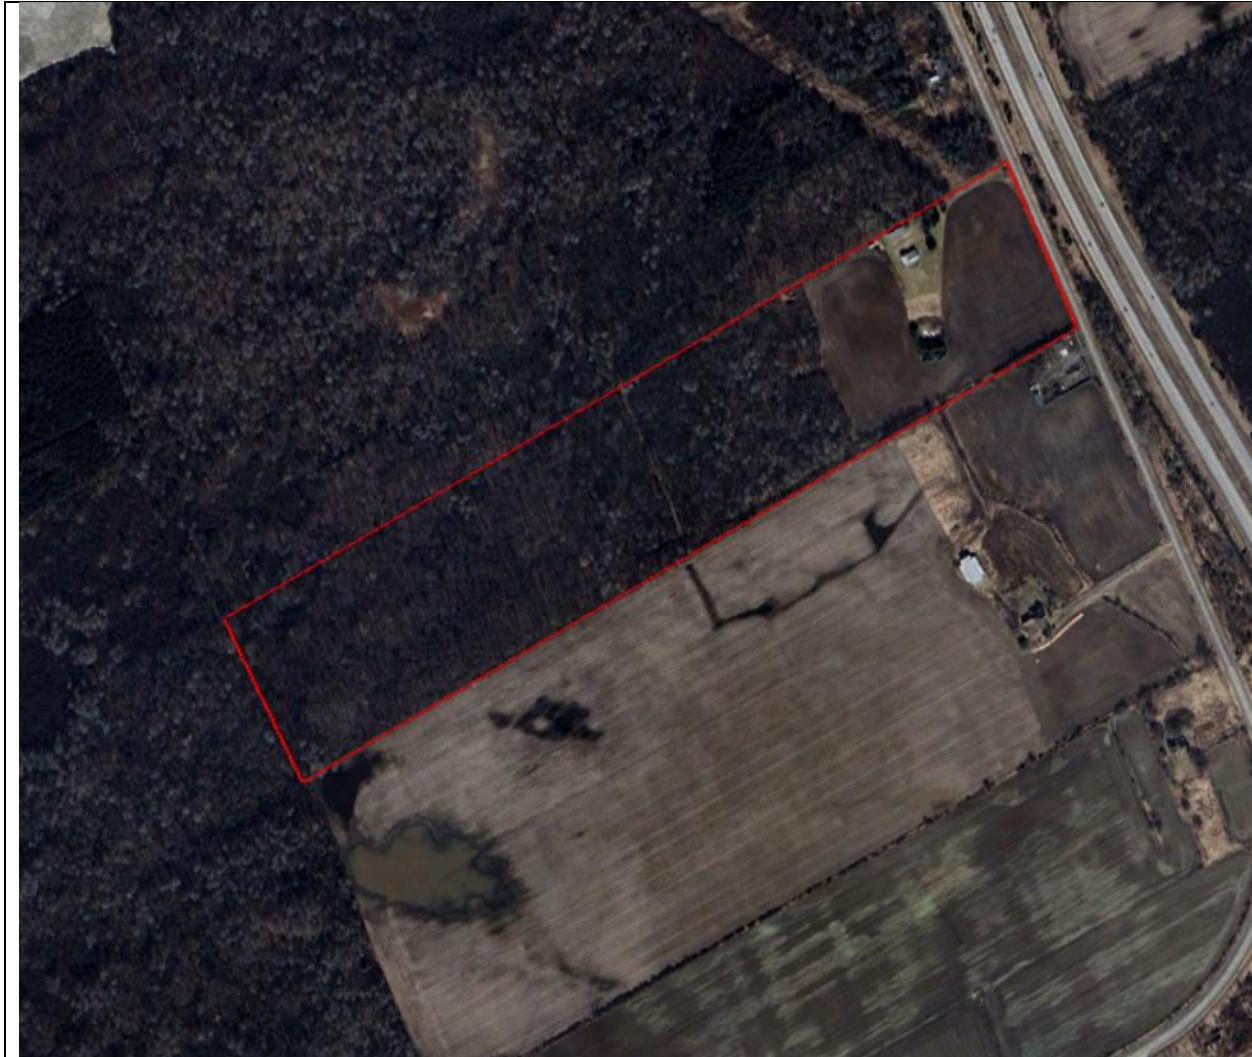
By 2020, the constructed banks are no longer visible, and the condition of the Creek continues to degrade through to 2024. In general, the Creek within the Project site follows a straight alignment; however, no visible changes to the planform of the tributary are observable in all aerial imagery due to tree cover.

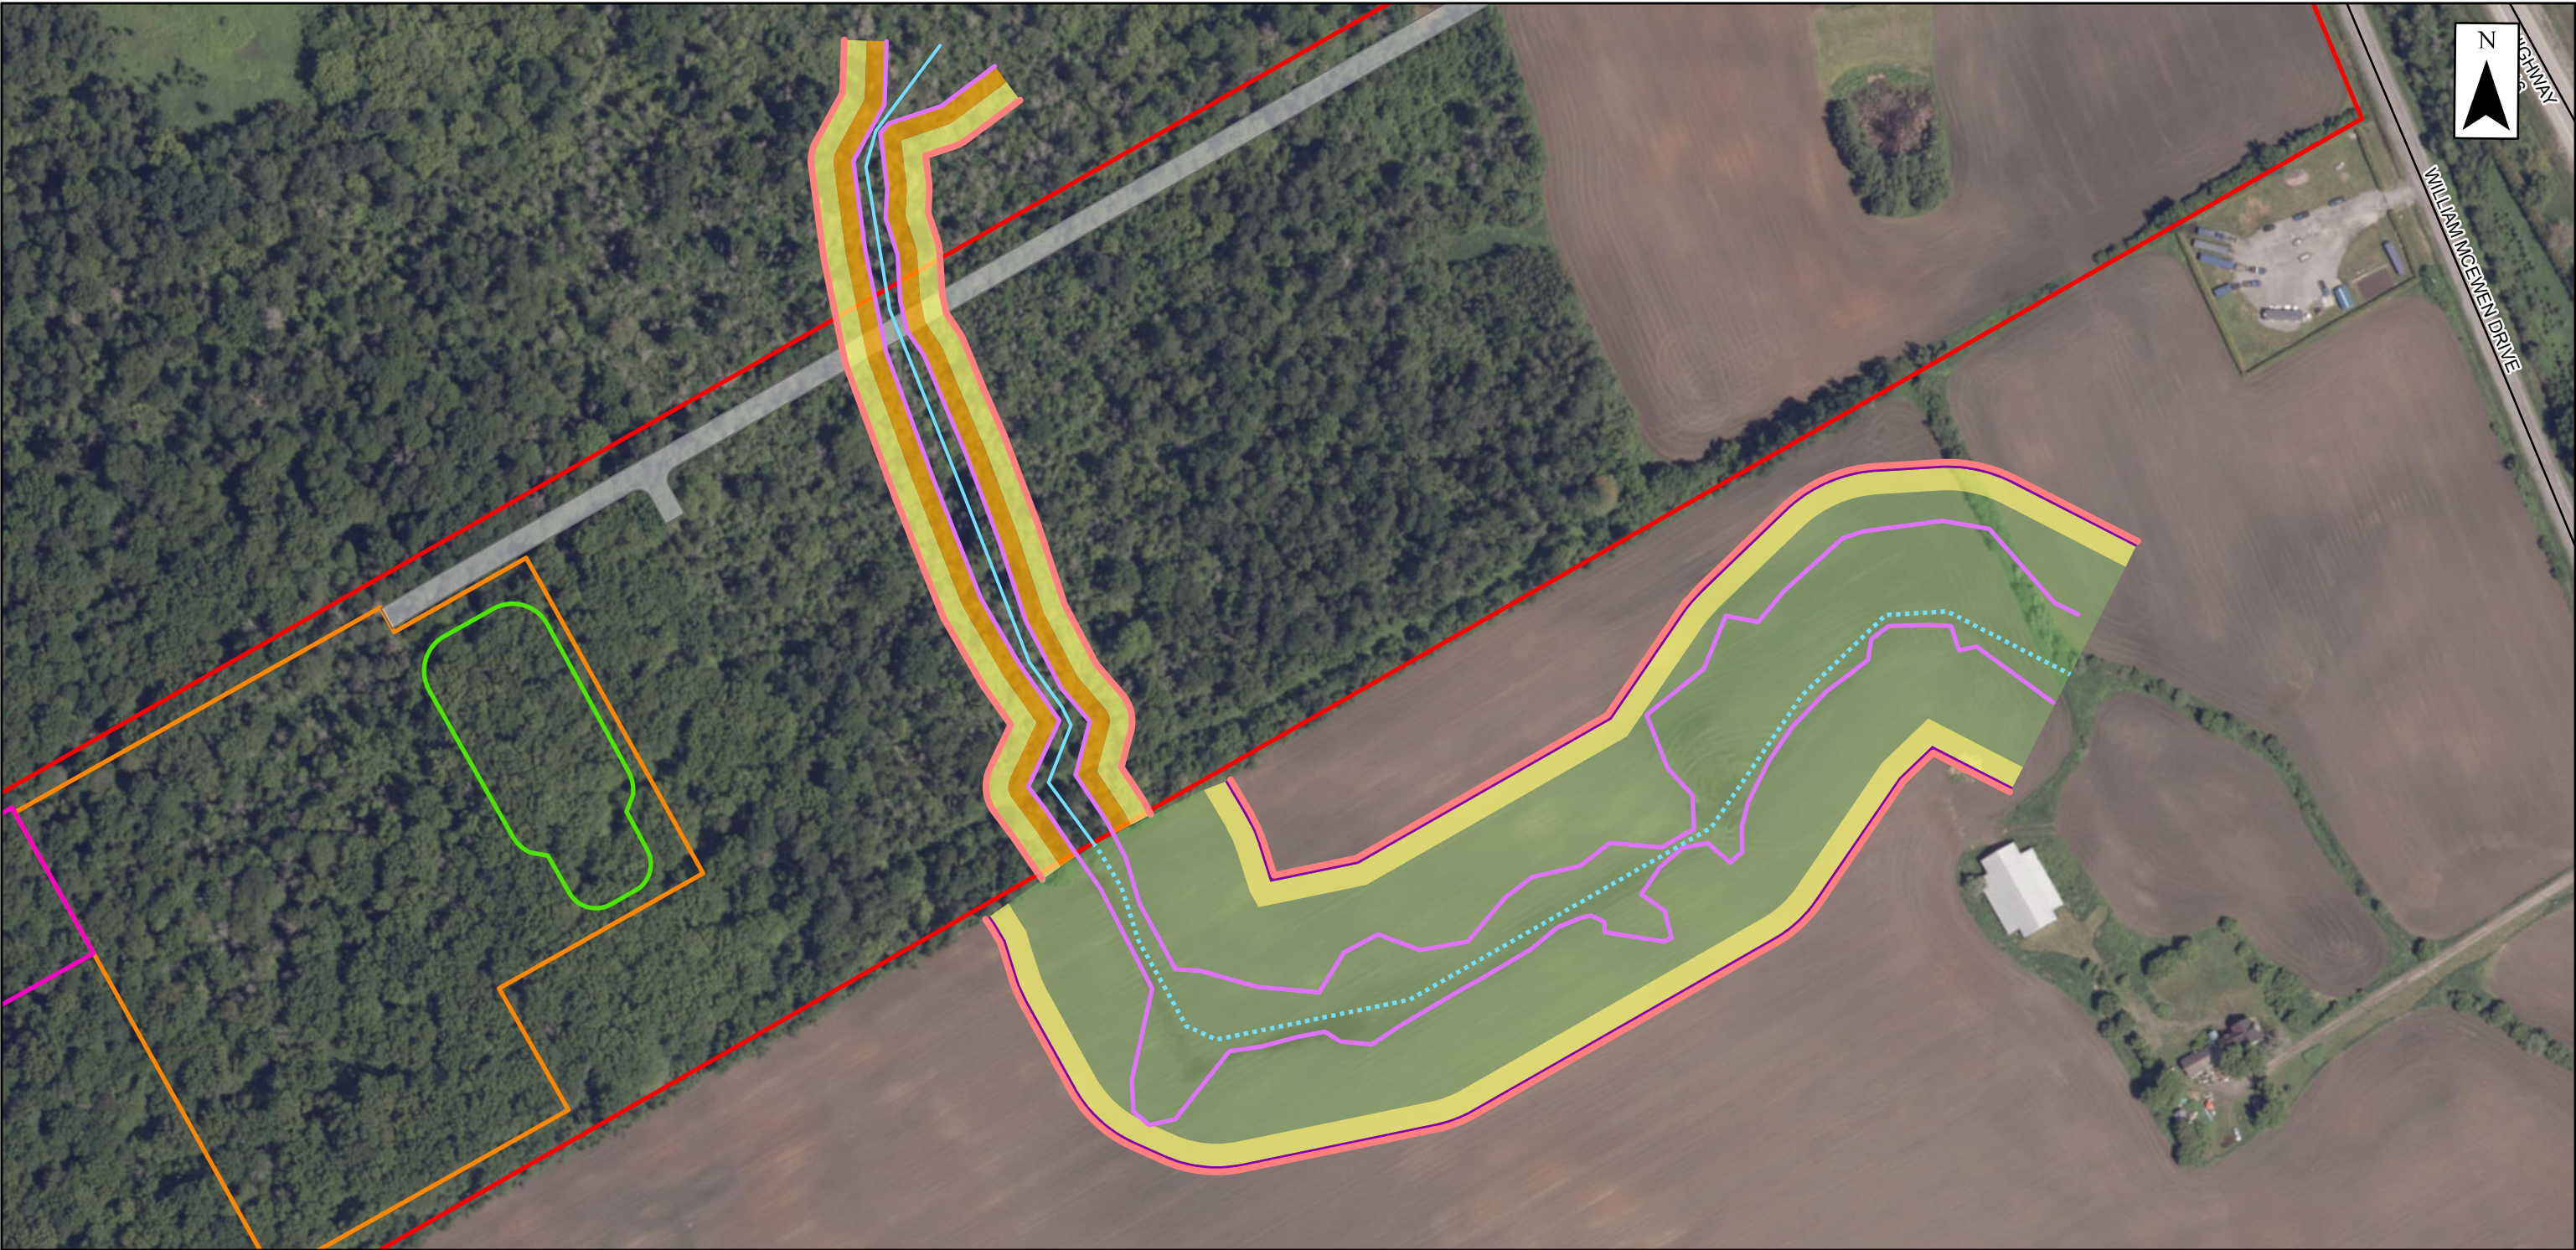
| FIGURE TITLE: Erosion Hazard Limits of the<br>Confined and Unconfined System Reaches | | | | | |

- The erosion hazard limits were delineated for both confined and unconfined reaches combining field assessments and historical aerial photograph interpretation and supported by hydraulic modelling. A 7 m toe erosion allowance and 8 m erosion access allowance were applied for the confined system. A meander belt width and 8 m erosion access allowance were used for the unconfined section with a factor of safety of 2 m.

- There is no overlap between the proposed development area and the delineated erosion hazard limits. Continued coordination with the stormwater design team is recommended to ensure integration of fluvial considerations into the development design.
