## TREE CONSERVATION REPORT

5872-5884 Hazeldean Road & 7  
Savage Drive

Tree Conservation Report submitted as Partial  
Requirements for a Site Plan Control Application.

December 3, 2024

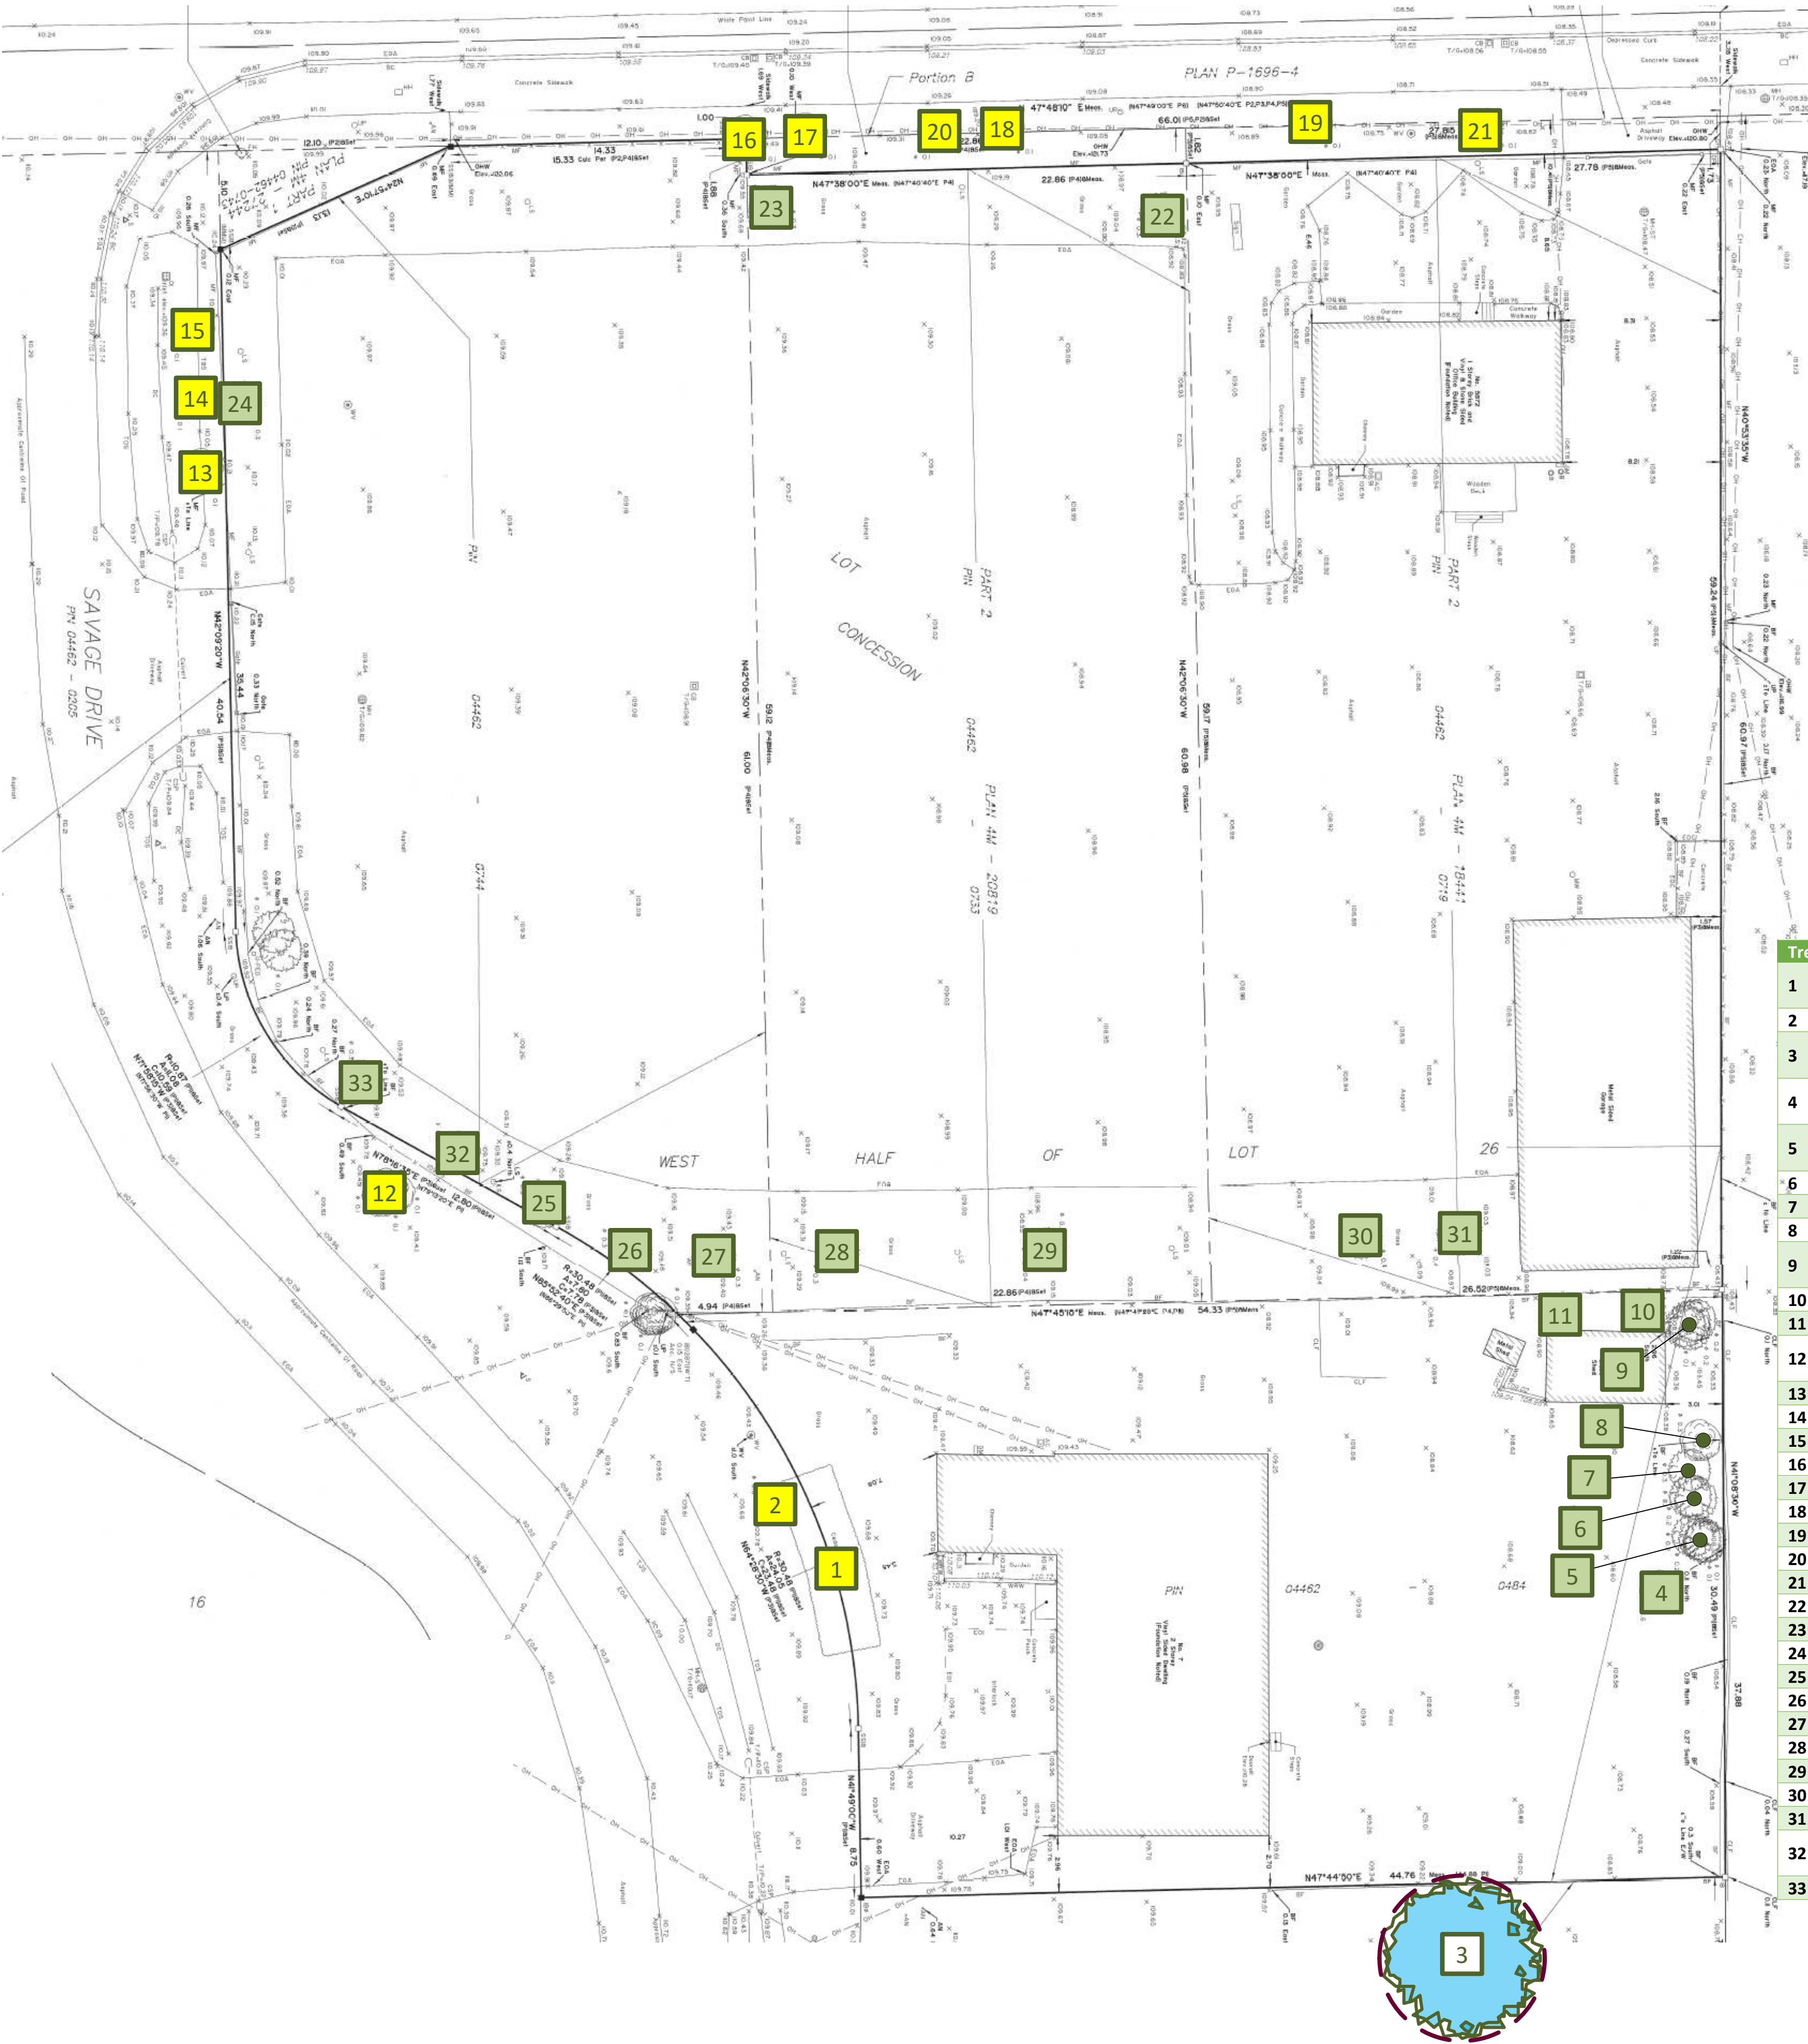
TCR - 5872-5884 Hazeldean and 7 Savage Map 2 - Proposed Development		
Date	Version	Prepared By
03/12/2024	1	KM

The proposed development includes 2 levels of underground parking covering a large majority of the lots. The required excavation will necessitate the removal of all private trees (specifically Trees **4-11** and **22-31**). Given these plans, it is unlikely engineering documents will change these recommendations.
