485 RICHMOND ROAD
OTTAWA, ONTARIO

MINTO COMMUNITIES INC.

ARBORIST REPORT

ARB-1

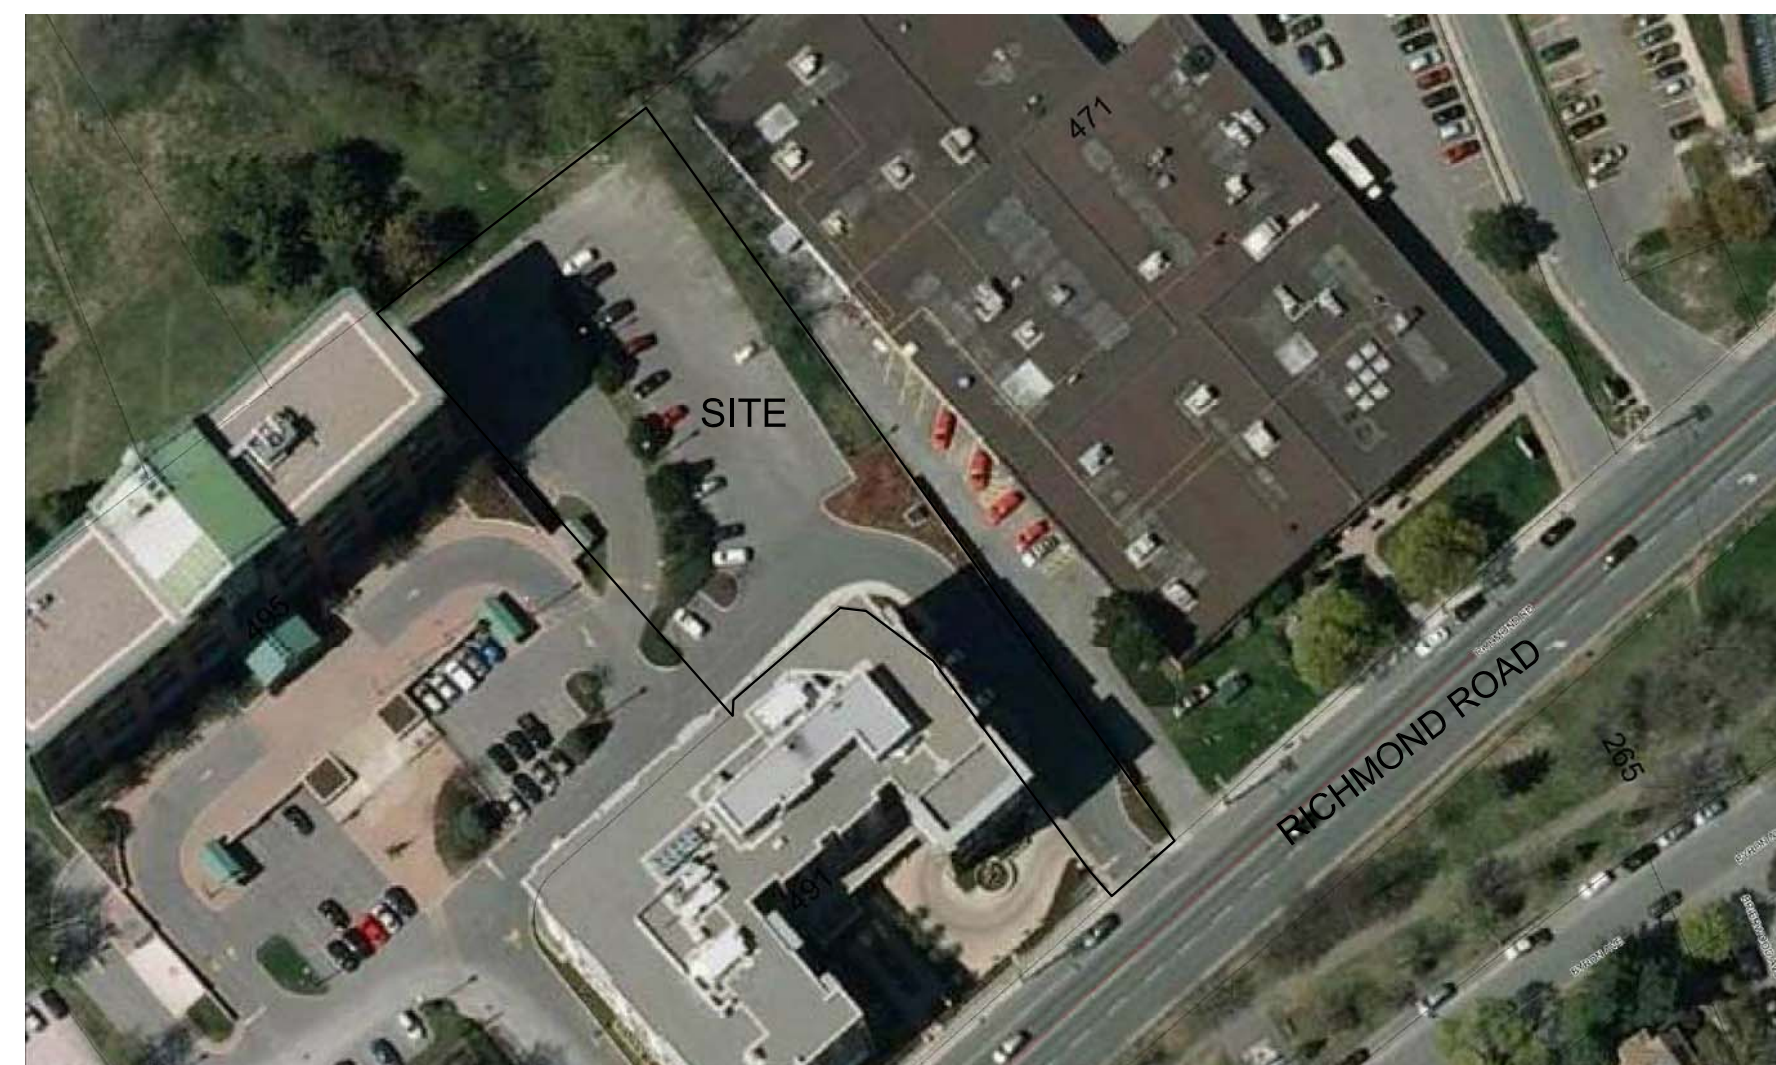
- A) LANDSCAPE SHRUBS ON ADJACENT PROPERTY. WELL-MAINTAINED.
- B) OVERGROWN HONEYSUCKLE BUSHES AND MANITOBA MAPLE VOLUNTEERS. OBSCURES TREE '4'.
- C) WEEDY PERENNIAL/ ANNUALS, MANITOBA MAPLE VOLUNTEERS. THE CANOPY OF A LARGE ELM ON THE ADJACENT PROPERTY OVERHANGS THE SITE.
- D) THE CANOPY OF A LARGE MANITOBA MAPLE ON THE ADJACENT PROPERTY OVERHANGS THE SITE.
- E) 5 SMALL *THUJA OCCIDENTALIS* (ALL WITH DBH <10cm DBH), IN POOR CONDITION.
- F) LANDSCAPE SHRUBS IN MODERATE CONDITION, INCLUDING LILAC, RUGOSA ROSE.
- G) LANDSCAPE SHRUBS, IN GOOD CONDITION, INCLUDING PRIVET HEDGE, AND RUGOSA ROSE.
