November 21, 2022

#### **<u>Re: Tree Conservation Report for Silver Maple #38 at 114 Richmond Road,</u>** <u>Ashcroft Homes' Q West Development</u>

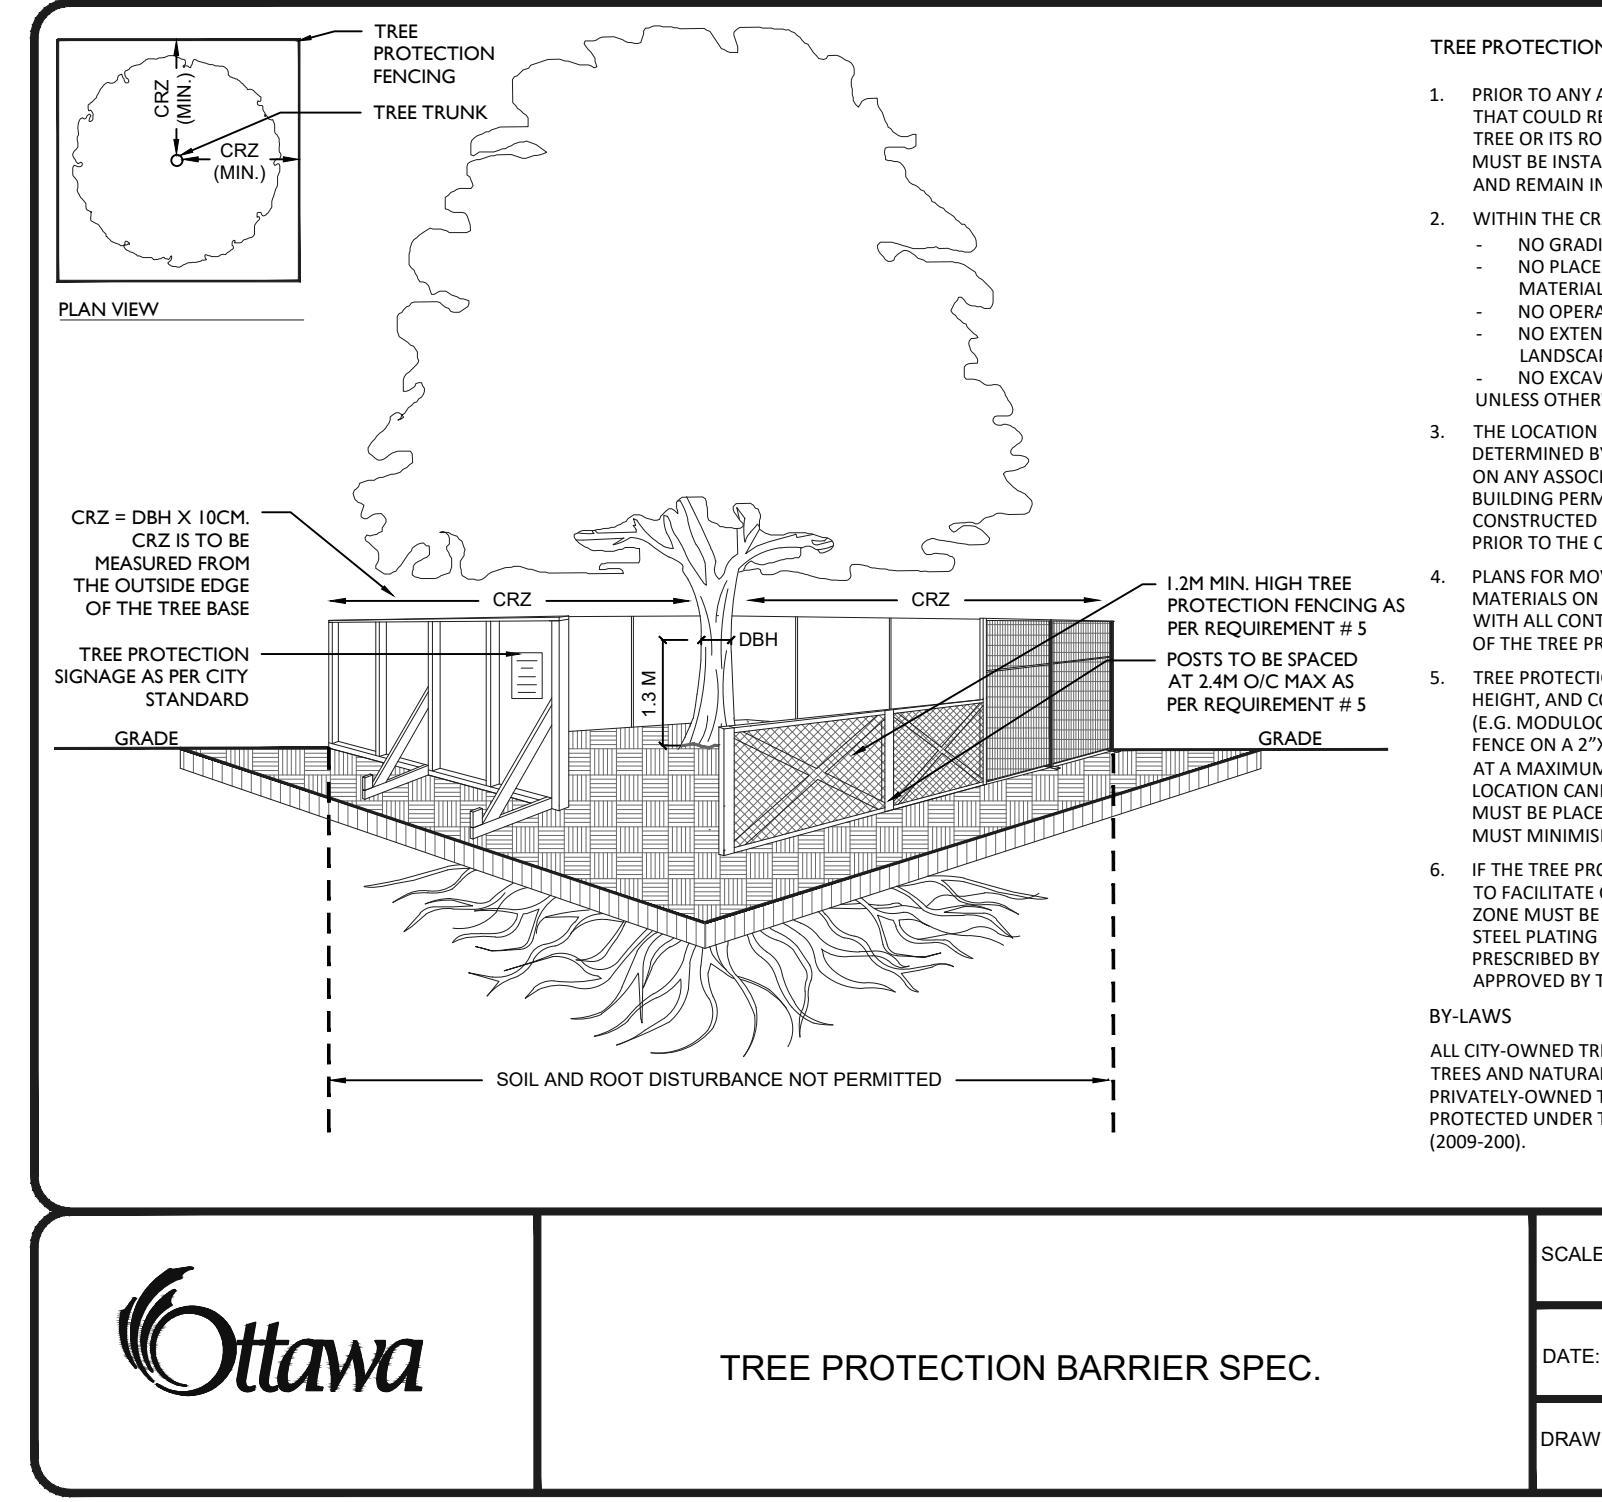
- 1. PRIOR TO ANY ACTIVITY IN PROXIMITY TO A PROTECTED TREE THAT COULD RESULT IN DIRECT OR INDIRECT INJURY TO THAT TREE OR ITS ROOTING AREA, TREE PROTECTION FENCING MUST BE INSTALLED AROUND THE CRITICAL ROOT ZONE (CRZ), AND REMAIN IN PLACE UNTIL THE WORK IS COMPLETE.

- 5. TREE PROTECTION FENCING MUST BE AT LEAST 1.2M IN HEIGHT, AND CONSTRUCTED OF RIGID OR FRAMED MATERIALS (E.G. MODULOC - STEEL, PLYWOOD HOARDING, OR SNOW FENCE ON A 2"X4" WOOD FRAME WITH POSTS TO BE SPACED AT A MAXIMUM OF 2.4 M APART). SUCH THAT THE FENCE LOCATION CANNOT BE ALTERED. ALL SUPPORTS AND BRACING MUST BE PLACED OUTSIDE OF THE CRZ, AND INSTALLATION MUST MINIMISE DAMAGE TO EXISTING ROOTS. (SEE DETAIL)

- 1. As per the City of Ottawa's tree protection barrier specification (included on the following page), erect a barrier as close as possible to the tree's CRZ. <u>At its final location, wooden hoarding is recommended.</u>
- 2. Do not place any material or equipment within the CRZ.
- 3. Do not attach any signs, notices or posters to any tree;
- 4. Do not raise or lower the existing grade within the CRZ without approval.
- 5. Tunnel or bore instead of trenching within the CRZ.
- 6. Do not damage the root system, trunk or branches of any tree.
- 7. Ensure that exhaust fumes from all equipment are NOT directed towards any tree's canopy.
