re: Geotechnical Assessment - Slope Review - Block 8
Proposed Multi-Storey Building
8466 Jeanne-d'Arc Boulevard - Ottawa

to: Brigil Construction - **Mr. Jean-Luc Rivard** - jlrivard@brigil.com
to: Brigil Construction - **Mr. Philip Thibert** - pthibert@brigil.com
date: June 23, 2021
file: PG4112-MEMO.02

Photographs from Site Visits – June 22, 2021

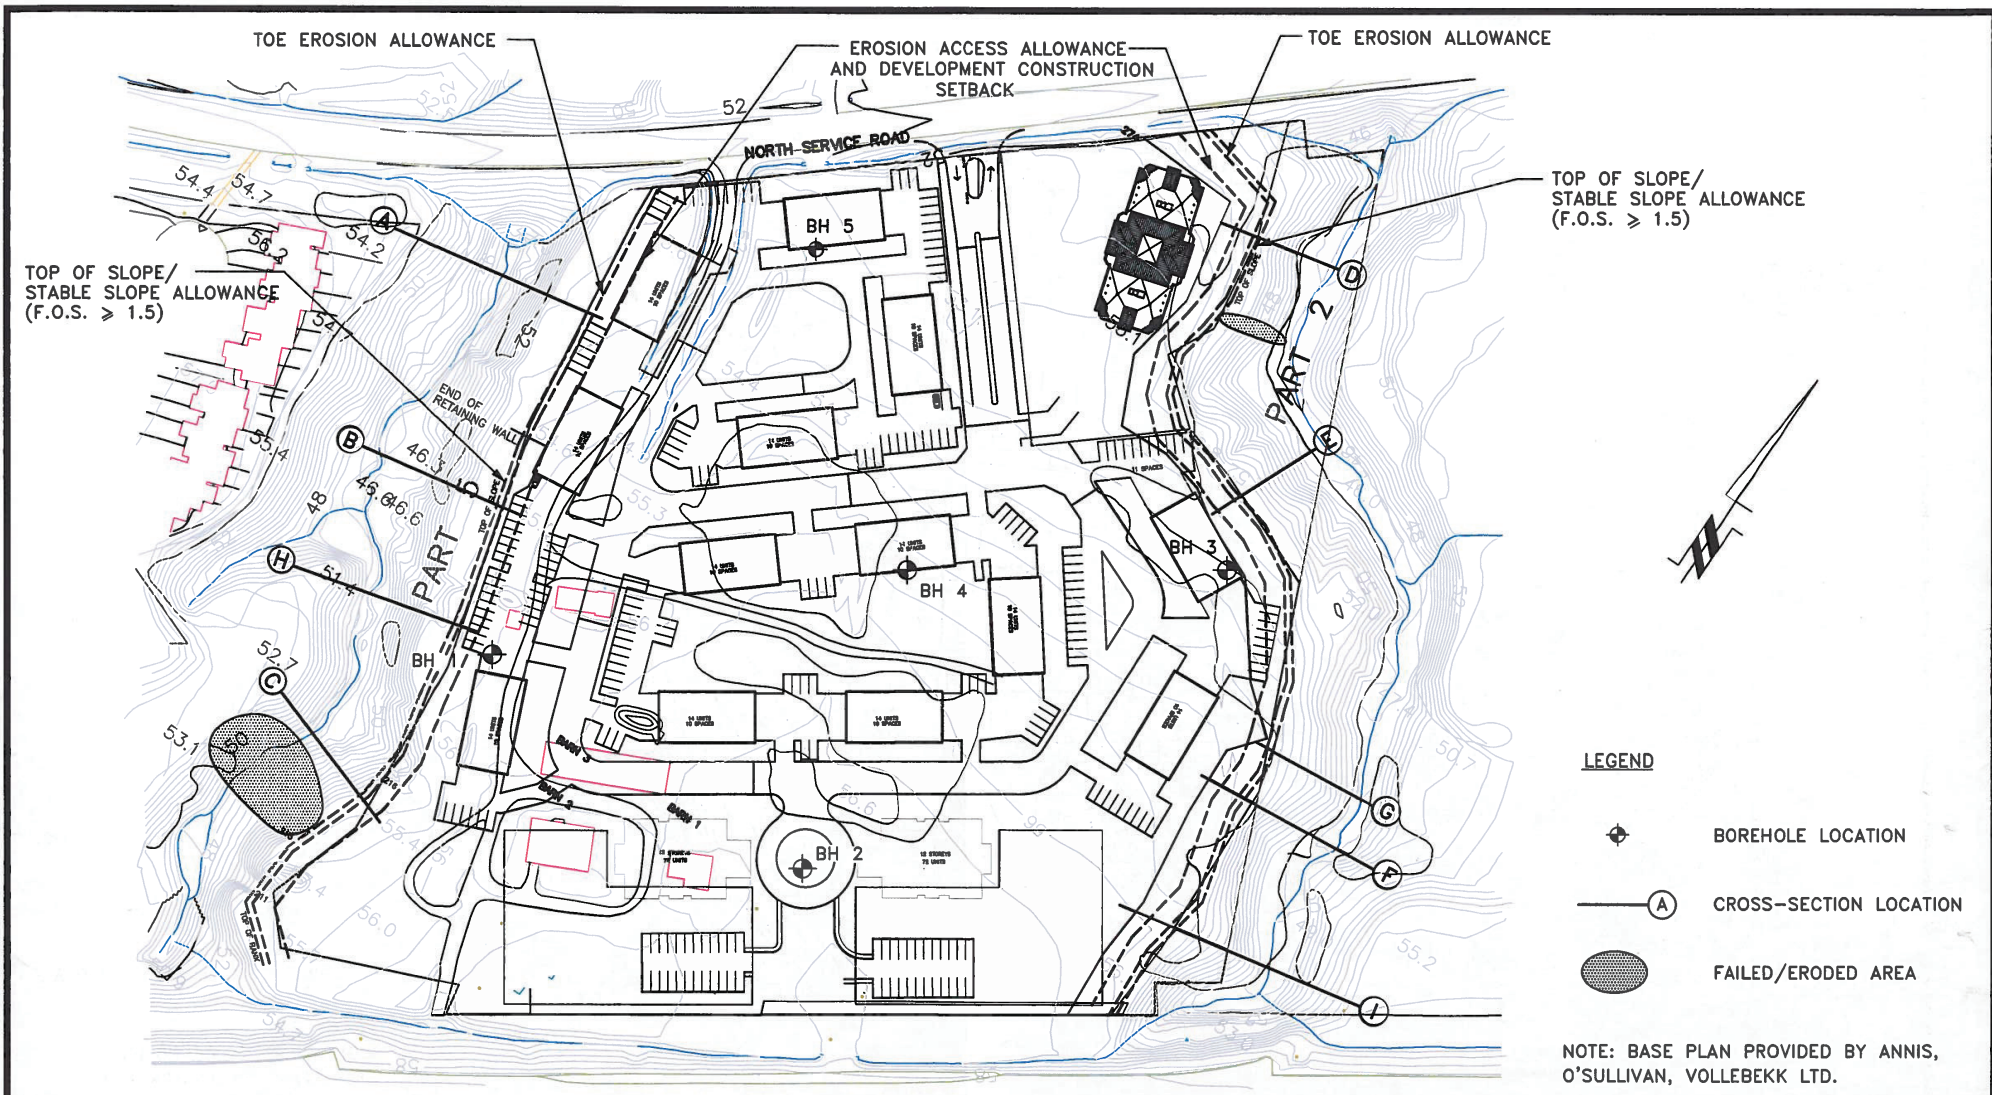
Figure 9, Section D, Seismic Conditions

The results of the previous slope stability analysis yielded factors of safety for static and seismic conditions of 2.73 and 2.36, respectively, which are considered to be well within acceptable limits from a geotechnical perspective. The study recommended an toe erosion allowance of 2 m and an erosion access allowance of 6 m, for a total required setback of 8 m from the top of slope.
