TCR
TREE
CONSERVATION
REPORT

2487 INNES
ROAD OTTAWA

MAY 4 2020
FOR SPC 1

RE: TREE CONSERVATION REPORT FOR 2487 INNES ROAD, OTTAWA

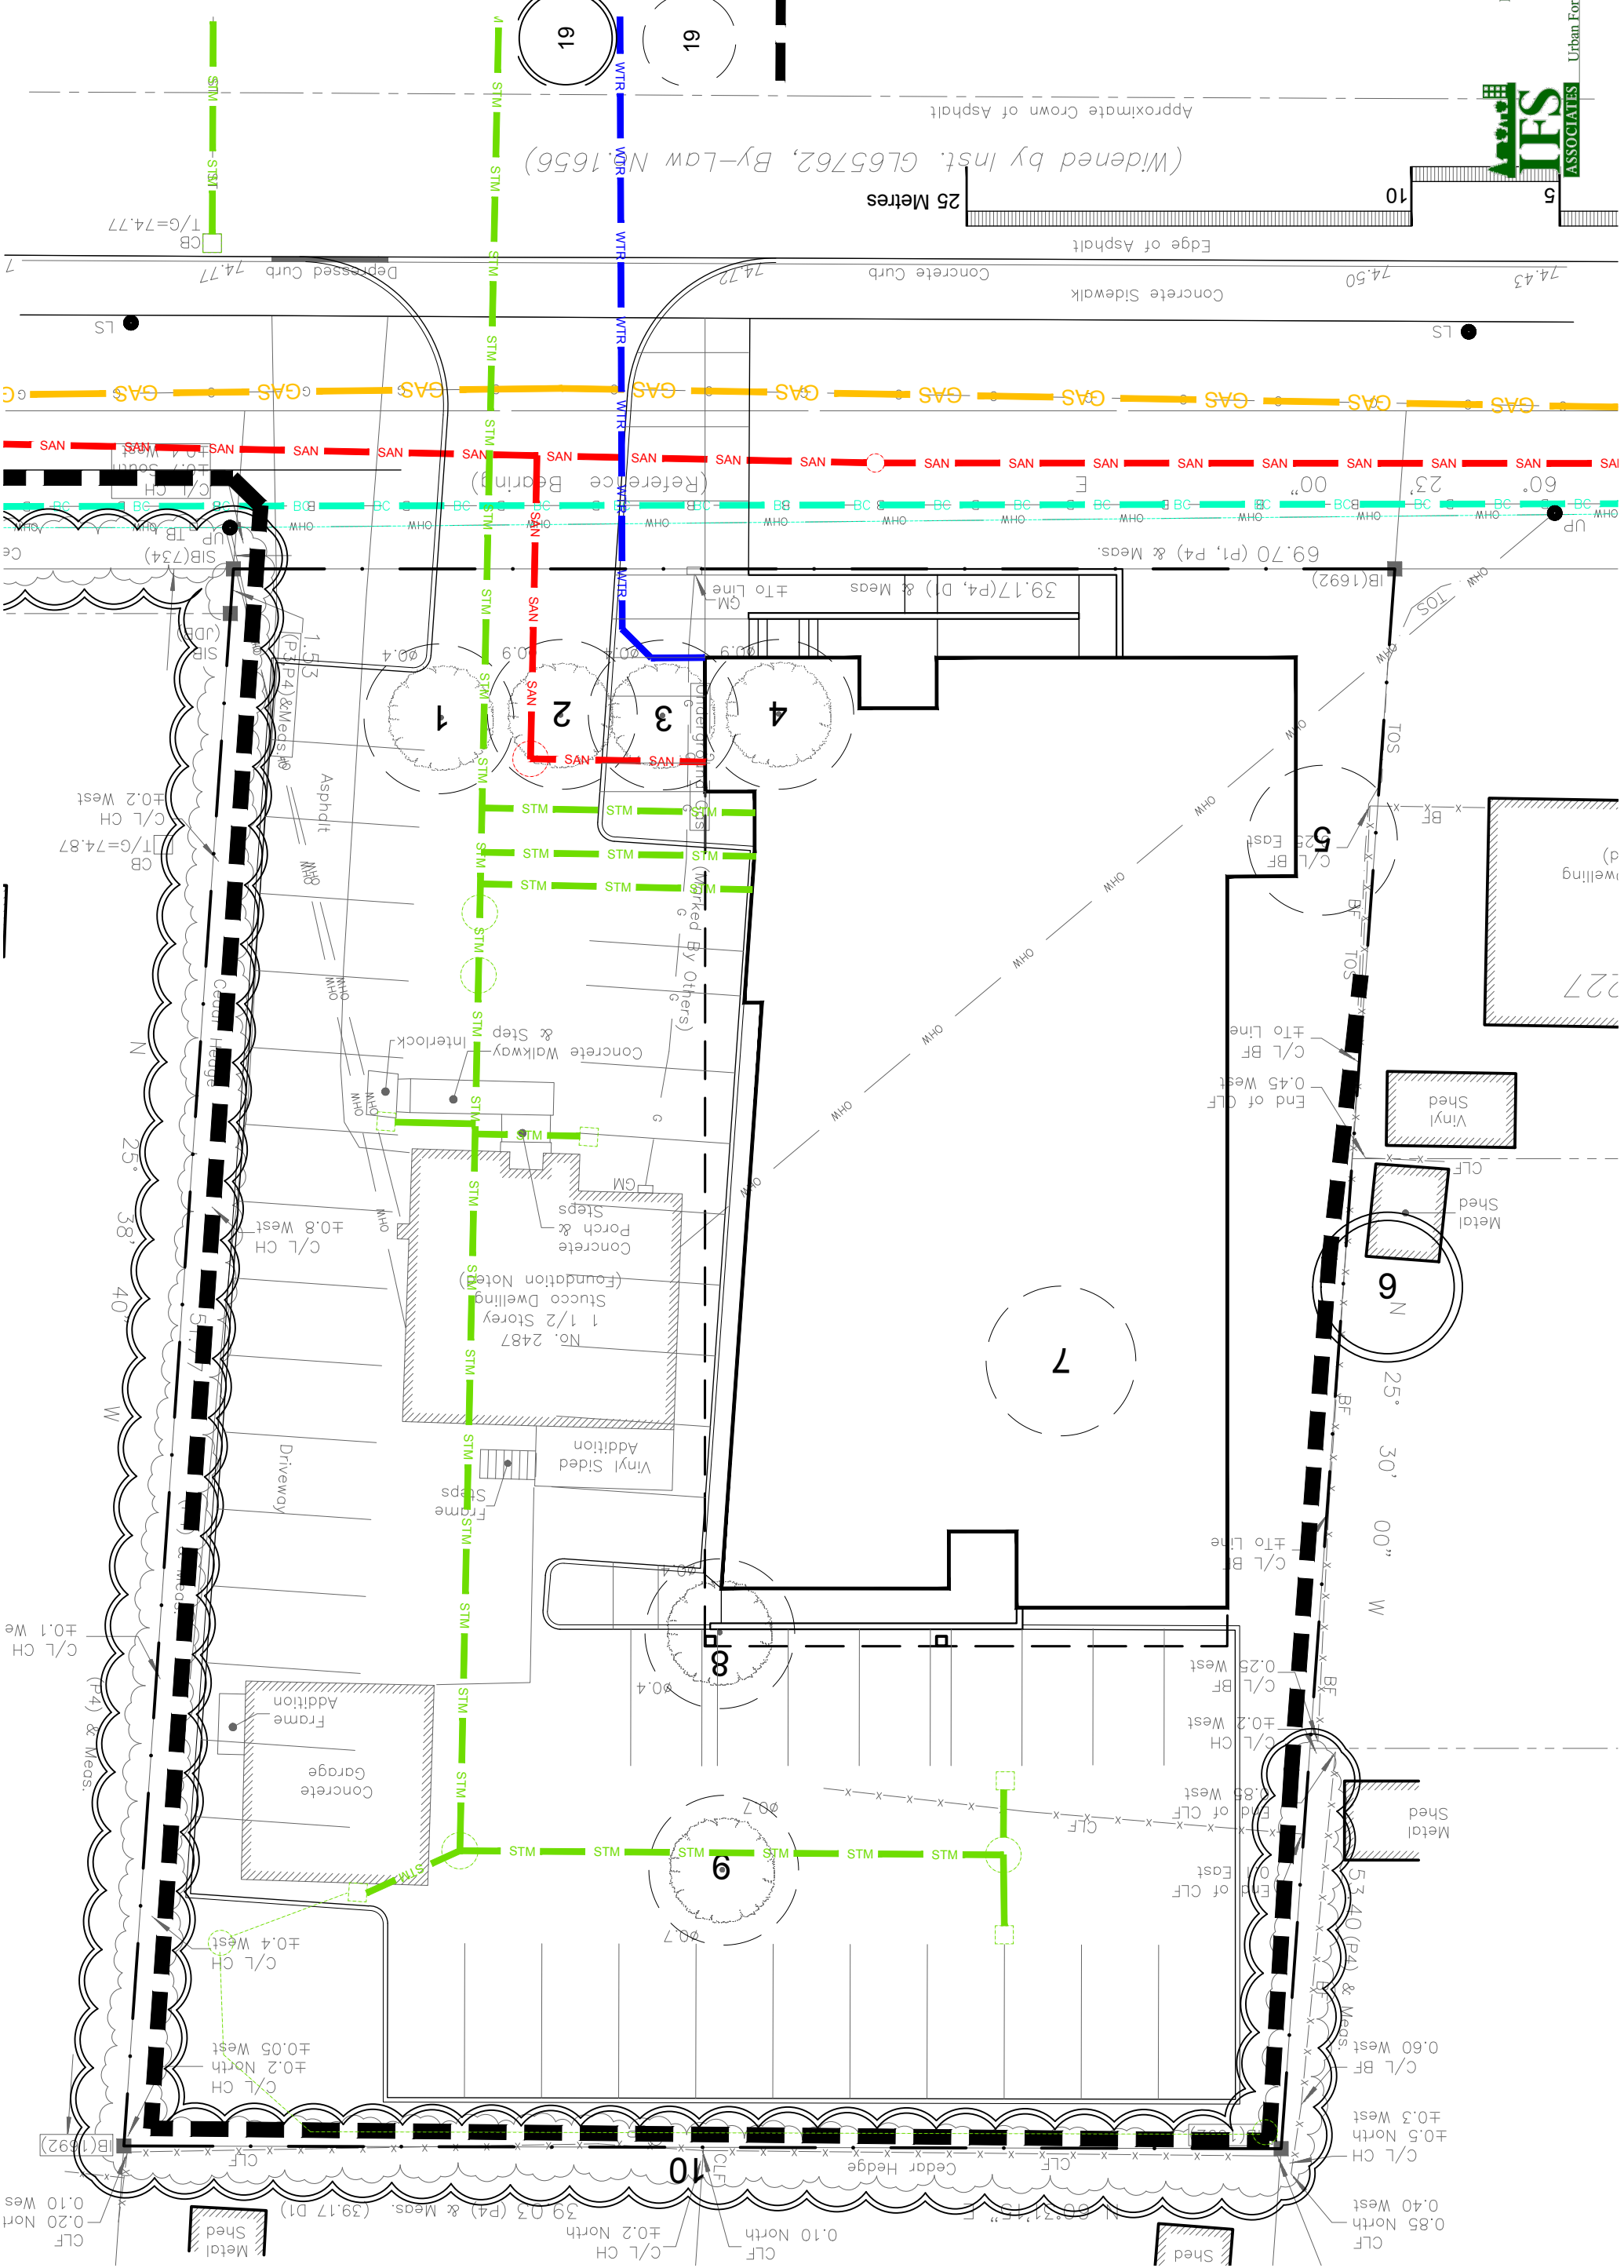
Table 1 below details the species, condition, size (diameter) and status of the individual trees on and adjacent to the subject property. Each of these trees is referenced by the numbers plotted on the accompanying tree conservation plan.

Tree No.	Tree species	Condition (VP→E)	DBH ¹ (cm)	Age class, tree condition notes & preservation status (to be removed or preserved and protected)
1	Eastern larch (<i>Larix laricina</i>)	Poor	44	Mature; tri-stemmed at 2.5m from grade; all three upright, southernmost stem dominant; open seam with exposed xylem in lower bole; native species; to be removed

7	Manitoba maple (<i>Acer negundo</i>)	Very poor	52	Mature; extensive basal wounding and decay; majority of crown is dead; tree is in advanced decline and hazardous; naturalized species; to be removed
8	White spruce	Fair	36	Mature; upright, narrow crown form; poor crown density, fair annual increment and needle colour; tree is in early decline; native species; to be removed
9	White pine	Good	60	Mature; single dominant stem for most of height; lower laterals removed leaving major wounds; crook in main stem at 6m; fair crown density, annual increment and needle colour native species; to be removed
10	White cedar (<i>Thuja occidentalis</i>)	Good	+/-10	Mature; majority of length maintained in hedge form, certain portions allowed to grow into full-sized trees; straddles property lines – some stems likely fully on adjacent private property; native species; to be preserved and protected

Preservation and protection measures intended to mitigate damage during construction will be applied for the hedge surrounding the subject property. The following measures are the minimum required by the City of Ottawa to ensure tree survival during and following construction:

1. Erect a fence at the critical root zone (CRZ¹) of trees;
2. Do not place any material or equipment within the CRZ of the tree;
3. Do not attach any signs, notices or posters to any tree;
4. Do not raise or lower the existing grade within the CRZ without approval;
5. Tunnel or bore when digging within the CRZ of a tree;
6. Do not damage the root system, trunk or branches of any tree;
7. Ensure that exhaust fumes from all equipment are NOT directed towards any tree's crown.
