TREE
CONSERVATION
REPORT V2.0

1655 and **1619** Carling Ave

Tree Conservation Report submitted as Partial Requirements for a Site Plan Control Application

Date: February 23, 2021

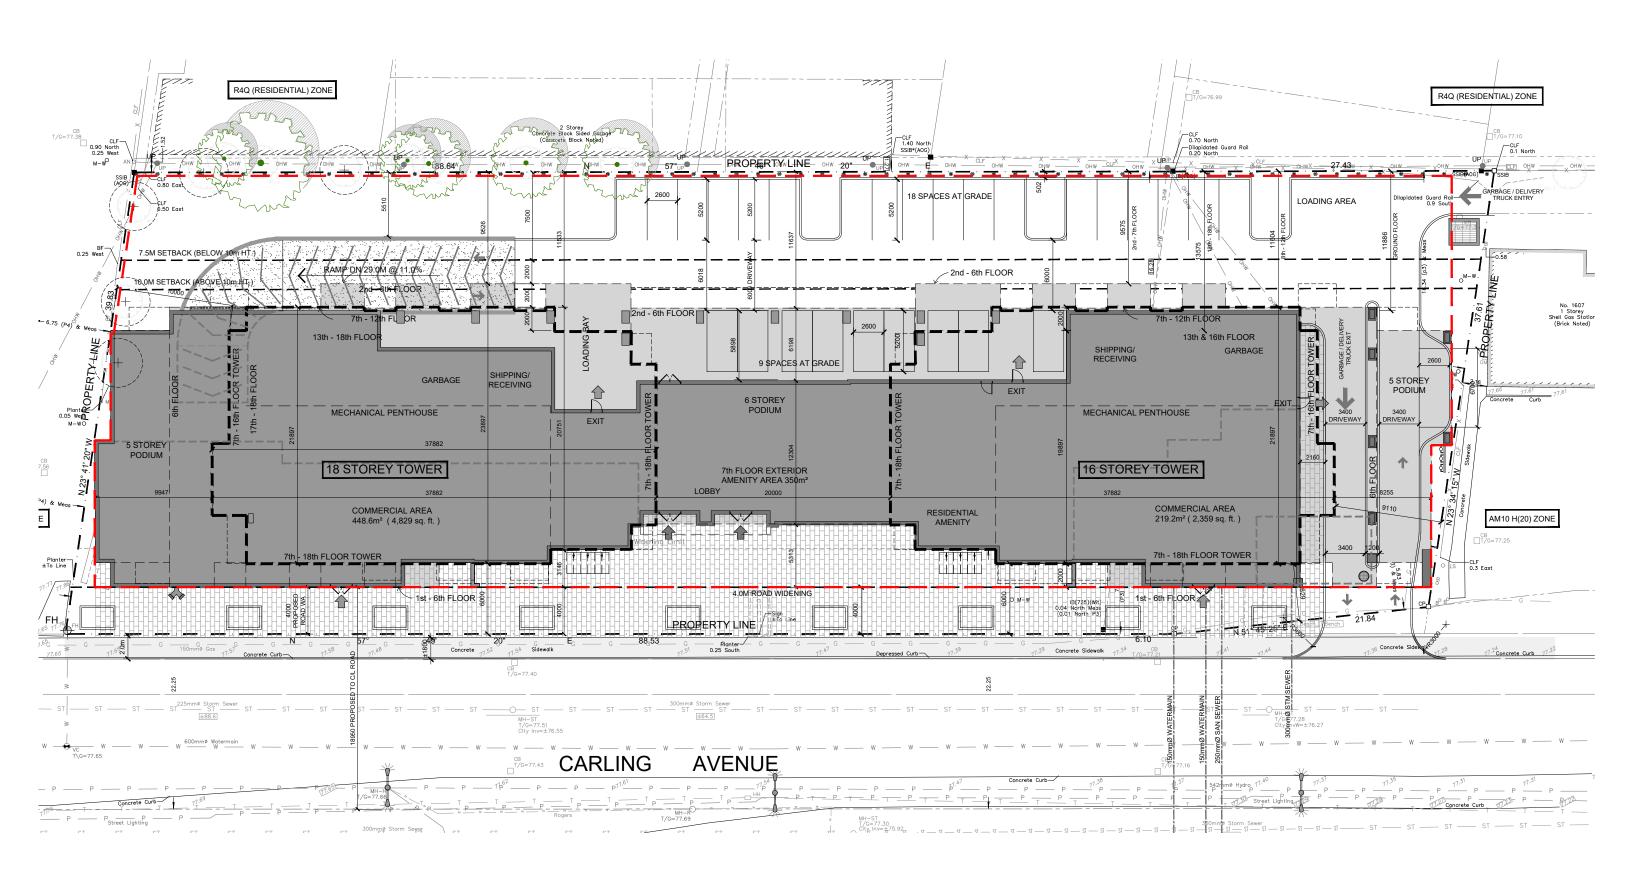
Tree Conservation Report – 1655/1619 Carling Ave
Tree layer prepared by Dendron Forestry Services
Version 1.0, August 9, 2020

The site plan provided in this report has been supplied by RLA and the red dotted line shows the extent of excavation for the underground parking lot. The excavation will extend to the property line along the north and west side, compromising the root systems for all trees along these edges and removal is recommended for all the trees on site. Note that some along the northern property line are jointly owned with neighbours on Tillbury who should be contacted prior to removal.
