# STAGE II CULTURAL HERITAGE IMPACT STATEMENT & CONSERVATION PLAN

145 Loretta Avenue & 951 Gladstone Avenue, Ottawa,  
Ontario

**Revision V5 January 2022**

**RE: 951 Gladstone Avenue  
 Building Condition Review**

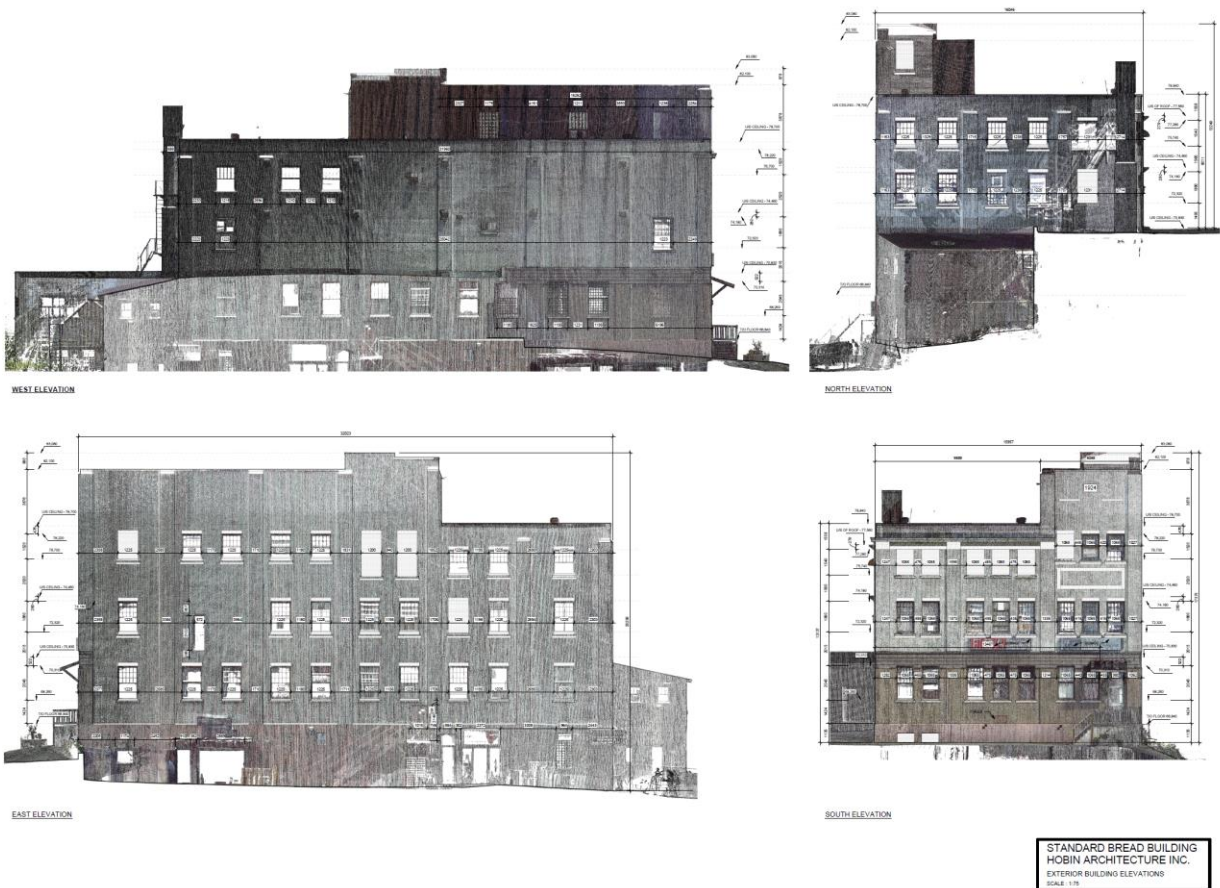
Figure 27: Photogrammetric recording of the Standard Bread Building. Source Hobin Architects

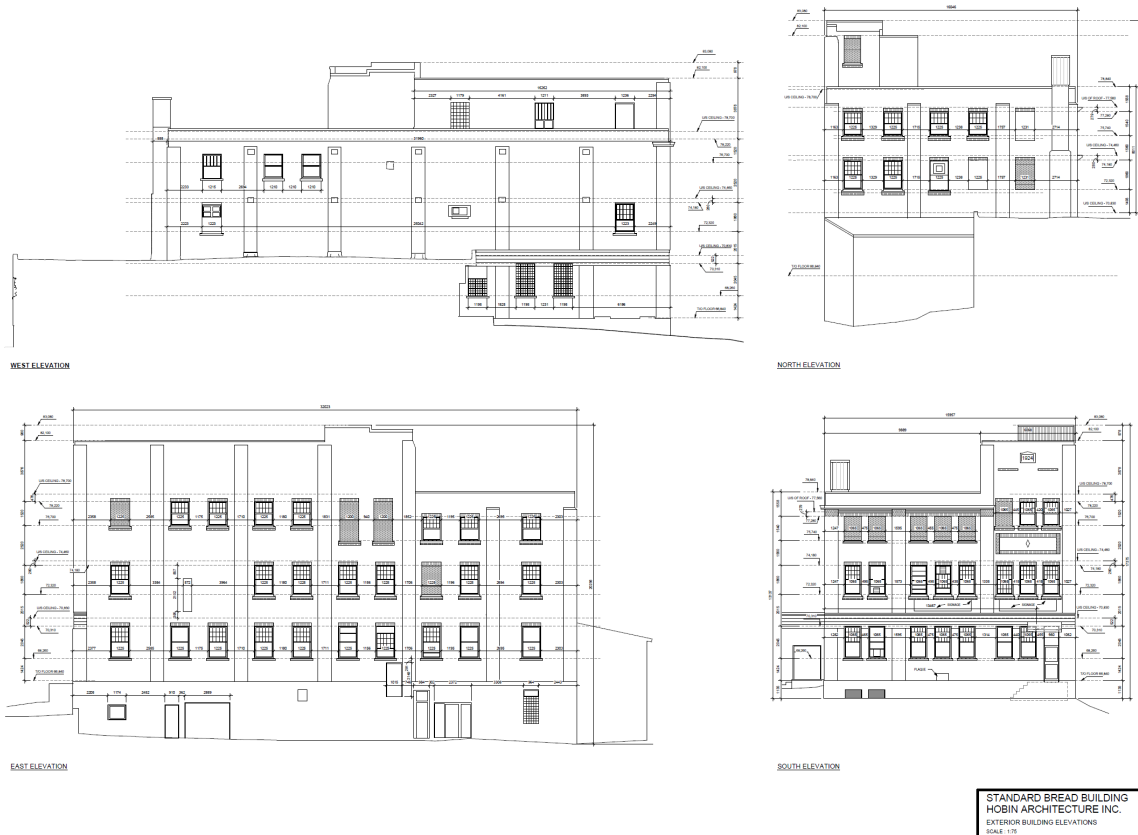
Figure 28: Dimensioned As-found record of elevation and floor plans of the Standard Bread Building. Source Hobin Architecture Inc.

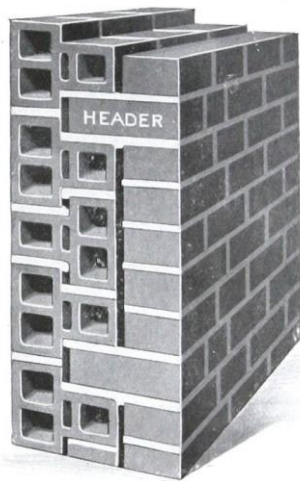
The bricks are a pressed brick with ground shale as the primary raw material, common for the period as clay deposits were being exhausted. The bricks are wire cut and have a textured surface that is painted. The removal of the paint from the interstices in the brick surfaces will be difficult if not impossible as the oil-based paint is well adhered to the surfaces. The brickwork is generally in good condition with localized spalled bricks. The brickwork in the areas that were inspected appeared to be well adhered to the terra-cotta backup walls when sounded with a hammer.

Figure 31: A mock-up sketch illustrating the Standard Bread wall composition tilted Wall of Denison Tile Face with Pressed or Common Brick. Source Sun Brick Co. Limited Manufactures of "Suntex" Products pg 73.
