# STAGE II CULTURAL HERITAGE IMPACT STATEMENT & CONSERVATION PLAN

145 Loretta Avenue & 951 Gladstone Avenue,  
Ottawa, Ontario

**PREPARED BY: COMMONWEALTH HISTORIC RESOURCE MANAGEMENT**

**Revision V5 October 2022**

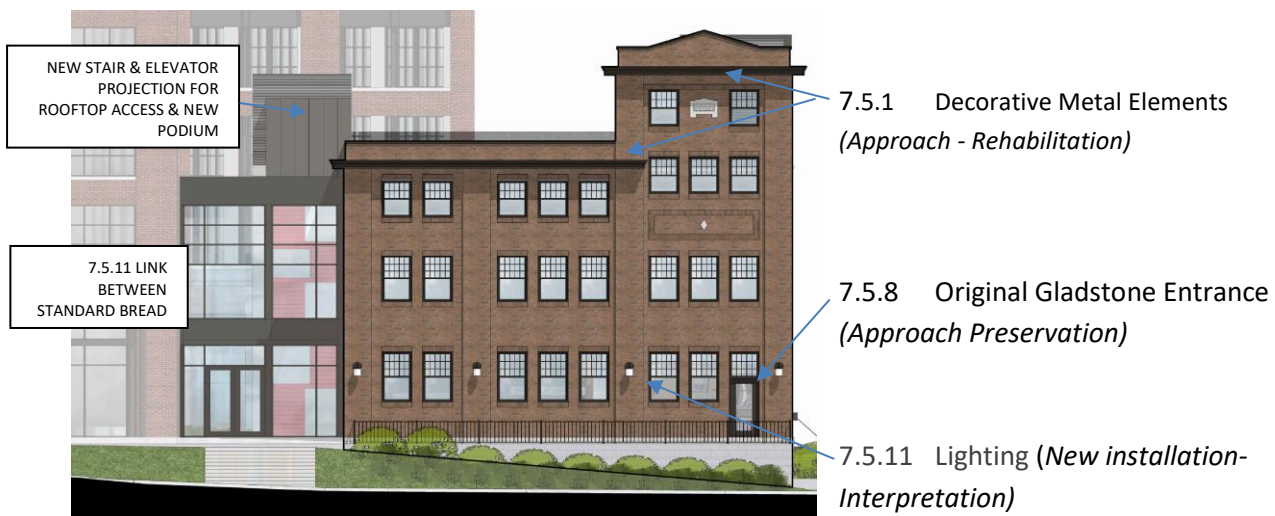
South Elevation

The gabled brick and metal parapets are in poor condition (figure 30) and will require restoration and for whole sections, the flashing and cornice profile details will have to be fabricated based on the photographs and remaining elements.

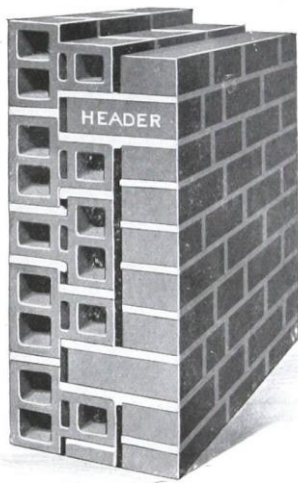
The bricks are a pressed brick with ground shale as the primary raw material, common for the period as clay deposits were being exhausted. The bricks are wire cut and have a textured surface that is painted. The removal of the paint from the interstices in the brick surfaces will be difficult if not impossible as the oil-based paint is well adhered to the surfaces. The brickwork is generally in good condition with localized spalled bricks. The brickwork in the areas that were inspected appeared to be well adhered to the terra-cotta backup walls when sounded with a hammer.

Figure 31: A mock-up sketch illustrating the Standard Bread wall composition tilted Wall of Denison Tile Face with Pressed or Common Brick. Source Sun Brick Co. Limited Manufactures of "Suntex" Products pg 73.

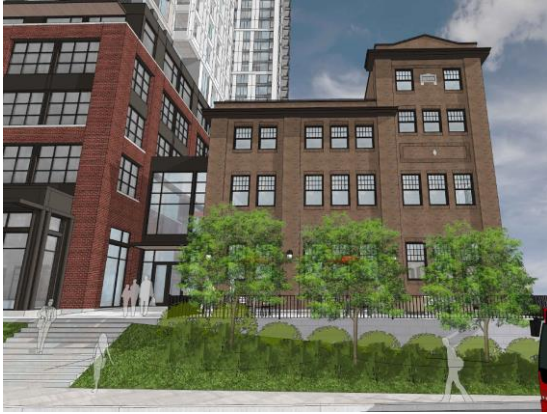
Figure 34: A rendering of the entrance treatment with the transition from the street level to the link entrance. A terrace in front of the Standard Bread serves the traditional entrance, a character defining attribute. Source: Hobin Architecture. 2022.

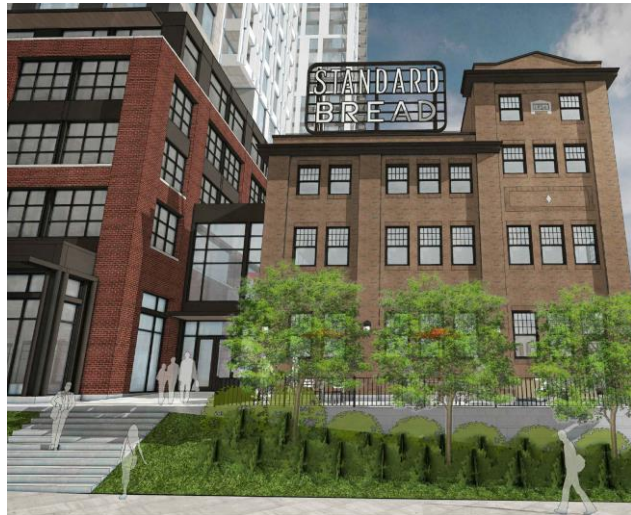
Figure 35: A historic photo illustrates the original sign with a rendering of the signage treatment being considered. Source: Hobin Architecture. 2022.

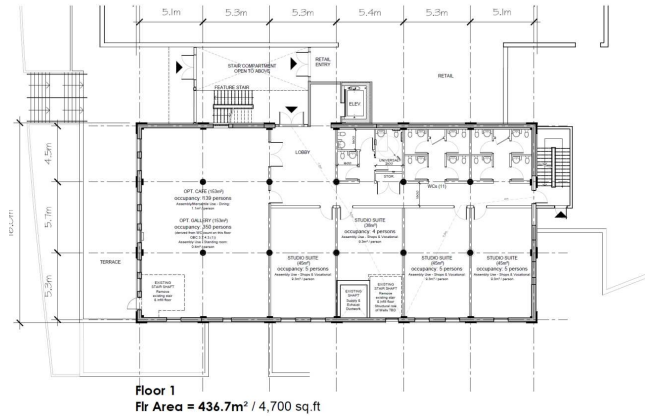
Figure 36: Ground floor plan illustrating the mushroom columns establishing the grid pattern.

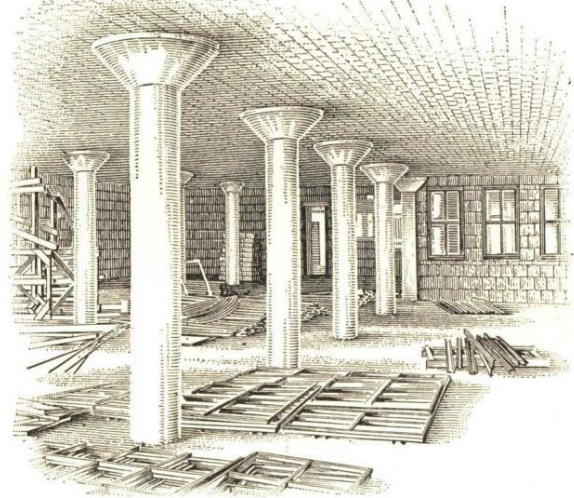
FIG. 63

Figure 37: Concrete Mushroom Columns are a character defining feature. Source: Fig. 63 illustration from *Plain and Reinforced Concrete Construction*.

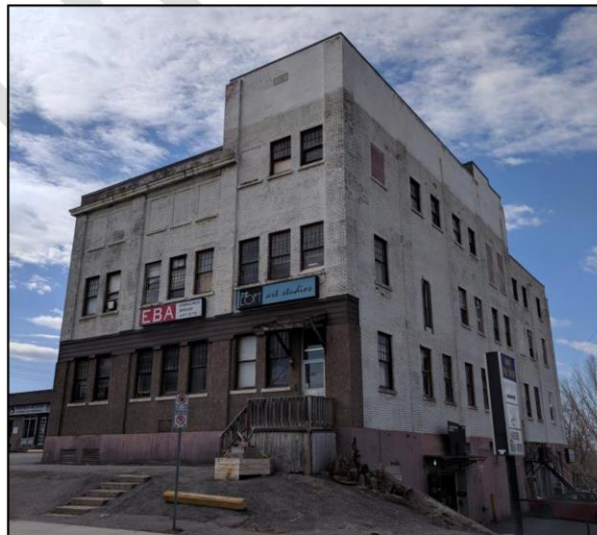
Photo 1: 951 Gladstone Avenue, south and east elevations [JCAL 2018].

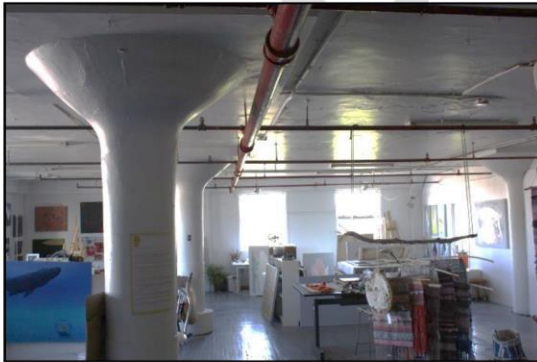
The interior concrete columns and floor slabs appear to be in good condition in general. An area of spalled concrete on the underside of the 3rd floor was observed. Loose concrete has been removed and the corroded rebar is visible. Although this is not an immediate structural concern, it does create a weak point in the floor slab. The deterioration does not appear active and was likely caused by water leakage or elevated moisture levels from previous building operations.

Photo 2: Typical columns inside the building [JCAL 2018].
