Project:  
**Gladstone and Loretta**  
 OTTAWA, ONTARIO

Drawing:  
**TREE CONSERVATION REPORT**

Scale:	1:250	Date:	04 OCT 2018
Design By:	QL	Drawn By:	QL
Project Number:	1987-01	Sheet Number:	TCR 1.0

Scale: 1:250	Date: 04 OCT 2018
Design By: QL	Drawn By: QL
Project Number: 1987-01	Sheet Number: TCR 1.1

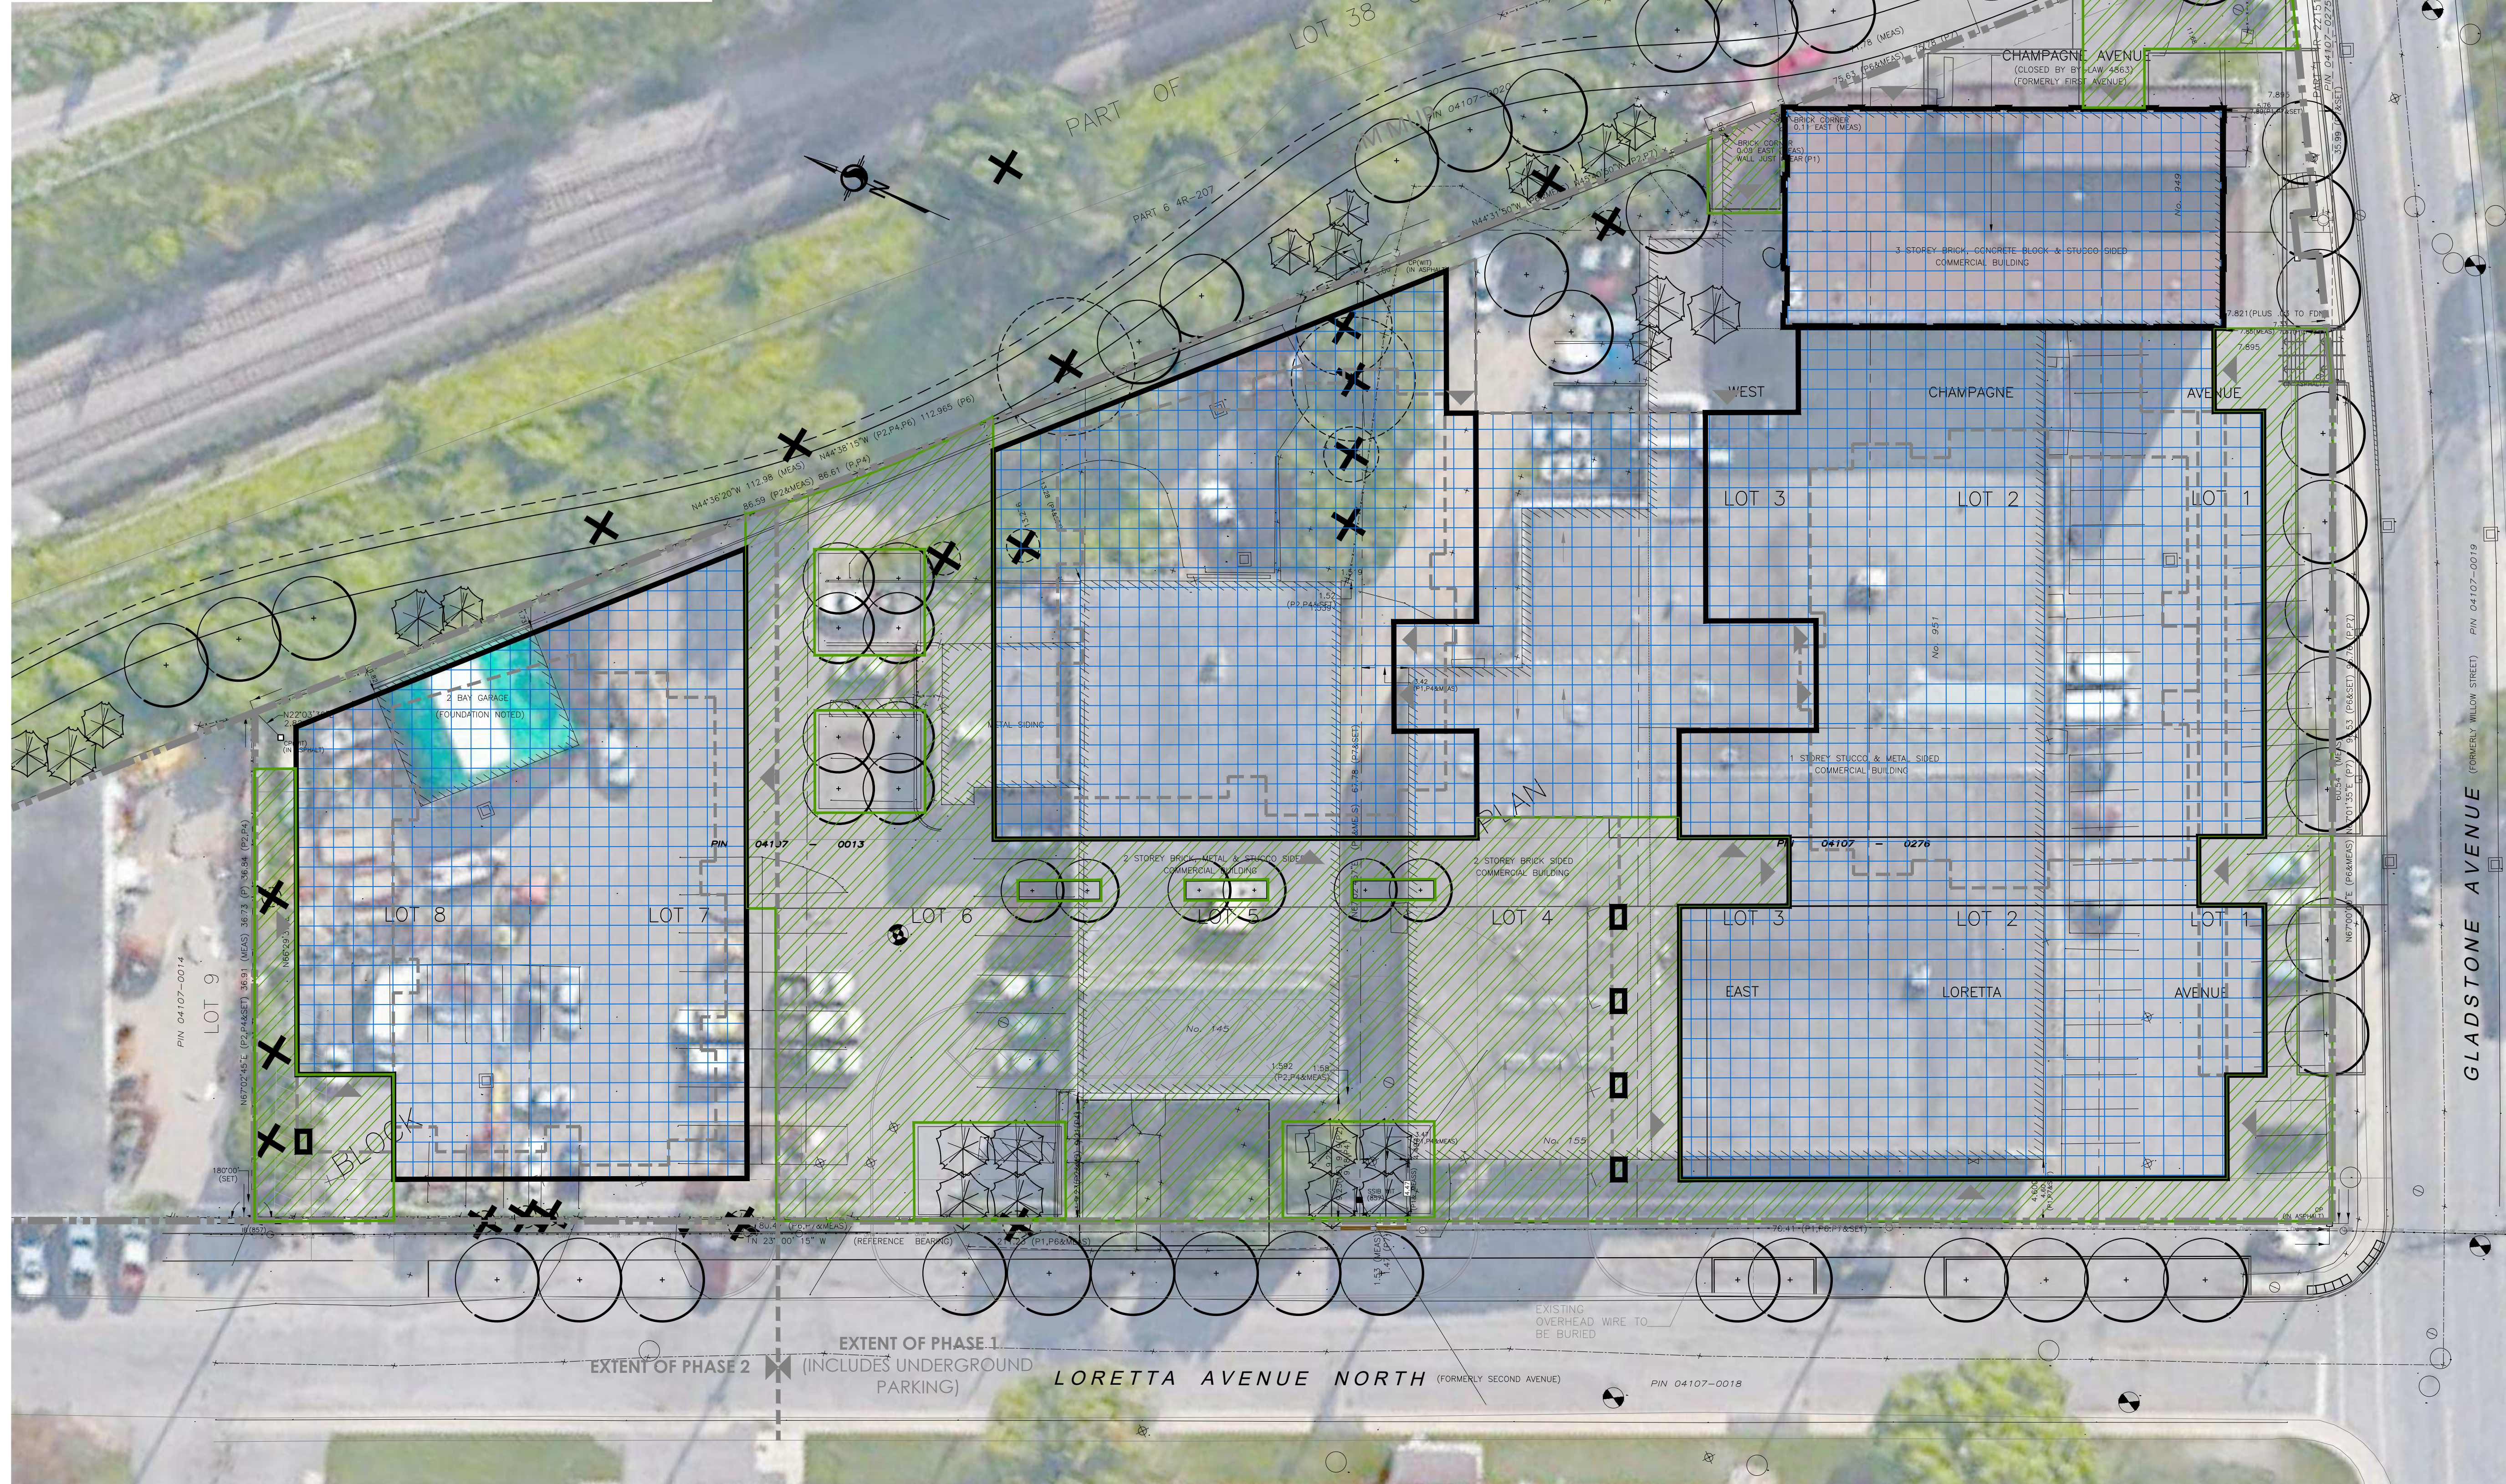
THE LINEAR LANDSCAPE AREA NORTHEAST OF THE SITE RUNS ADJACENT TO THE EXISTING O-TRAIN TRACKS. THIS AREA IS SEPARATED FROM THE COMMERCIAL PROPERTIES WITH CHAIN LINK FENCE AT THE TOP OF A SLOPE. THE AREA IS DENSE WITH INVASIVE PLANTS SUCH AS MANITOBA MAPLE, WILD GRAPE VINE AND VIRGINIA CREEPER. THE AREA HAS A GREAT DEAL OF DEAD TREES AND MISCELLANEOUS DEBRIS MAKING THE AREA DIFFICULT TO ACCESS.

THE SITE LACKS SIGNIFICANT TREES OF VALUE. THE PRESENT TREES OFFER LITTLE BENEFIT TO THE SITE IN TERMS OF ECOLOGY, CHARACTER, OR SHADE VALUE. THE GENERAL CONDITION OF THE SITE'S TREES ARE POOR WITH A DECLINING STATE OF HEALTH.
