TREE CONSERVATION REPORT

18 Louisa Street, Ottawa, Ontario

May 26, 2021

revised August 09, 2024

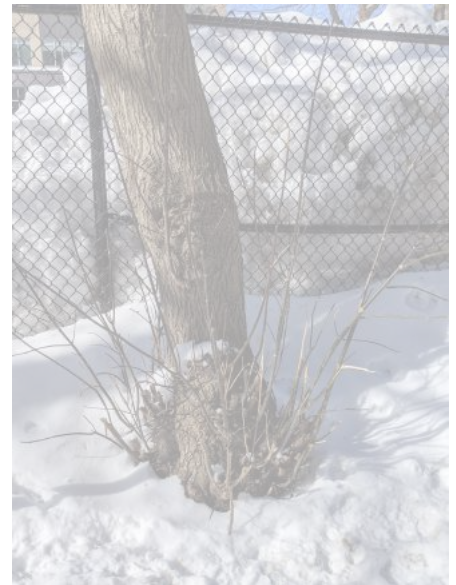
Trees #12, 13, 14 will be impacted by the proposed development (transformer location and access drive). These are Ash trees and do not appear to have received inoculation against Emerald Ash Borer. As the initial inventory was conducted in the winter, overall canopy condition was impossible to determine. However, as Figure 1 shows, all the Ash trees

appear to be in overall good condition as of May 26th, 2021. The roots on all three trees are slightly girdled, but canopies appear to be full and lush.

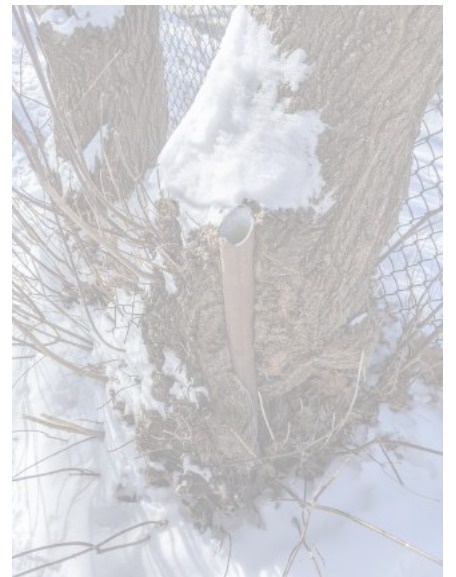
Trees # 1-11 are in direct conflict with the proposed development. According to the proposed site plan, the parking garage extends to the property line on all sides. Therefore, all trees are scheduled to be removed. The majority of these trees were in fair to poor condition, as shown in Figure 2 below (*updated November 10, 2021*).
