# TREE CONSERVATION REPORT

1058-1066 Silver Street  
and 1291-1305 Summerville Avenue

January 24, 2024

## Tree Conservation Report v2.0

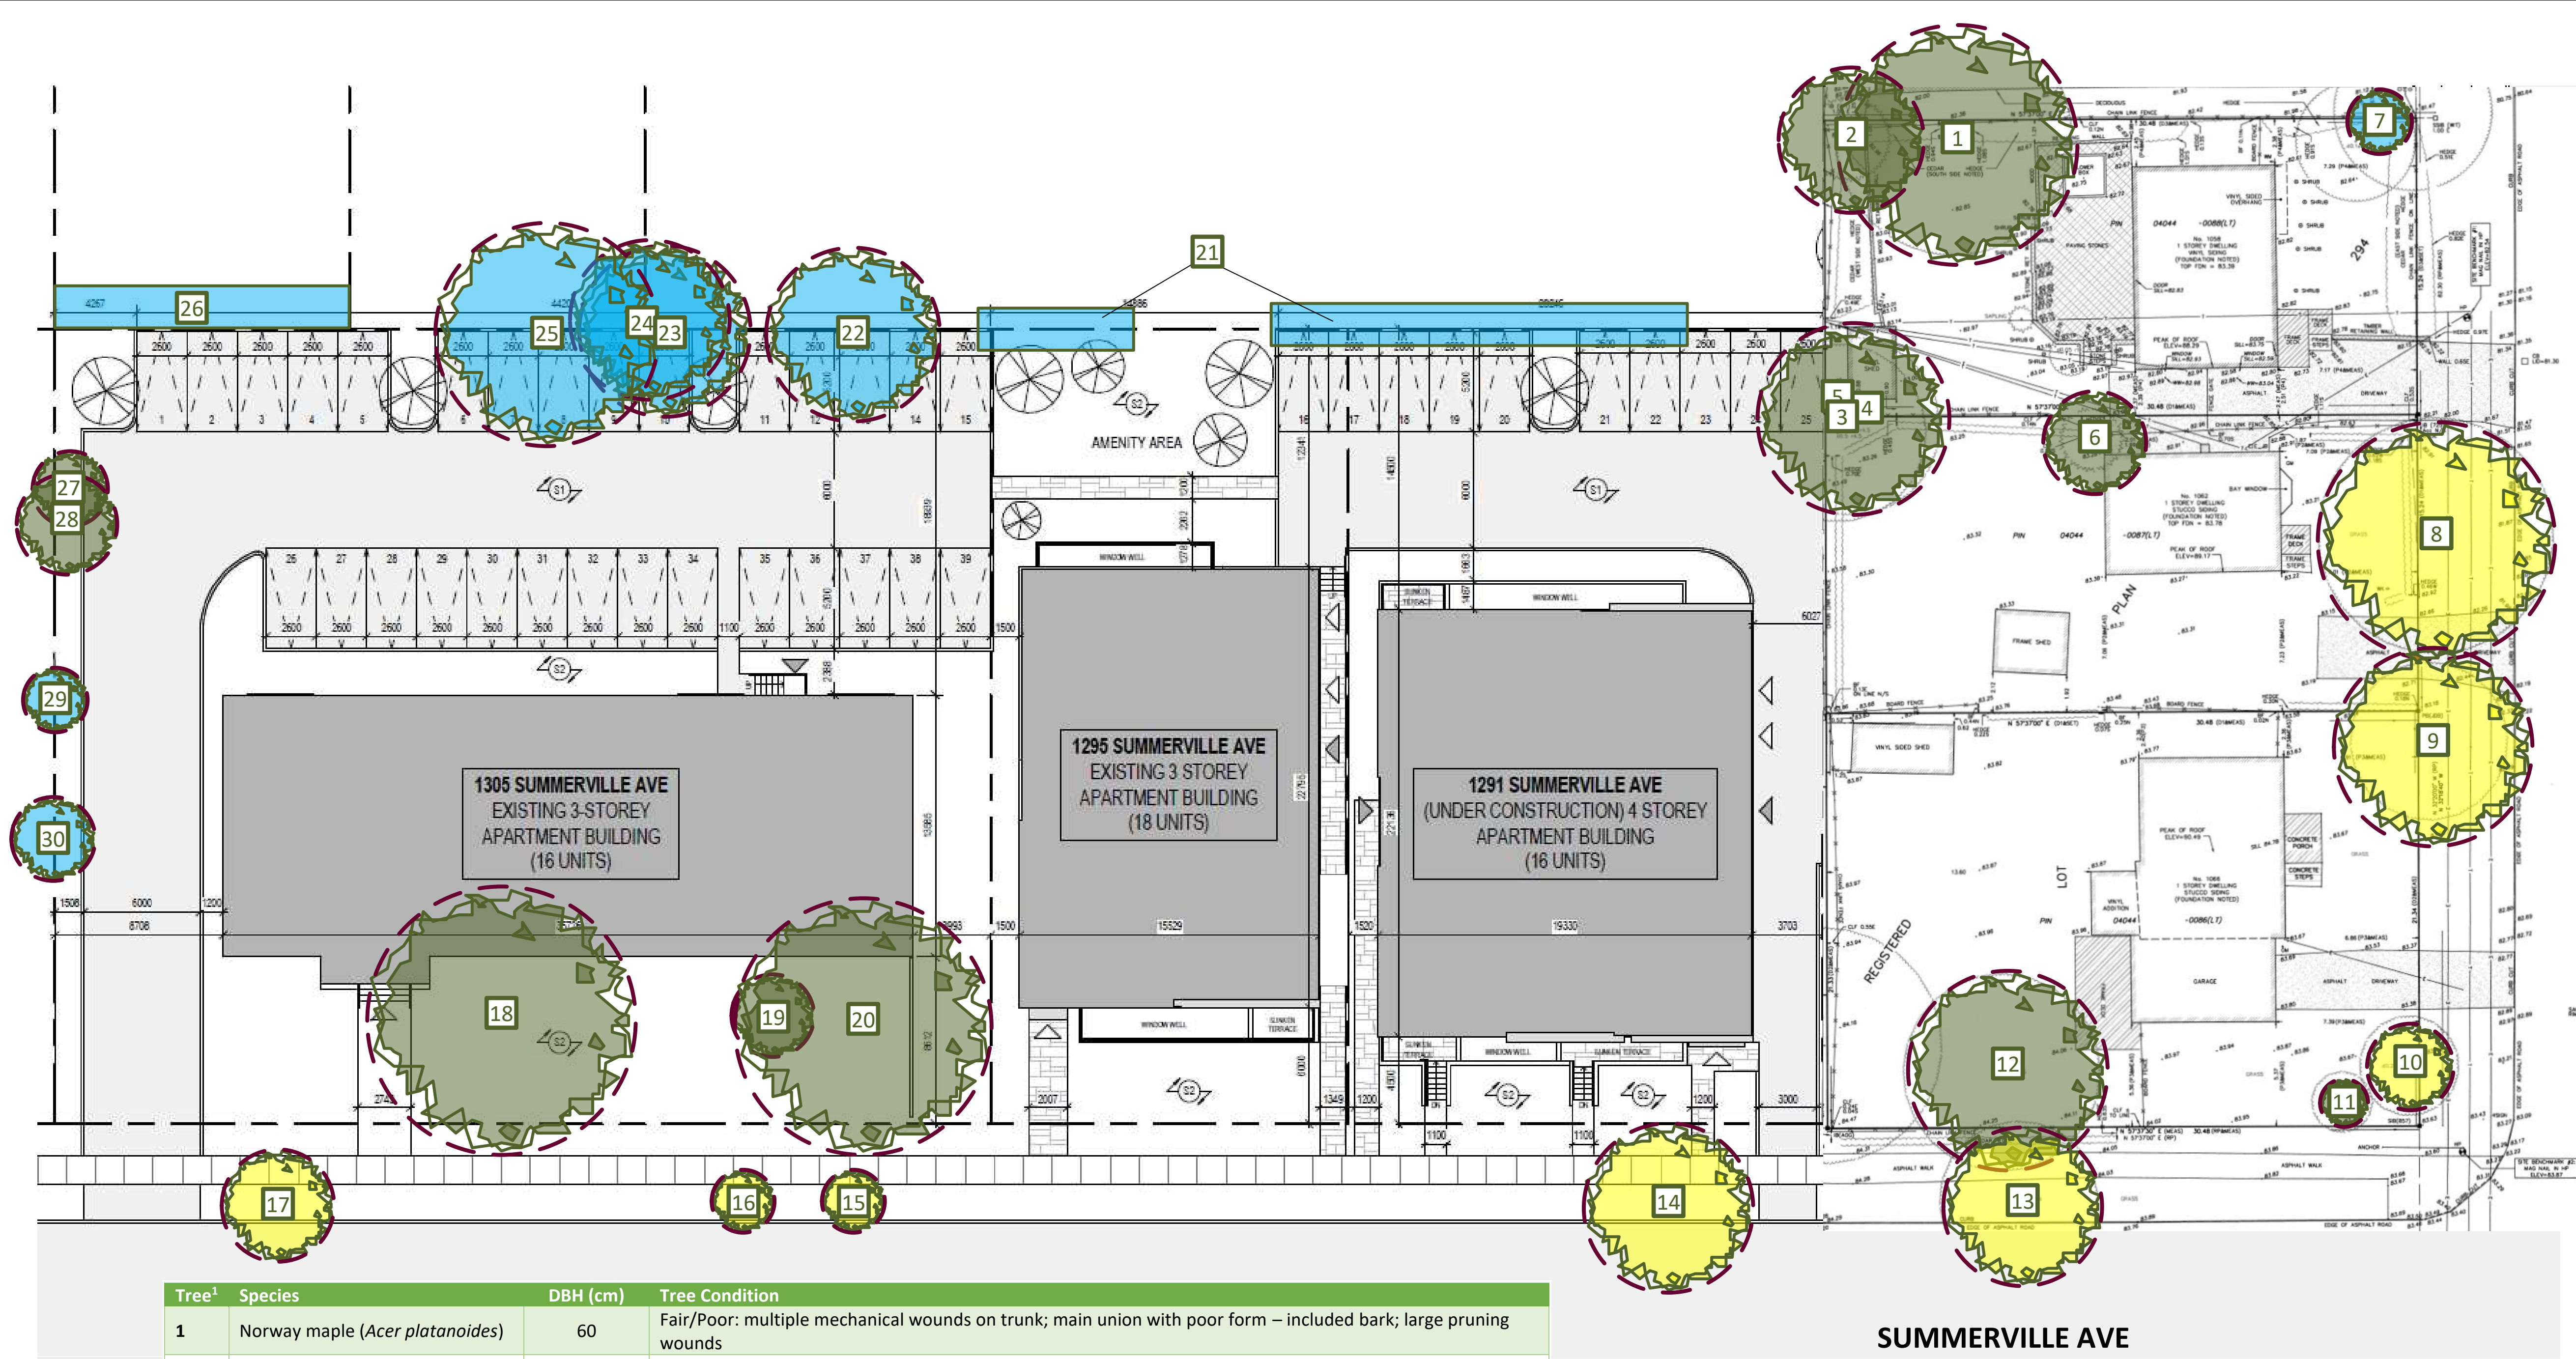
TCR Map – 1058-1066 Silver St, 1291-1305 Summerville Ave  
 Tree layer prepared by  
 Dendron Forestry Services  
 Existing vegetation, January 12, 2024

18 <sup>4</sup>	Little leaf linden ( <i>Tilia cordata</i> )	44, 50	Fair: 44cm stem dying at top – leaning significantly towards road
19 <sup>4</sup>	Red maple ( <i>Acer rubrum</i> )	20	Good: crown slightly asymmetrical
20 <sup>4</sup>	Norway maple ( <i>Acer platanoides</i> )	64	Fair: large seams on two sides of trunk; minor decay in small wounds
21 <sup>4</sup>	Manitoba maple ( <i>Acer negundo</i> )	21 stems 10-35cm	All stems poor: heavily pruned under hydro wires – most branching is epicormic shoots; many with significant leans
22 <sup>4</sup>	Siberian elm ( <i>Ulmus pumila</i> )	43	Poor: poor form; cavity in main bole; decay in wounds; broken branches; pruned around wires
23 <sup>4</sup>	Siberian elm ( <i>Ulmus pumila</i> )	42	Poor: pruned around wires; asymmetrical crown; decay in wounds; poor form
24 <sup>4</sup>	Manitoba maple ( <i>Acer negundo</i> )	39	Poor: pruned around wires; asymmetrical crown; decay in wounds; poor form

25 <sup>4</sup>	Siberian elm ( <i>Ulmus pumila</i> )	55 (estimate)	Poor: heavy lean towards Dorchester; dead branches; poor form; growing on fence
26 <sup>4</sup>	White spruce ( <i>Picea glauca</i> )	4 stems ~15cm	Good/Fair: pruned under wires – some with poor form
27 <sup>4</sup>	Manitoba maple ( <i>Acer negundo</i> )	15	Fair: slight lean; canker in canopy; growing under wires
28 <sup>4</sup>	Manitoba maple ( <i>Acer negundo</i> )	15, 20	Fair/Poor: heavy lean to the south; epicormic shoots throughout canopy; growing on fence
29 <sup>4</sup>	Norway maple ( <i>Acer platanoides</i> )	18 (estimate)	Fair/Poor: moderate lean; grown around fencing
30 <sup>4</sup>	Eastern white cedar ( <i>Thuja occidentalis</i> )	18, 8 (estimate)	Fair: asymmetrical – growing beside house; chlorosis and dieback in canopy near A/C unit.
