TREE CONSERVATION REPORT

Preliminary report for 1983 Carling Ave

Tree Conservation Report submitted as Partial
Requirements for a Site Plan Control Application

Address: 1983 Carling Ave

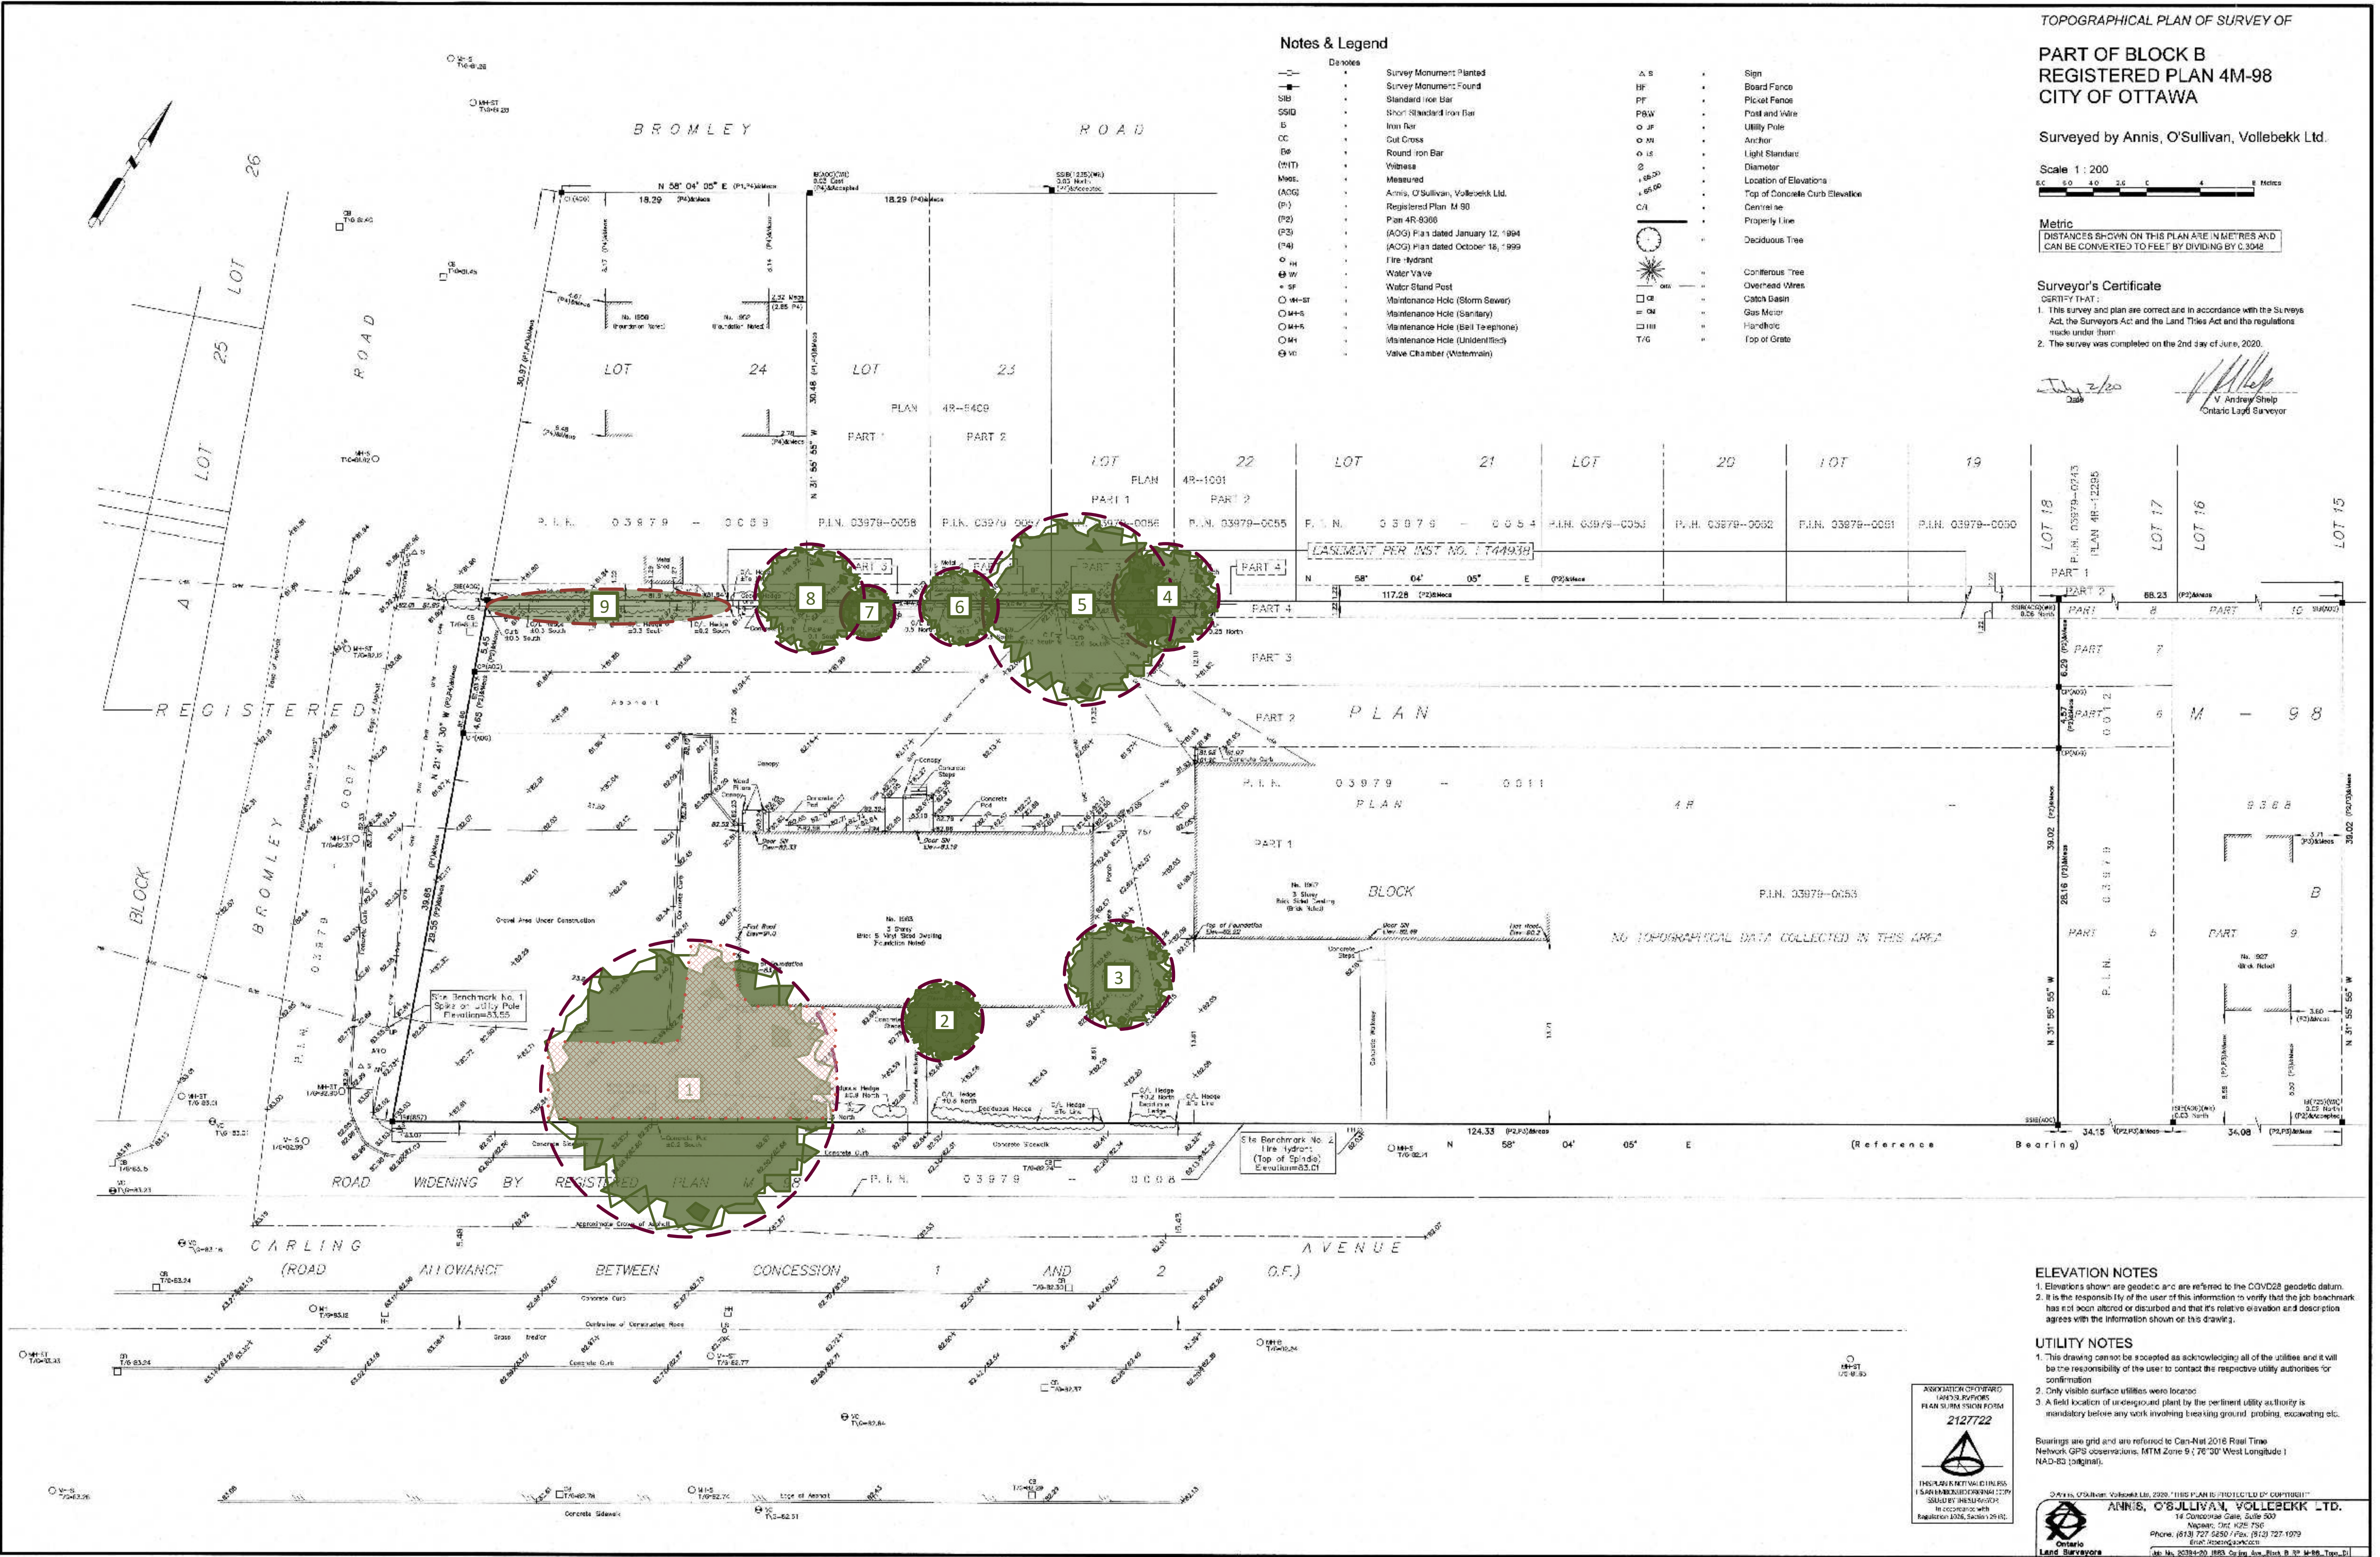
Recommended Tree Protection Fencing Area

Critical Root Zone

Note that the tree layer has been added to the original survey plan supplied by the client in pdf format. This layer refers to the trees only, and the original survey plan has not been altered in the process.
