Tree Conservation Report

150 Kanata Avenue

April 6, 2022

Stantec Consulting Ltd.
1331 Clyde Avenue
Ottawa ON K2C 3G4
Project No. 160410368

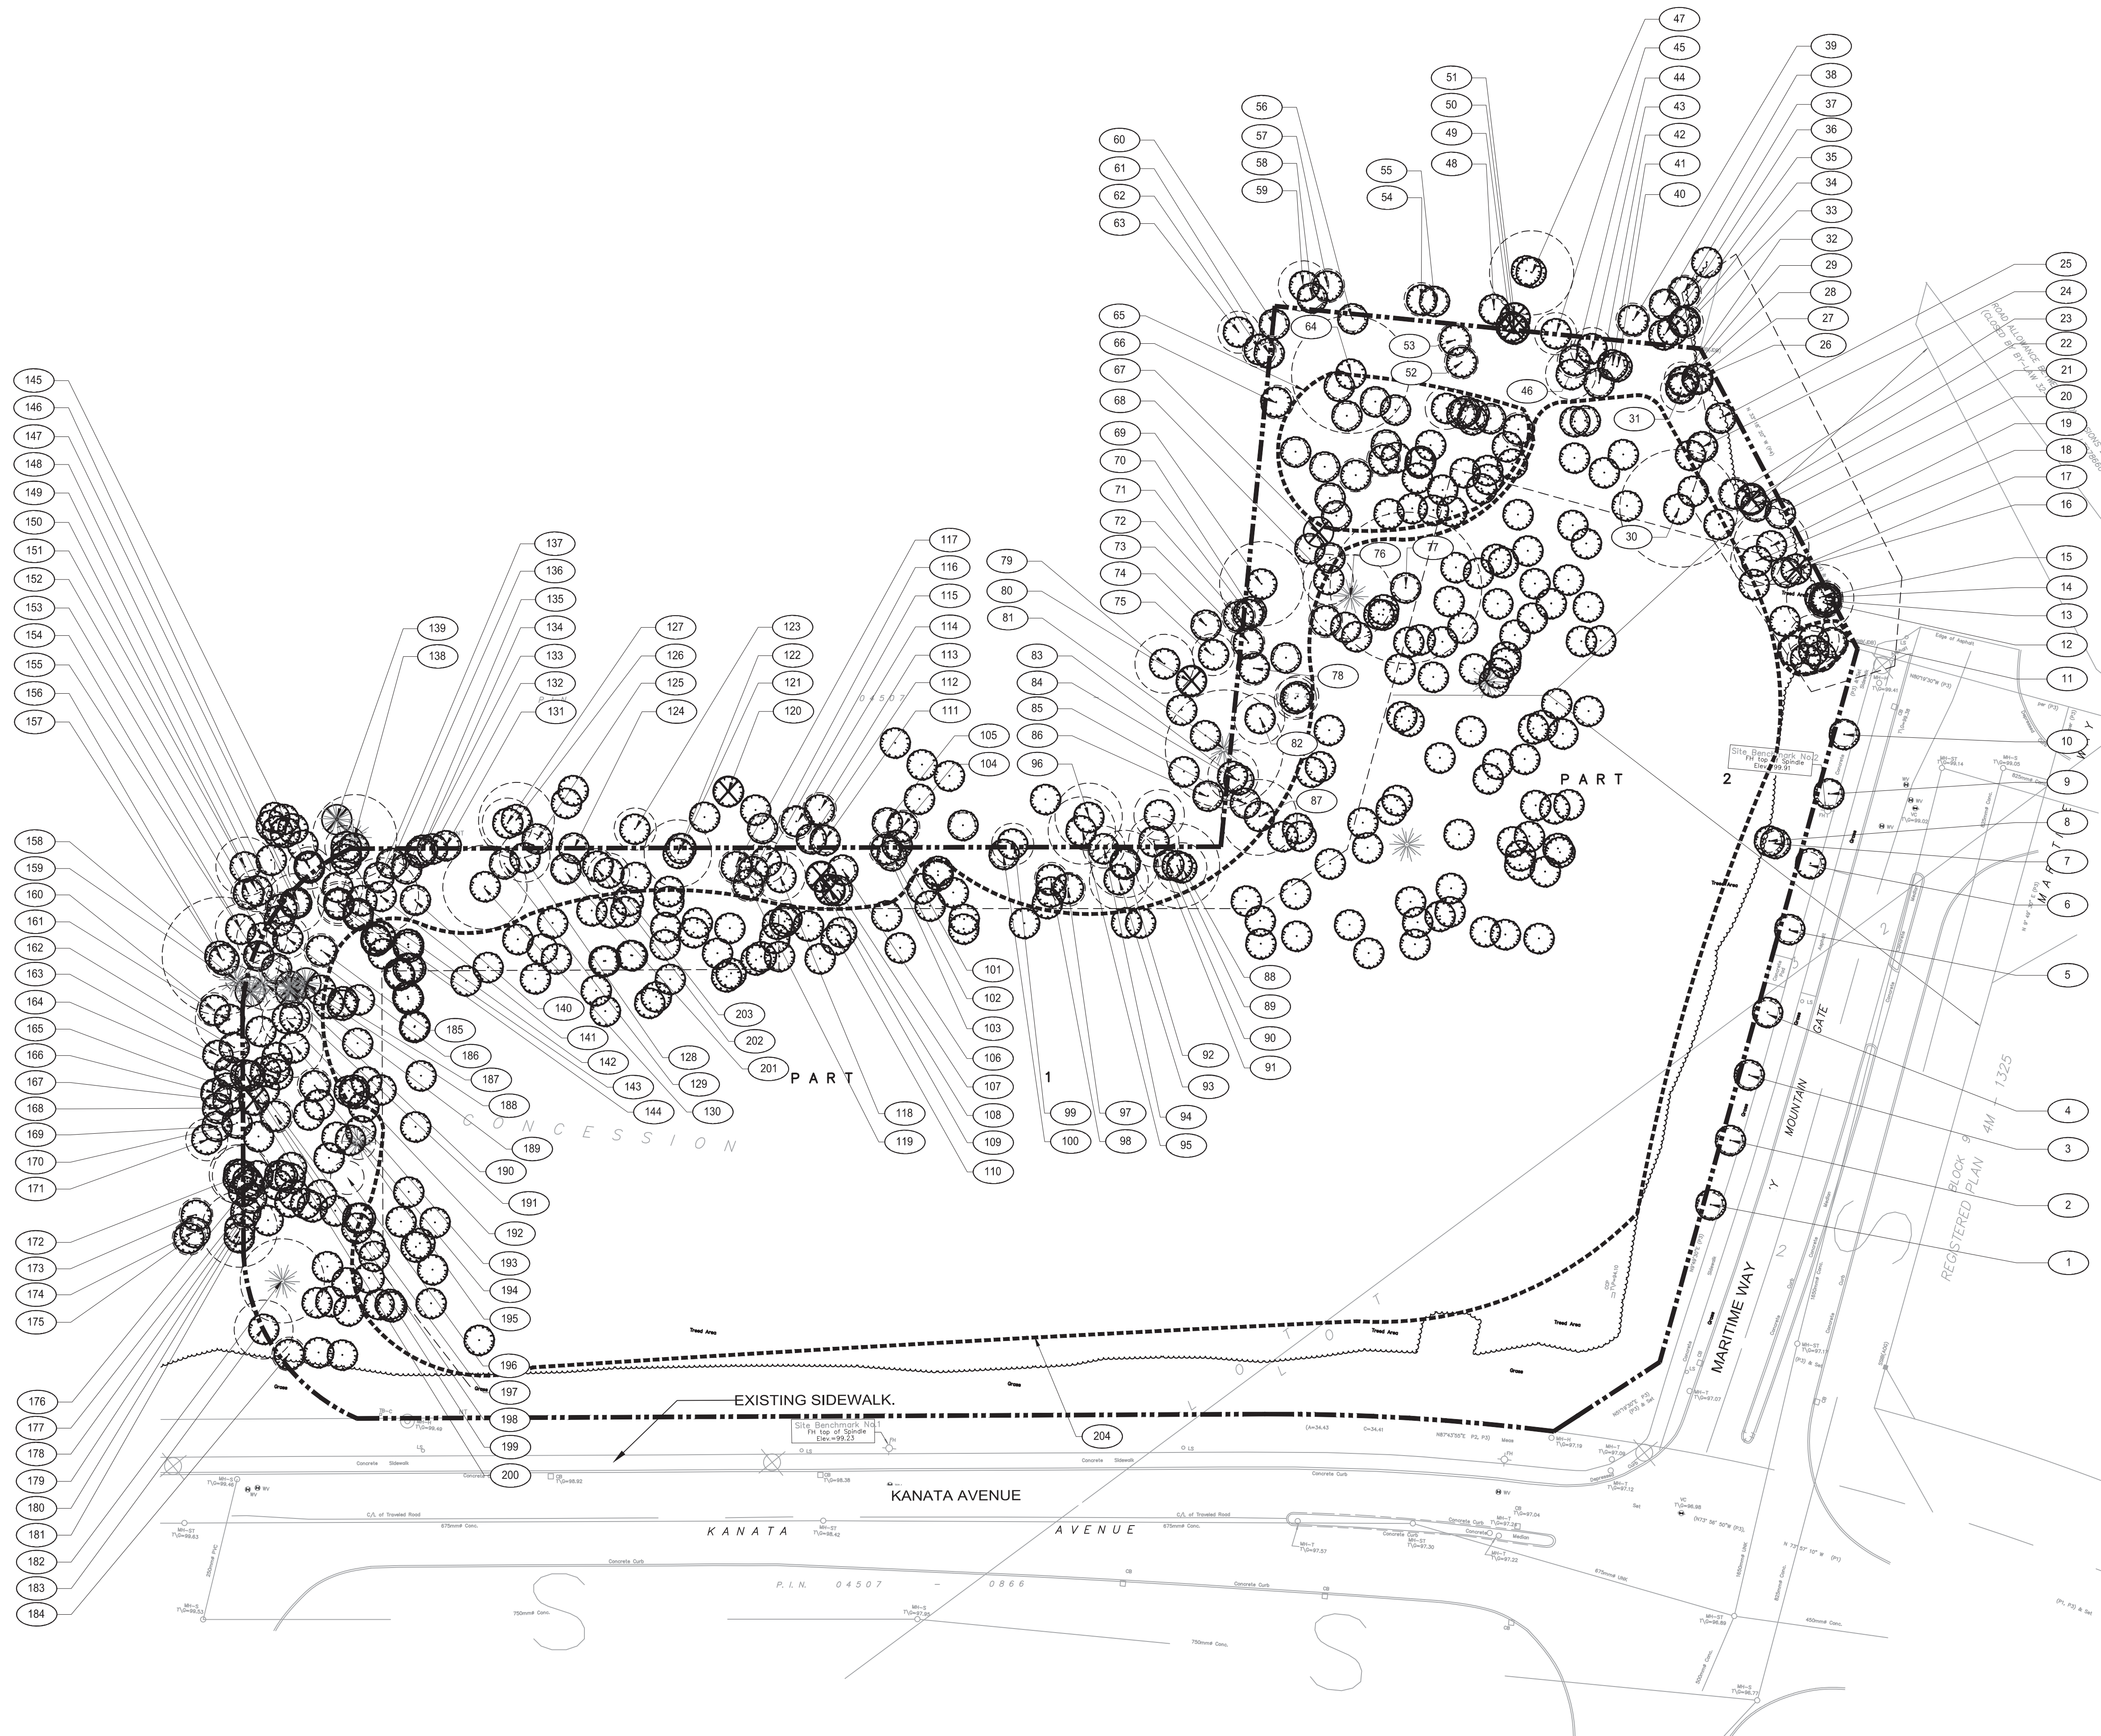
Title
CURRENT VEGETATION

The trees are generally evenly naturally distributed on site with some open “pockets” without any trees; the presence of snow did not provide the opportunity to determine if these openings are the result of bedrock being at the surface. Other openings are created by fallen trees; a number of fallen trees have been observed on the Subject site.

- The ash trees are showing signs of Emerald Ash Borer. These trees are usually in poor health conditions, showing signs of severe declining health or dead. As indicated in Table 1 above, a total of nine (9) red ash or 4.5% were inventoried during the tree assessment investigation.
- When combining the poor to poor/declining and dead trees it is observed that approximately 20.5% of the trees are not showing good health condition. This is observable through the presence of fallen trees over the entire Subject Site and dead standing trees.
- Most trees with a DBH equals or greater than 50 cm are in overall fair to poor health condition with three (3) of these trees being dead and two (2) others in declining health.
