TREE CONSERVATION REPORT V2.0

109-115 Dalhousie

Tree Conservation Report submitted as Partial
Requirements for a Site Plan Control Application,
February 16, 2022

Dendron Forestry Services

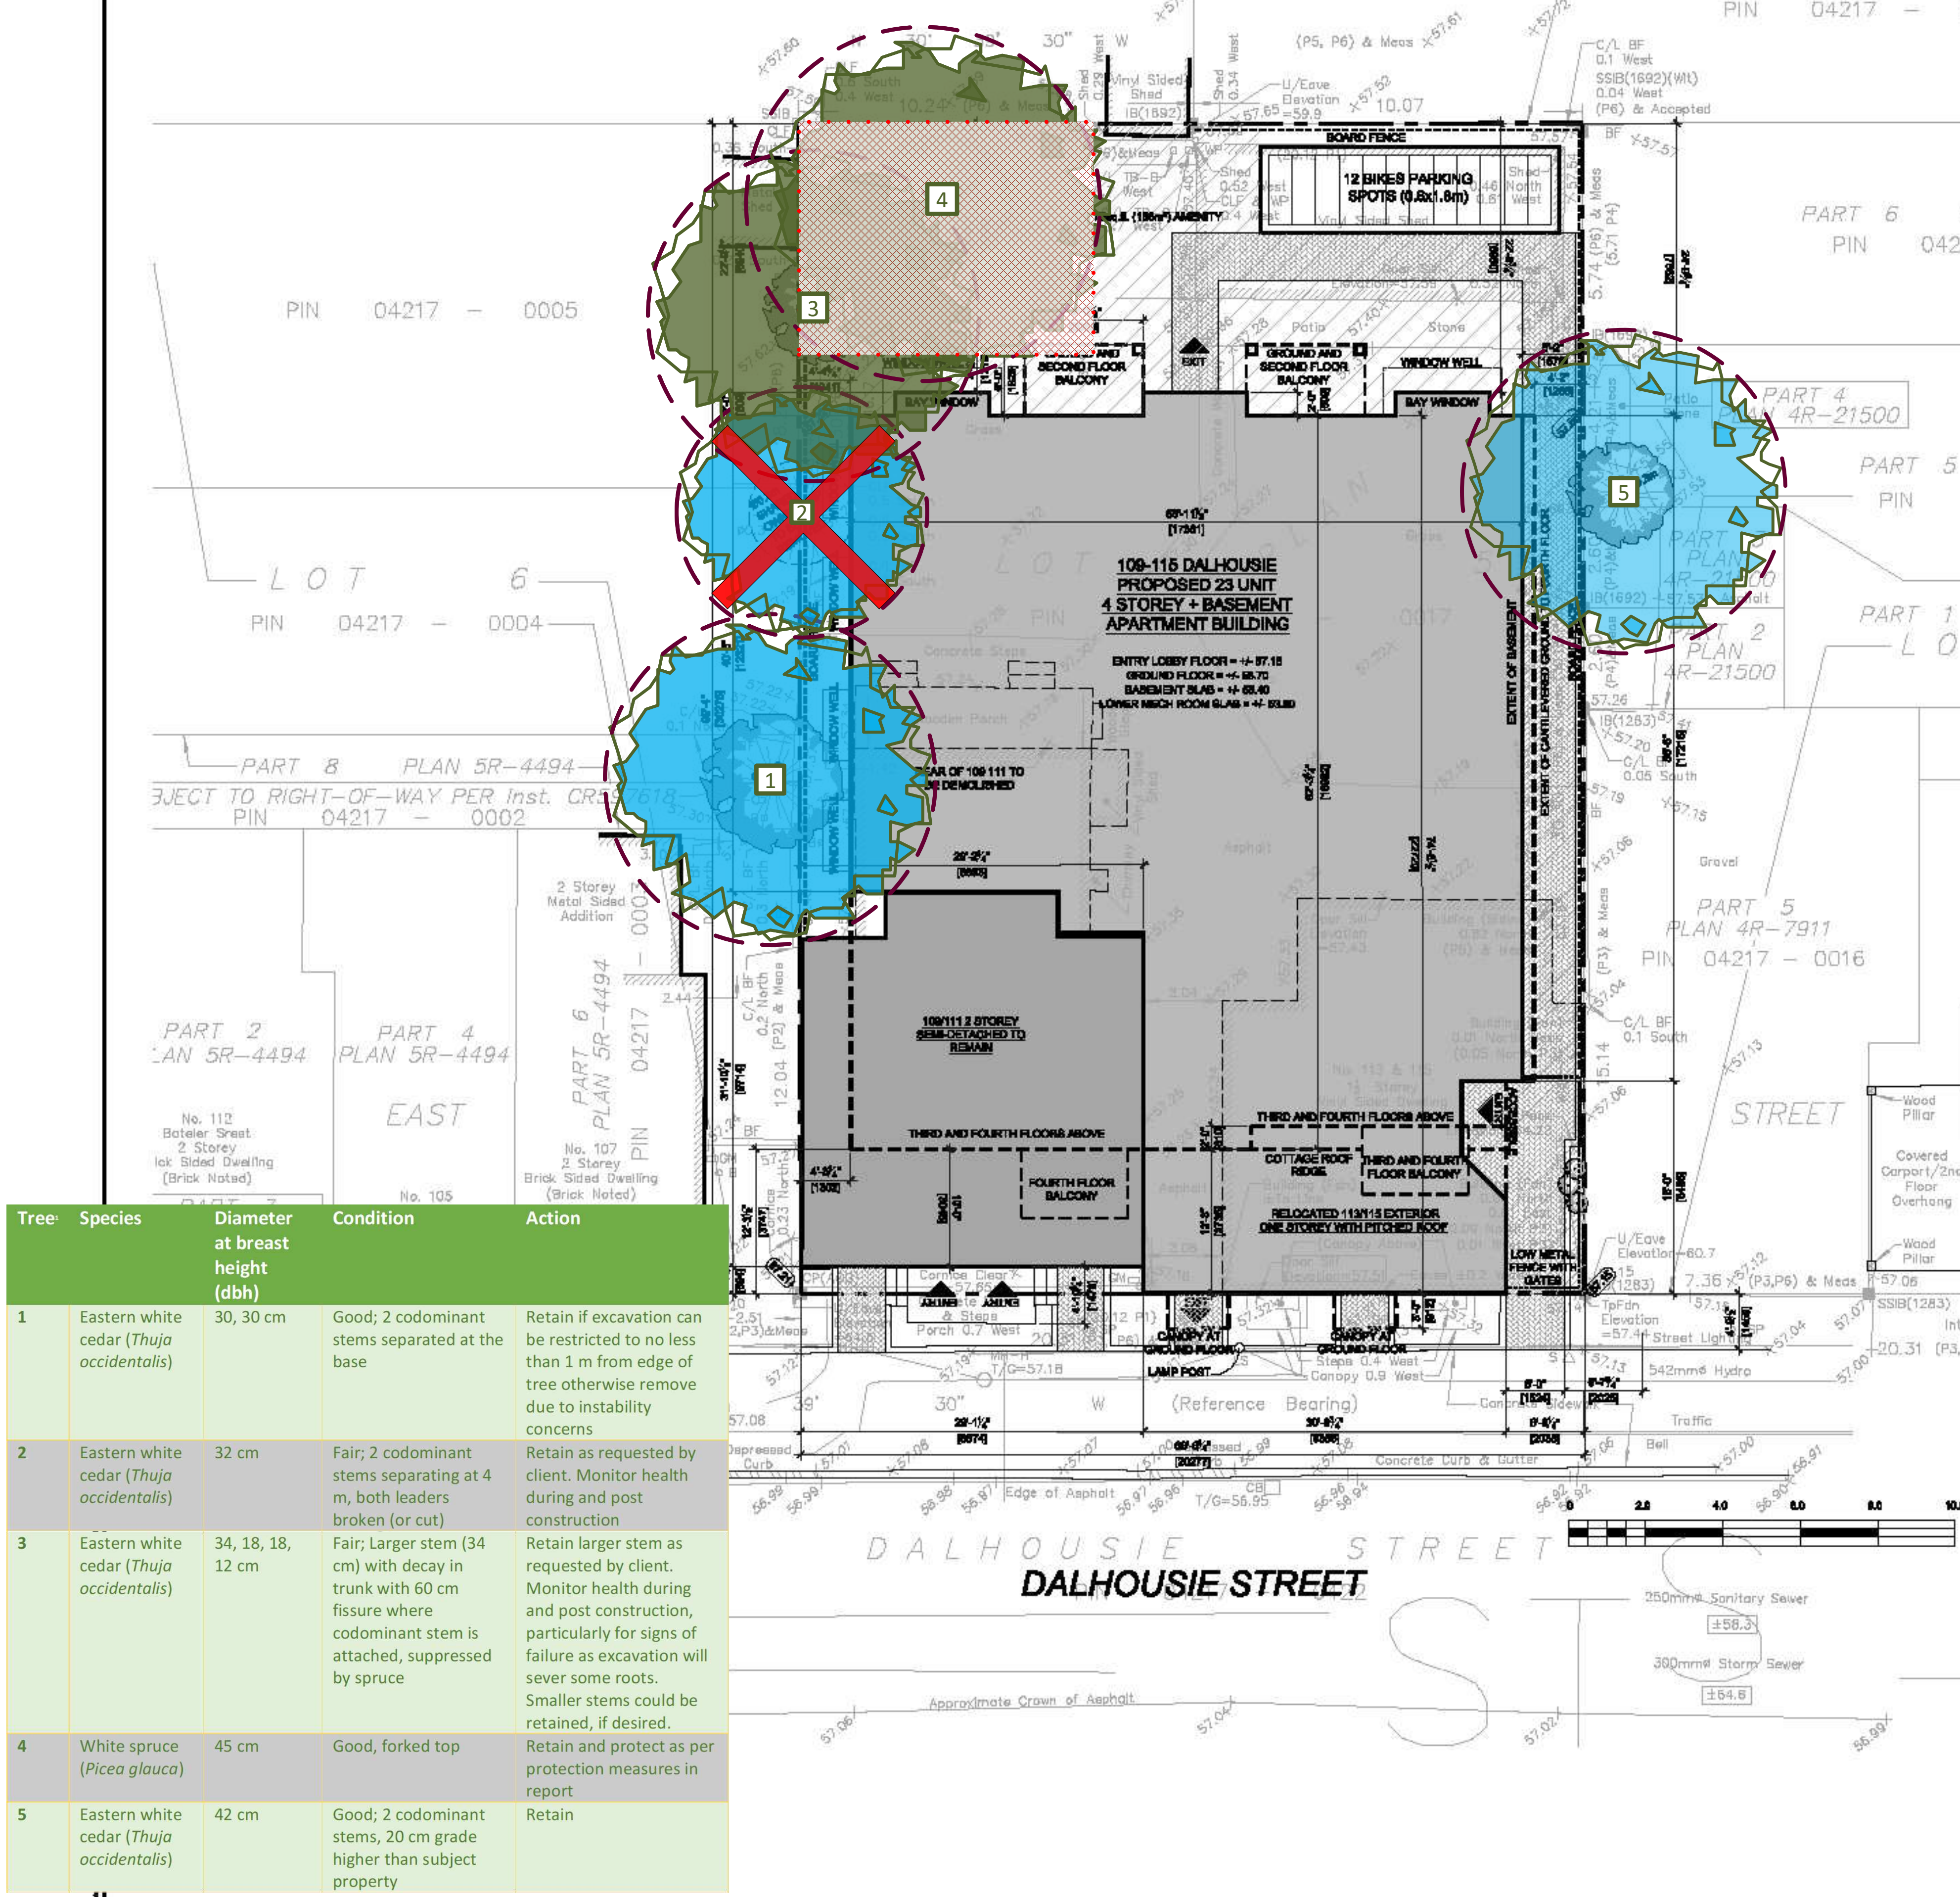
Tree	Species	Diameter at breast height (dbh)	Condition	Action
1	Eastern white cedar (<i>Thuja occidentalis</i>)	30, 30 cm	Good; 2 codominant stems separated at the base	Retain if excavation can be restricted to no less than 1 m from edge of tree otherwise remove due to instability concerns
2	Eastern white cedar (<i>Thuja occidentalis</i>)	32 cm	Fair; 2 codominant stems separating at 4 m, both leaders broken (or cut)	Retain as requested by client. Monitor health during and post construction
3	Eastern white cedar (<i>Thuja occidentalis</i>)	34, 18, 18, 12 cm	Fair; Larger stem (34 cm) with decay in trunk with 60 cm fissure where codominant stem is attached, suppressed by spruce	Retain larger stem as requested by client. Monitor health during and post construction, particularly for signs of failure as excavation will sever some roots. Smaller stems could be retained, if desired.
4	White spruce (<i>Picea glauca</i>)	45 cm	Good, forked top	Retain and protect as per protection measures in report

5	Eastern white cedar (<i>Thuja occidentalis</i>)	42 cm	Good; 2 codominant stems, 20 cm grade higher than subject property	Retain
