May 29, 2023

RE: TREE CONSERVATION REPORT FOR 3447 OLD ALMONTE ROAD, OTTAWA (CORKERY COMMUNITY CENTRE)

Table 1. Species, diameter, condition and status of trees at 3447 Old Almonte Road

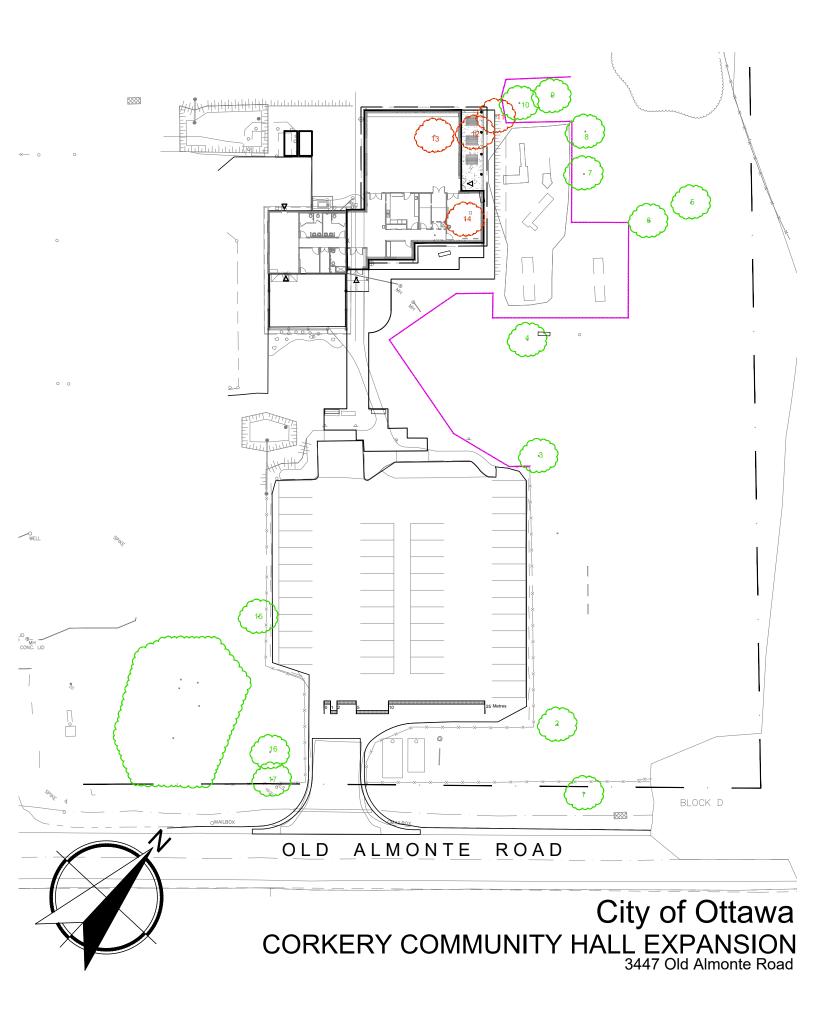
Table 1 below details the species, condition, size (diameter) and status of the individual trees on the subject property. Each of these trees is referenced by the numbers plotted on the tree conservation plan on page 5 of this report.
