UPDATED CONSERVATION PLAN CHAMPLAIN OIL COMPANY SERVICE STATION 70 RICHMOND ROAD OTTAWA, ONTARIO

PREPARED BY: JOHN STEWART, COMMONWEALTH HISTORIC RESOURCE MANAGEMENT

Updated V3 June 2023

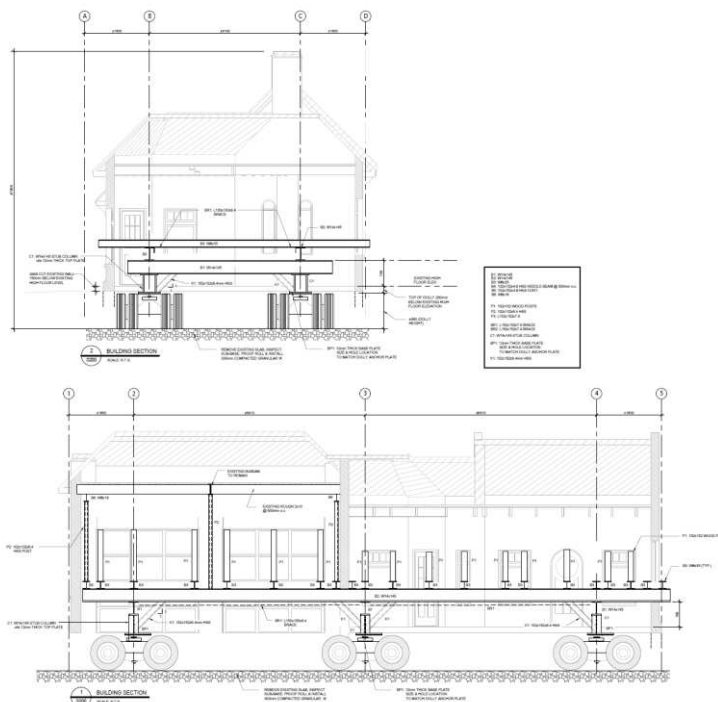
Structural Protrusions will not align with existing block coursing and removing full blocks in those areas will result in very large openings. For structural reasons, the openings should be as small as possible in order to leave as much masonry in place as possible. Since the stucco on the exterior will be patched and reparged, and the interior will potentially, be insulated and clad with drywall, openings should be cut out as required and later patched with new blocks and grout. Cleland Jardine Engineers. 2023.

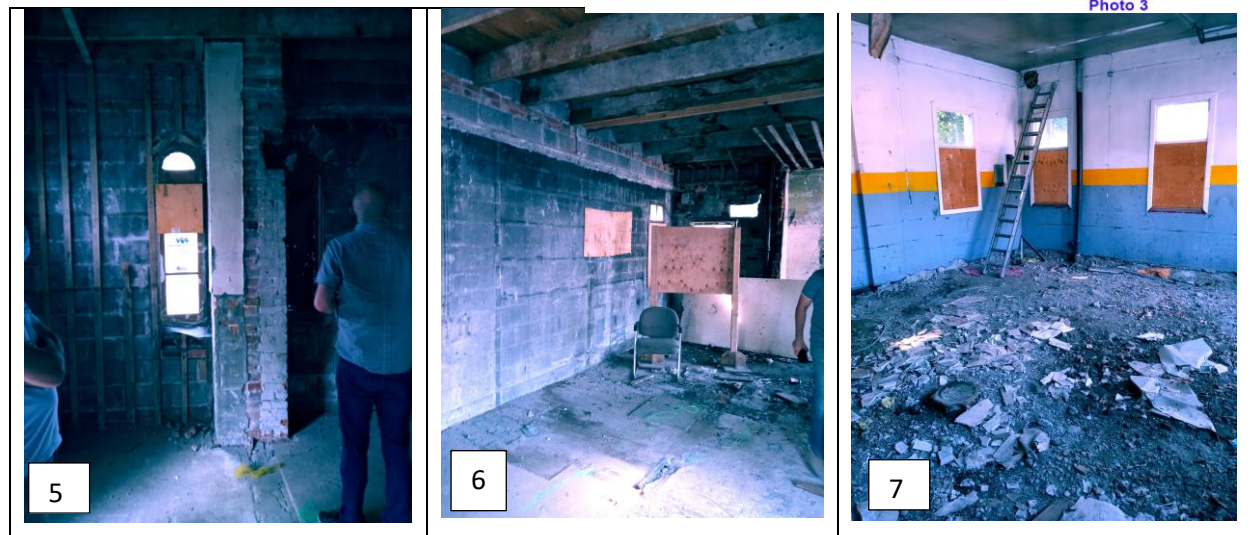
Figure 19: Interior views; 5. Looking towards the east wall with round headed windows on either side of the chimney. View 6. And 7. Interior views of transition area and the service bays. Source Commonwealth 2021

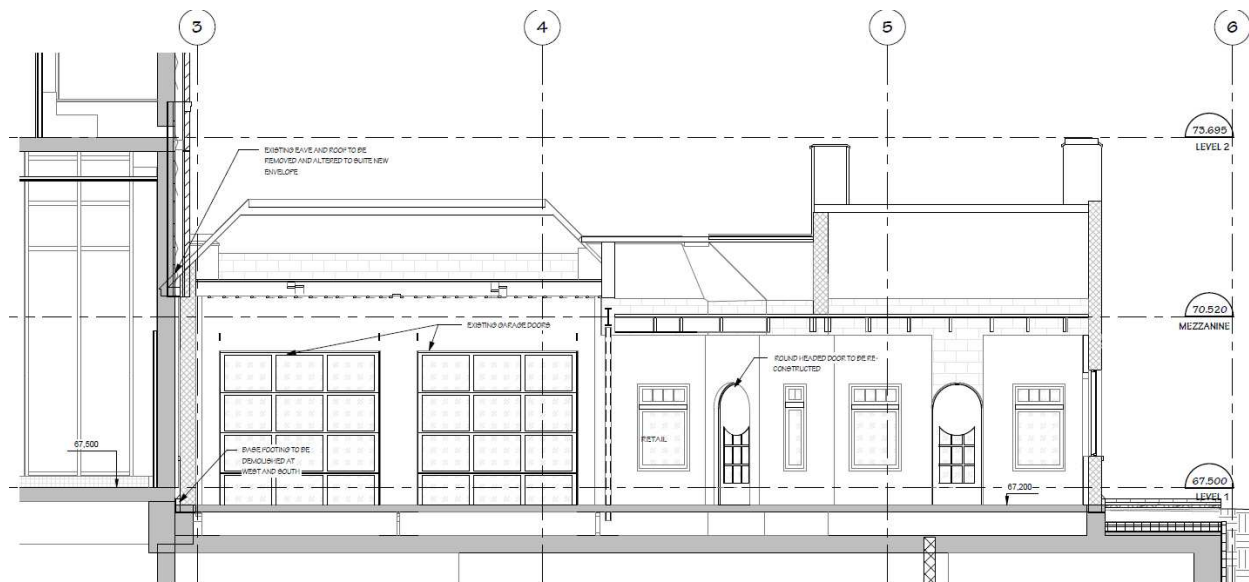
HERITAGE SECTION 2-LOOKING NORTH
SCALE: 1/4"

Figure 20: Section looking north with the West wall indicating the structural shear wall will block three windows along the west elevation.

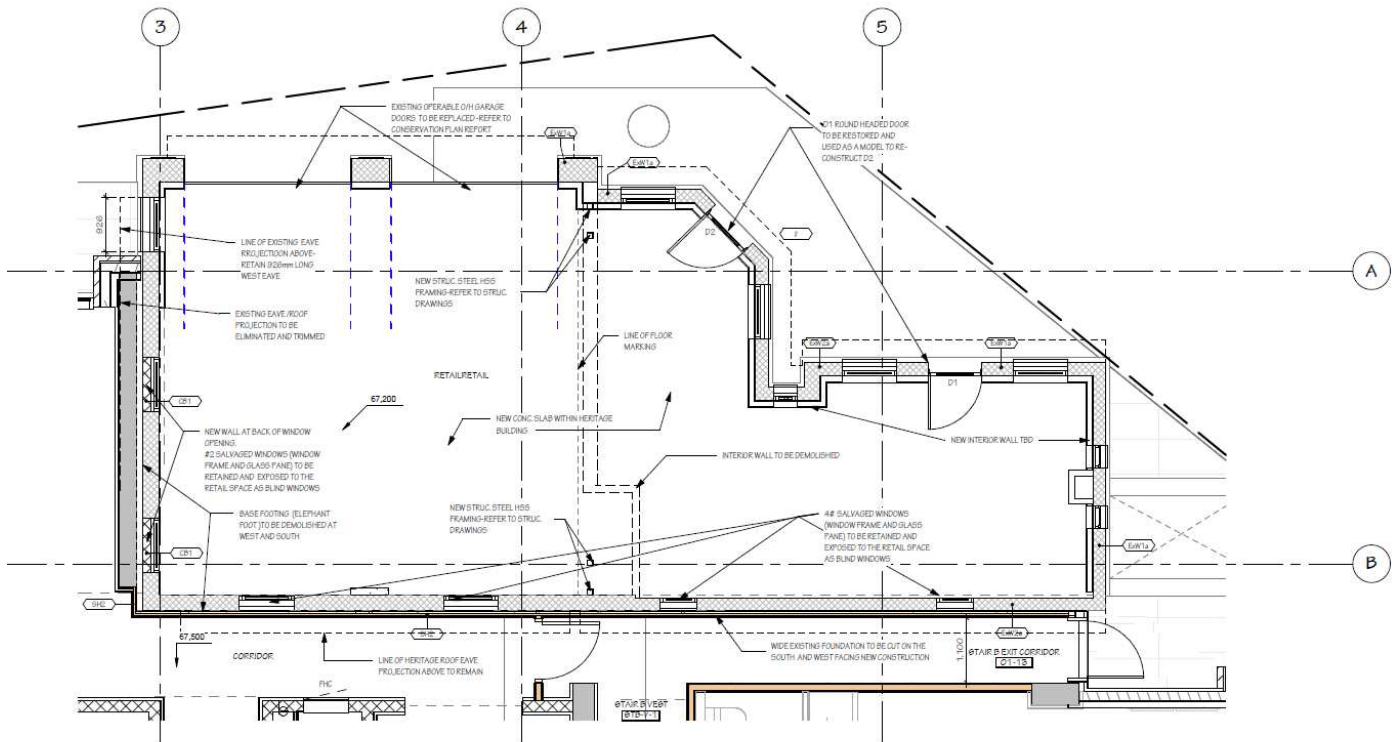
1 O1-LEVEL 1-HERITAGE FLOOR PLAN
A1.00c SCALE: 1:50

Figure 21: Retail floor plan documenting the areas of impact. Source: Hobin Architecture 2023.

- setting the floor level at 67.2 throughout,
- placing a shear wall adjacent to the Service Station west wall,
- Maintaining all of the windows along the west and south facades.
- Installing a 2-hour fire rated wall on the exterior south elevation.
- Insulating exterior walls and covering walls and ceiling with drywall or equivalent.

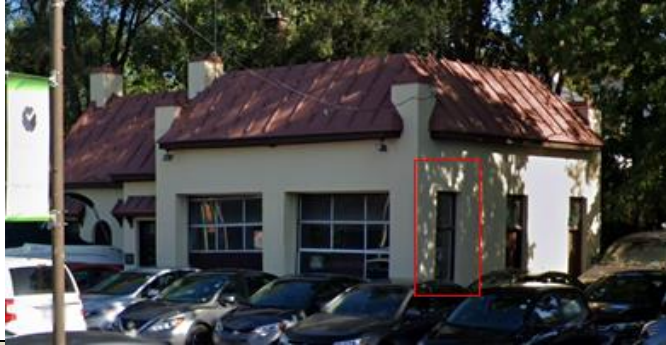
Figure 22: This view highlights in red the first of the three windows along the west side of the Service Station. The proposed midrise building has been set back and allows the side window to be interpreted from the exterior. Source: City of Ottawa.
