A CONSERVATION PLAN

CHAMPLAIN OIL COMPANY SERVICE STATION

70 RICHMOND ROAD OTTAWA, ONTARIO

FINAL April 30, 2022

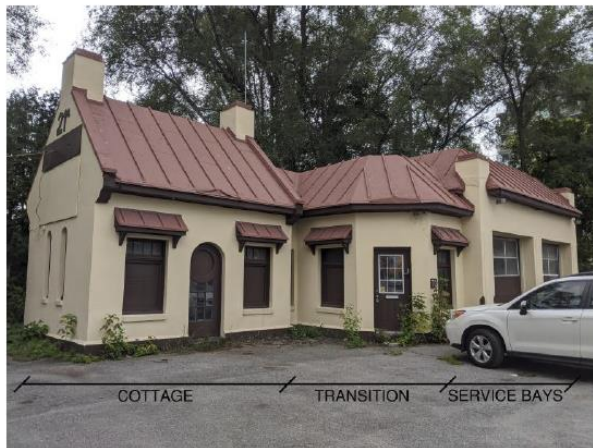
Photo 1: Overview of building [JCAL 2020]

In general there are three main spaces; the cottage, the transitional area and the service bays, see Photo 1. The transitional area and garage are divided by an interior loadbearing brick wall. The separation of these spaces is visible by the differing roof structures from the exterior.

The transitional area is highlighted by the many roof orientations and valleys. The metal roofing in this area has failed and there is significant water infiltration. It was not raining at the time of the visit, yet many of the wooden members were visibly wet. It is likely that significant portions of the roof structure are rotten and are actively deteriorating. The interior brick loadbearing wall separating the transitional area from the garage is also significantly deteriorated, with a large fracture across the doorway opening at the back of the building, and a variety of cracks in the wall at the front. The flooring in this space appears to be a concrete slab on grade.

The service bay area is an open space framed by two exterior block walls, the interior brick wall and the north (front) wall with a single block pier and two large garage door openings. The ceiling finishes were still in place so the roof structure was unable to be reviewed. However, based on the water damage to the ceiling finishes and algae/mould growing on the ground below, it is likely that there is significant water damage to the wood roof members. The ground in the garage is dirt infill. Note that the ground in the garage and around the property is likely contaminated from the historical garage use.

The following investigations are recommended prior to finalizing a concept for moving the structure:

- Complete three investigative test pits in each of the defined spaces to confirm footing depth;
- Remove the ceiling from the garage to review the roof structure and its condition.

- Rebuild the interior loadbearing brick wall;
- Repair deteriorated roof structure;
- Infill or brace the service bay door openings;

The roof structure, in addition to requiring repairs, will also be subjected to higher snow loads from being at the base of the new mid-rise structure. It is recommended to reinforce the roof structure for this higher snow load at the same time as the repairs, since many of the solutions will address both problems. However, it is possible that the existing roof over the service bay area is so severely deteriorated and under-designed for the higher snow loads that a complete new structure is required. In this case, the most effective approach may be to only move the repaired/upgraded cottage and transitional areas and dismantle/rebuild the service bays.
