Tree Conservation Report 424 Churchill Avenue North Ottawa, Ontario

CLIENT:	GSI Properties				
PROJECT NAME:	Tree Conservation Report 424 Churchill Avenue North Ottawa, Ontario				
REPORT TITLE:	Tree Conservation Report 424 Churchill Avenue North Ottawa, Ontario				
IBI REFERENCE: 139413					
VERSION:	1.0				
DIGITAL MASTER:	https://ibigroup.sharepoint.com/sites/Projects2/139413/Internal Documents/6.0_Technical/6.05_Landscape/03_Reports/LTR_424_Churchilll_2022-10-07_DRAFT.docx\2022-10-14\MG				
ORIGINATOR:	Tim McCormick				
REVIEWER:	Erin Hellinga				
AUTHORIZATION:	Tim McCormick				
CIRCULATION LIST:	Jemmy Taing (GSI Properties), Kris Benes (Open Plan Architects Inc.)				
HISTORY:

IBI GROUP DRAFT TREE CONSERVATION REPORT 424 CHURCHILL AVENUE NORTH OTTAWA, ONTARIO Submitted to GSI PROPERTIES

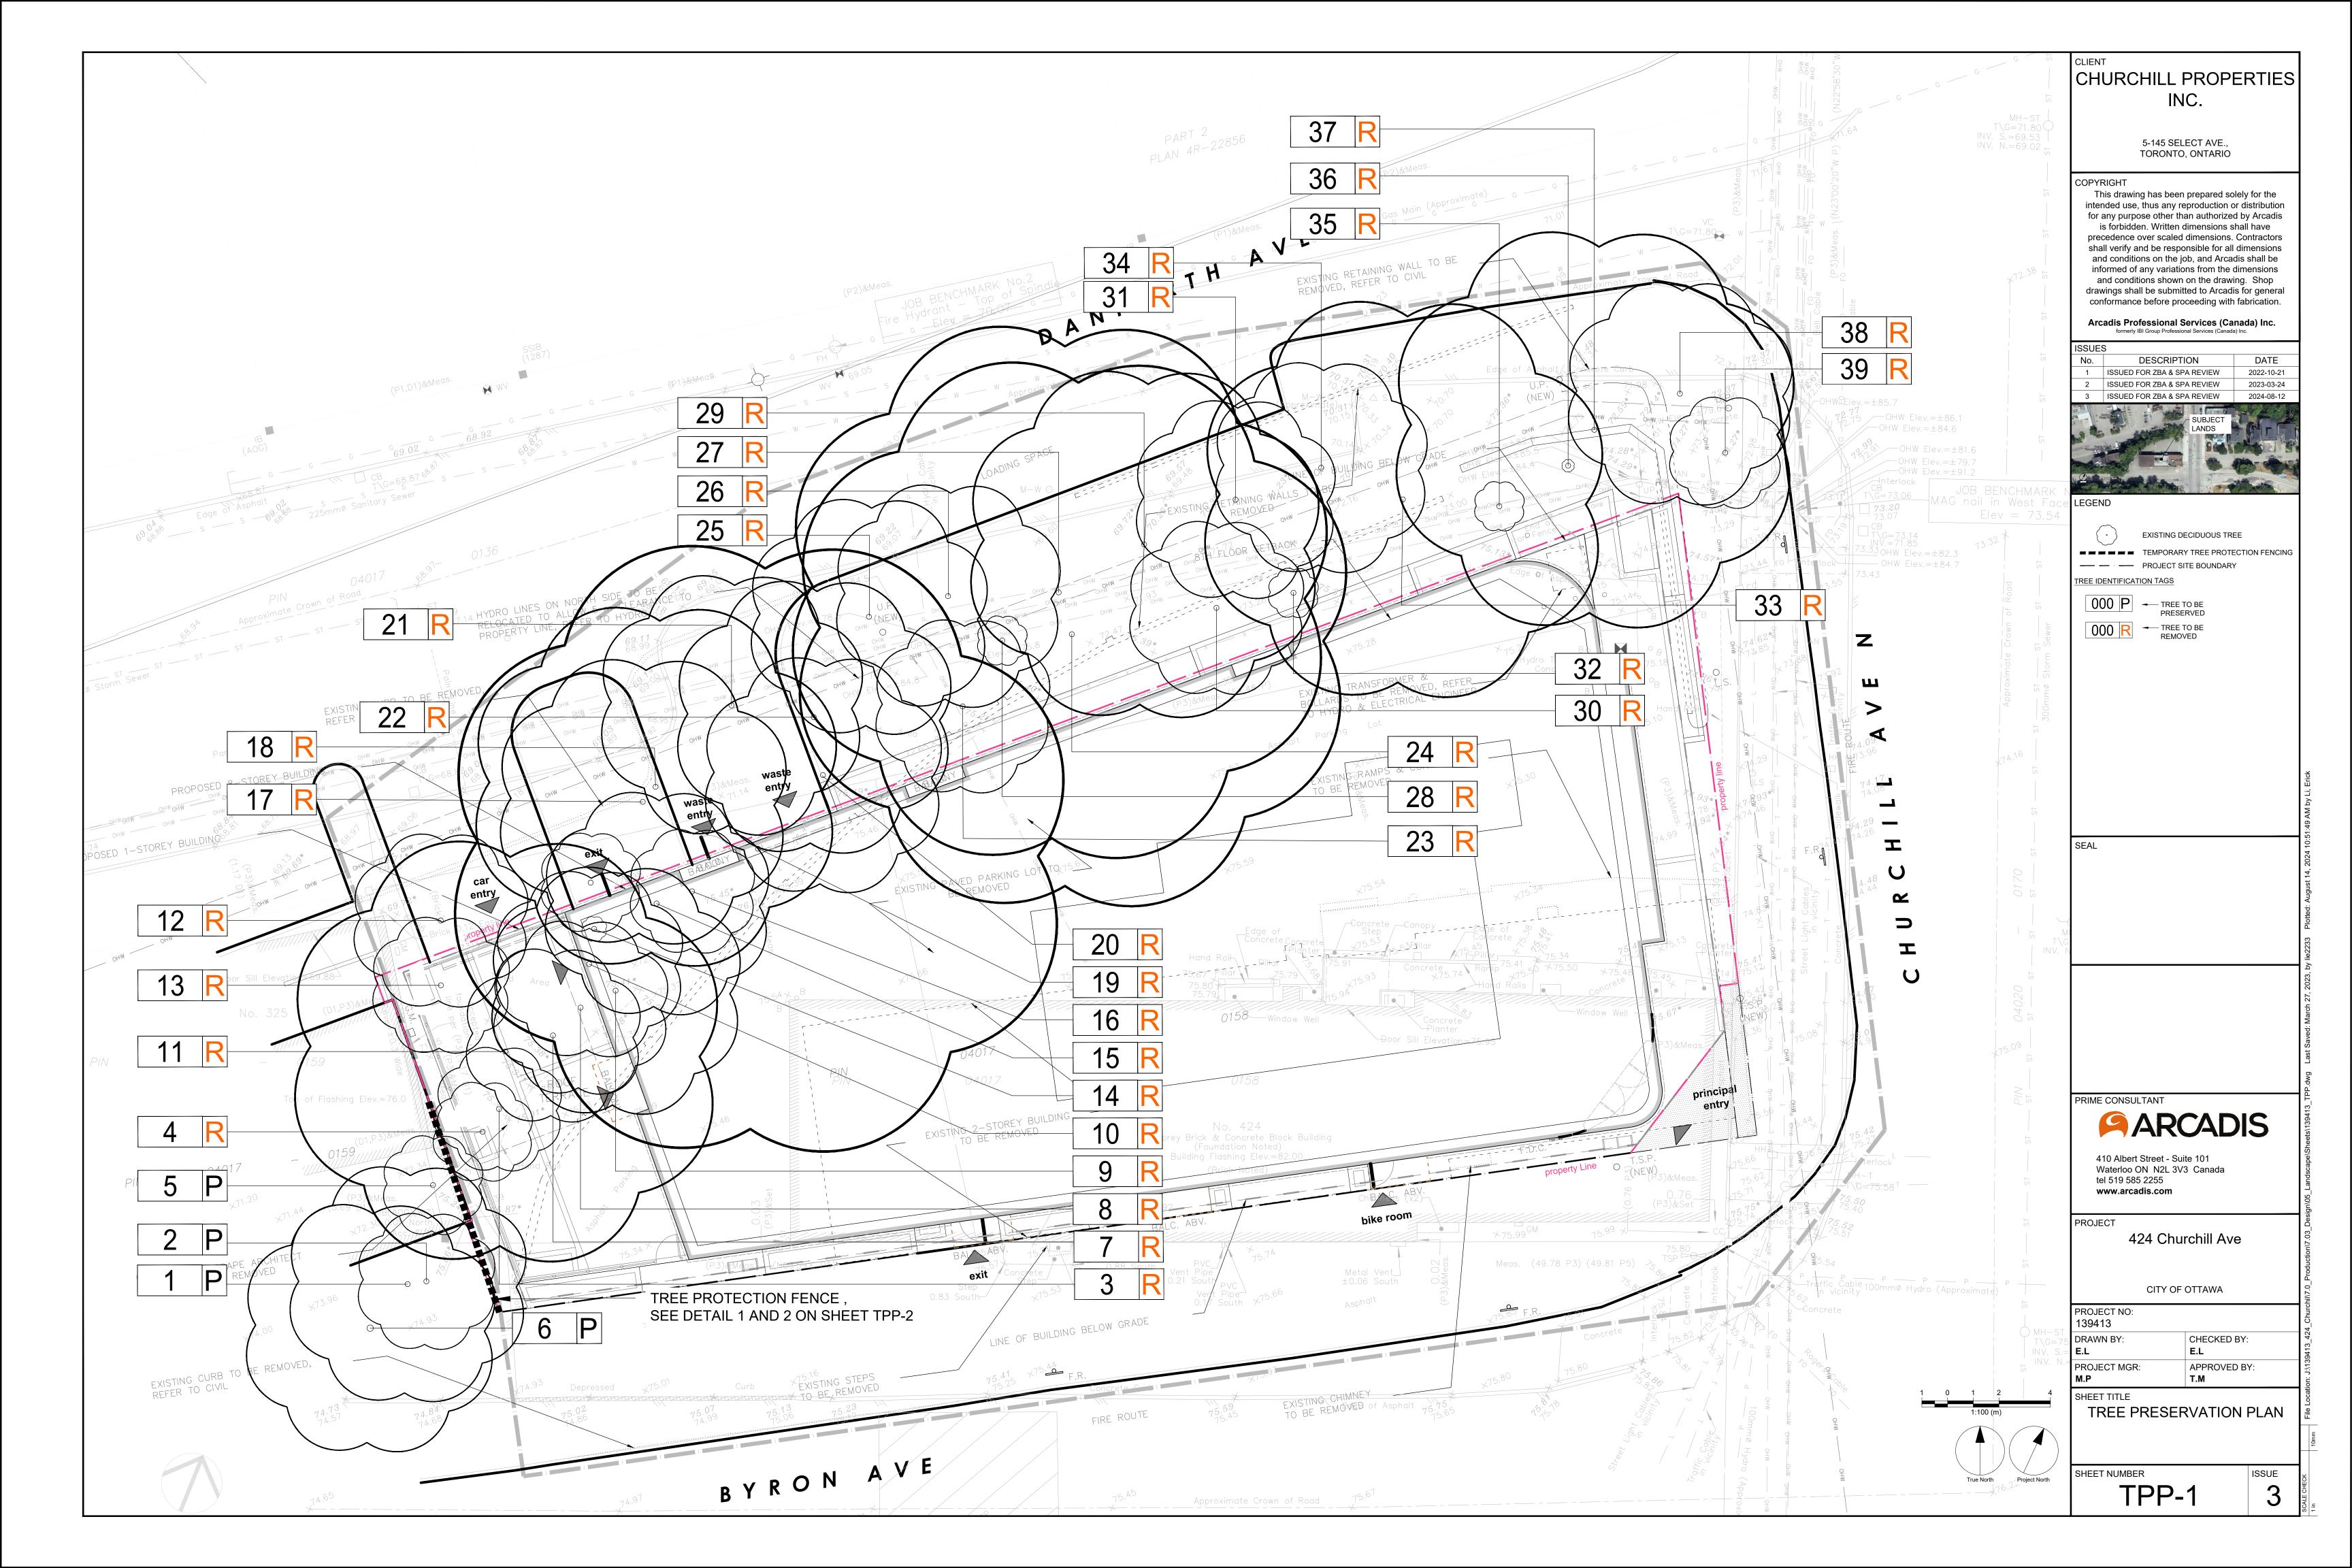
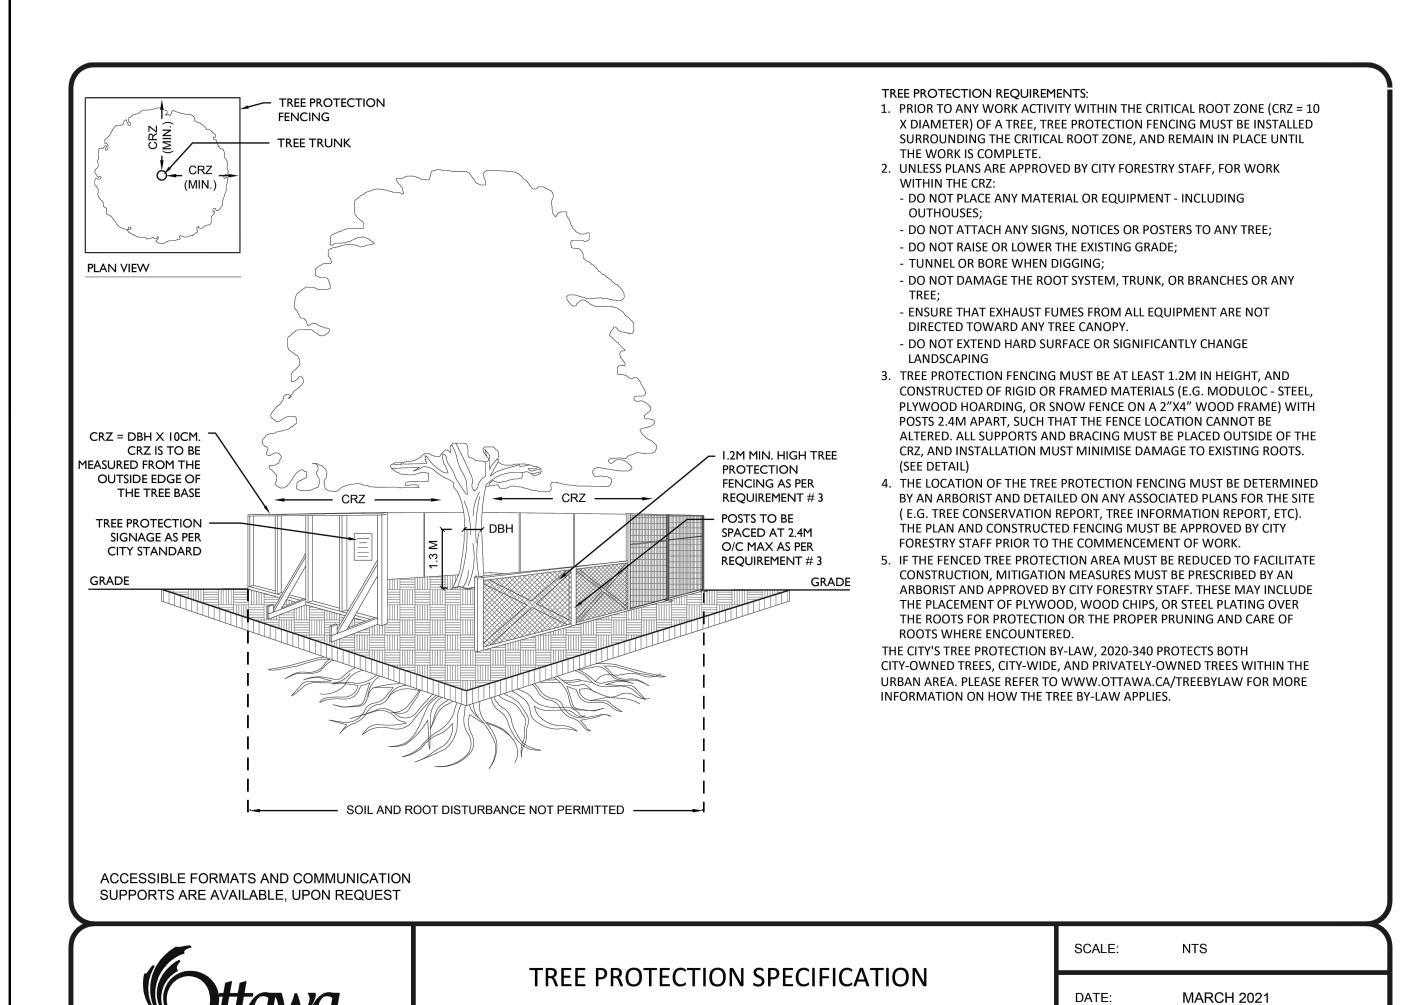
Tree Conservation Plan TPP-1 and TPP-2

An additional four (4) trees located beyond the subject property boundaries may be impacted by the proposed works and development. Tree protection fencing (TPF) is recommended along the property limit where these trees are located (see Appendix A for TPF recommendations).

- Four (4) trees are recommended to be preserved and protected.
- Thirty-five (35) trees are recommended to be removed:
 - Thirty-four (34) live trees and one (1) dead tree.

TO BE IMPLEMENTED FOR RETAINED TREES, BOTH ON SITE AND ON ADJACENT SITES, PRIOR TO ANY TREE REMOVAL OR SITE WORKS AND MAINTAINED FOR THE DURATION OF WORK ACTIVITIES ON SITE.
