## **Geotechnical Investigation and Slope Stability Assessment**

Final (4th Revision)

Proposed Humanics Sanctuary and Sculpture Park  
3400 Old Montreal Road  
Part of Lot 7, Concession 1, Old Survey  
Ottawa (Formerly Township of Cumberland), Ontario

OTT-00229886-A0

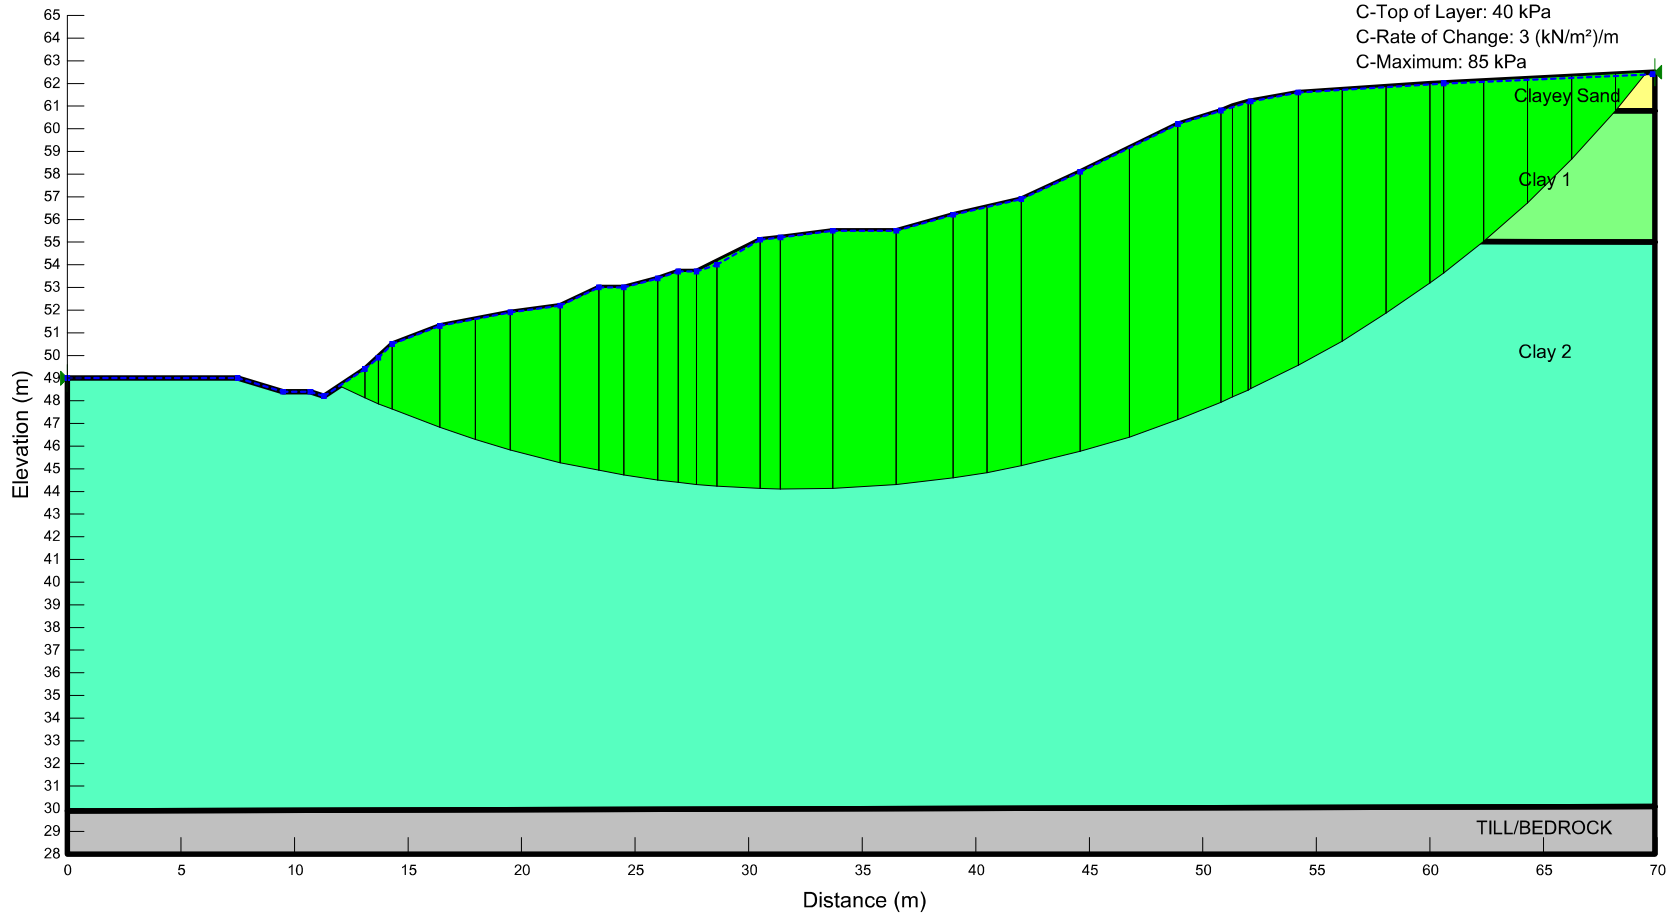
Figure 31

Project : OTT-00229886-A0  
SLOPE STABILITY ASSESSMENT  
3400 Old Montreal Road, Cumberland, On.  
Slope Stability Analysis - Existing Slope  
Section - F-F - Effective Stress Analysis  
Set Back Determination

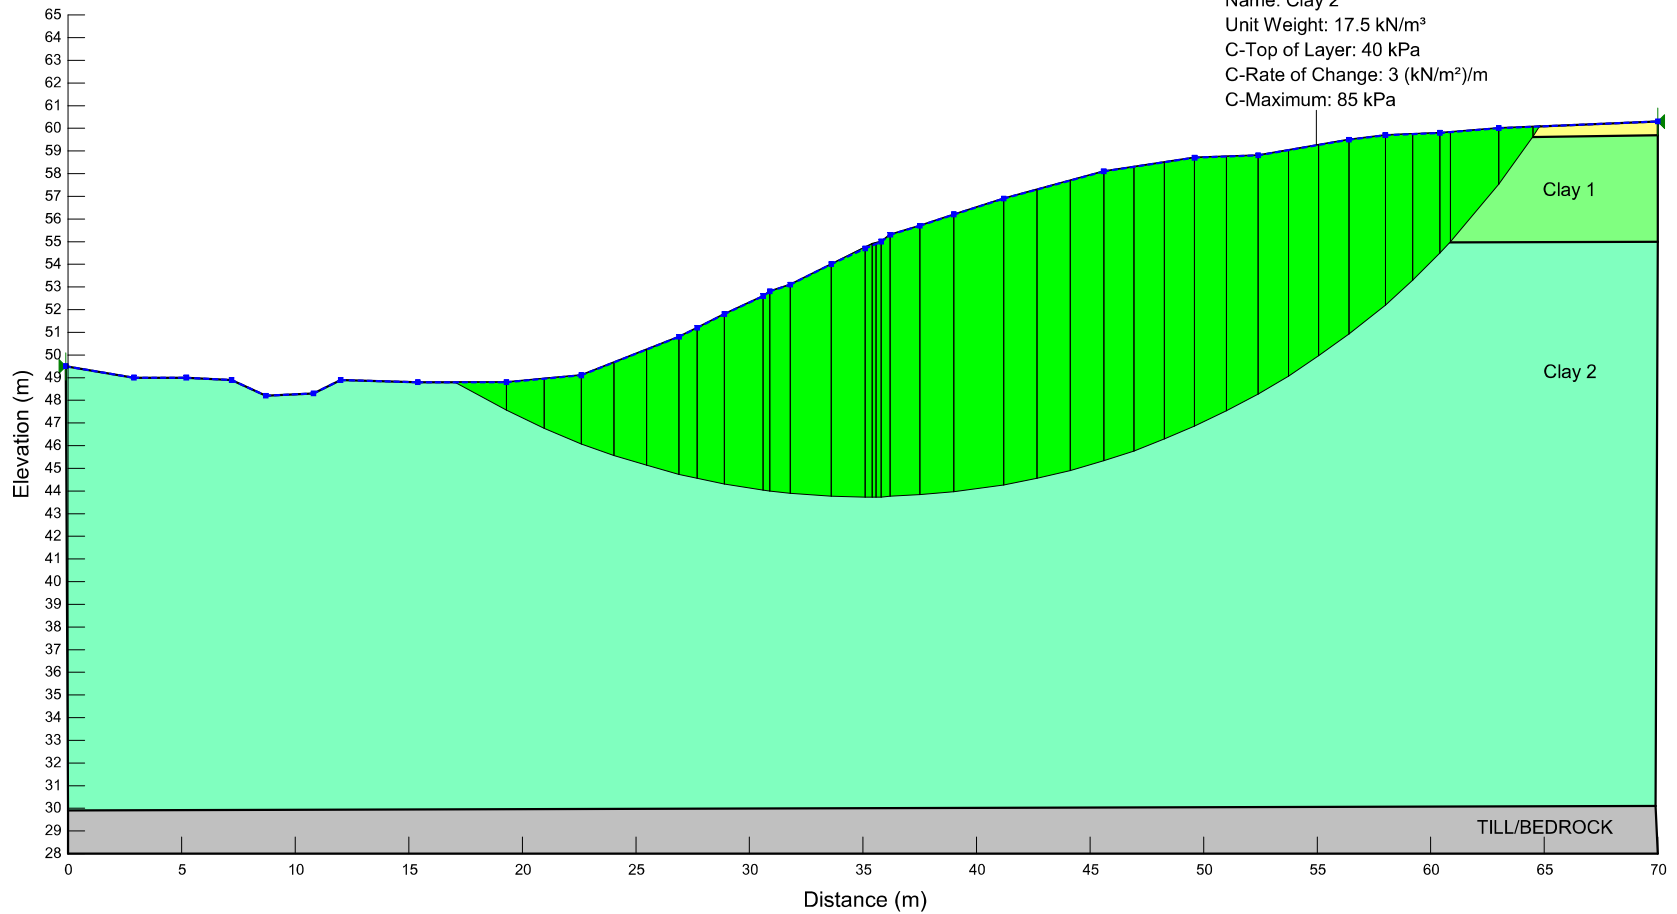
Project : OTT-00229886-A0  
 SLOPE STABILITY ASSESSMENT  
 3400 Old Montreal Road, Cumberland, On.  
 Slope Stability Analysis - Existing Slope  
 Section -F-F - Total Stress Analysis - Seismic

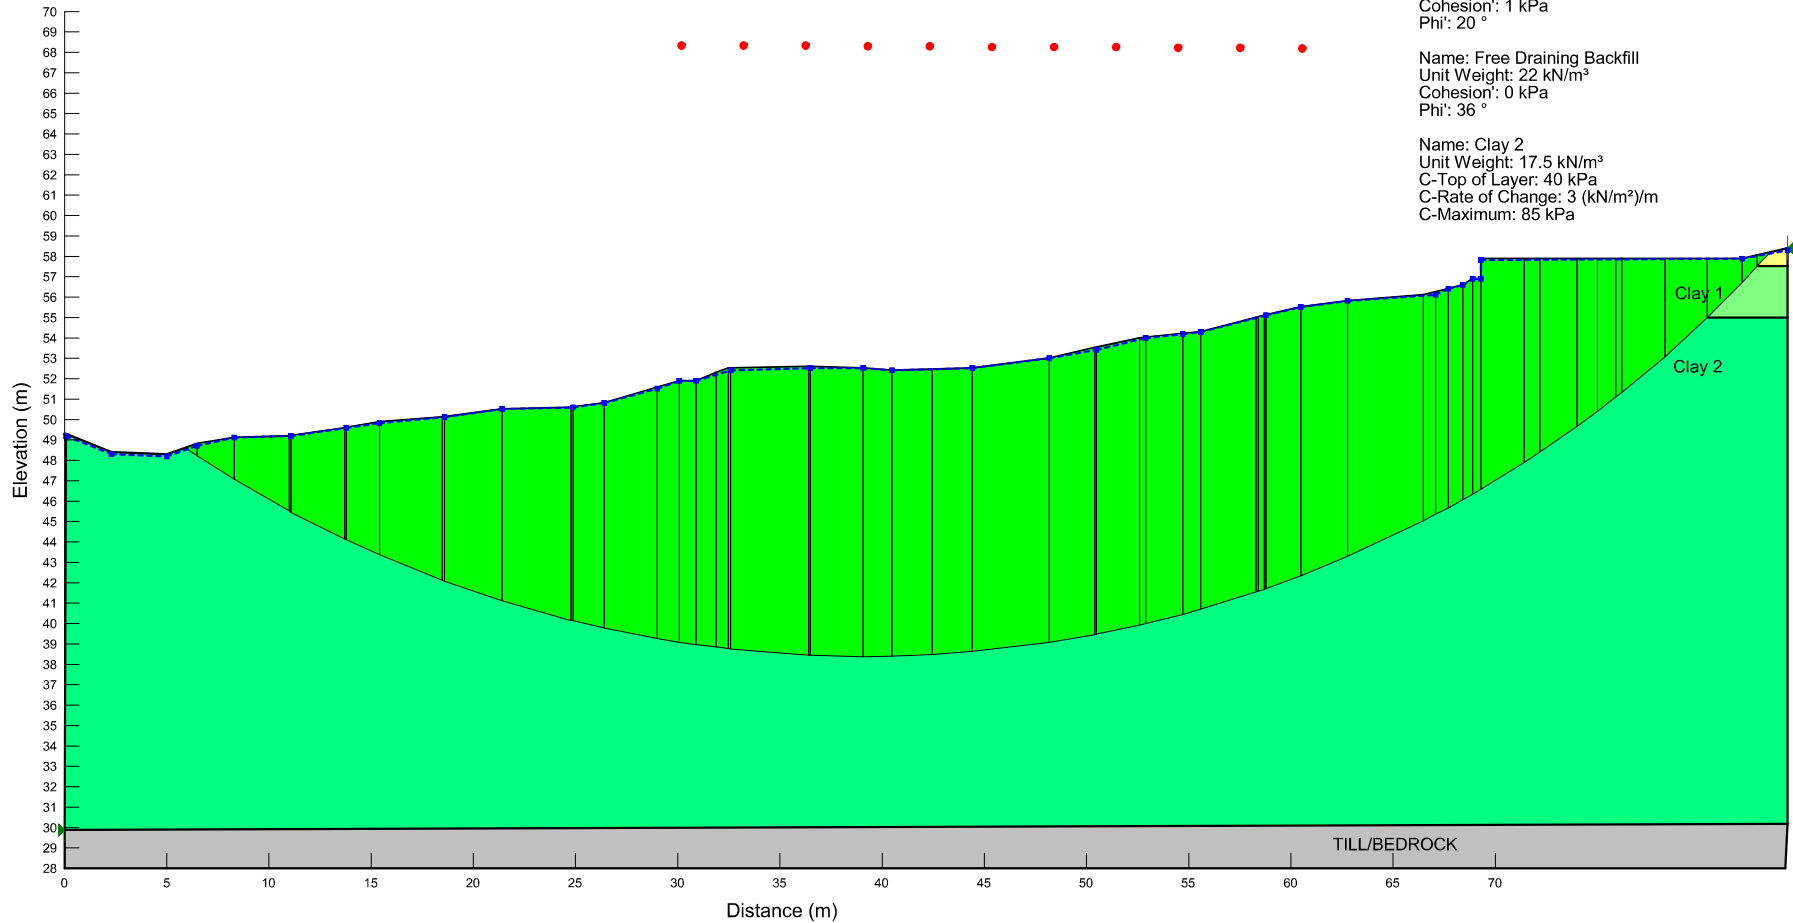
Figure 36

Slope Stability Analysis - Existing Slope & Proposed Retaining Wall  
Section - G-G - Total Stress Analysis - Seismic

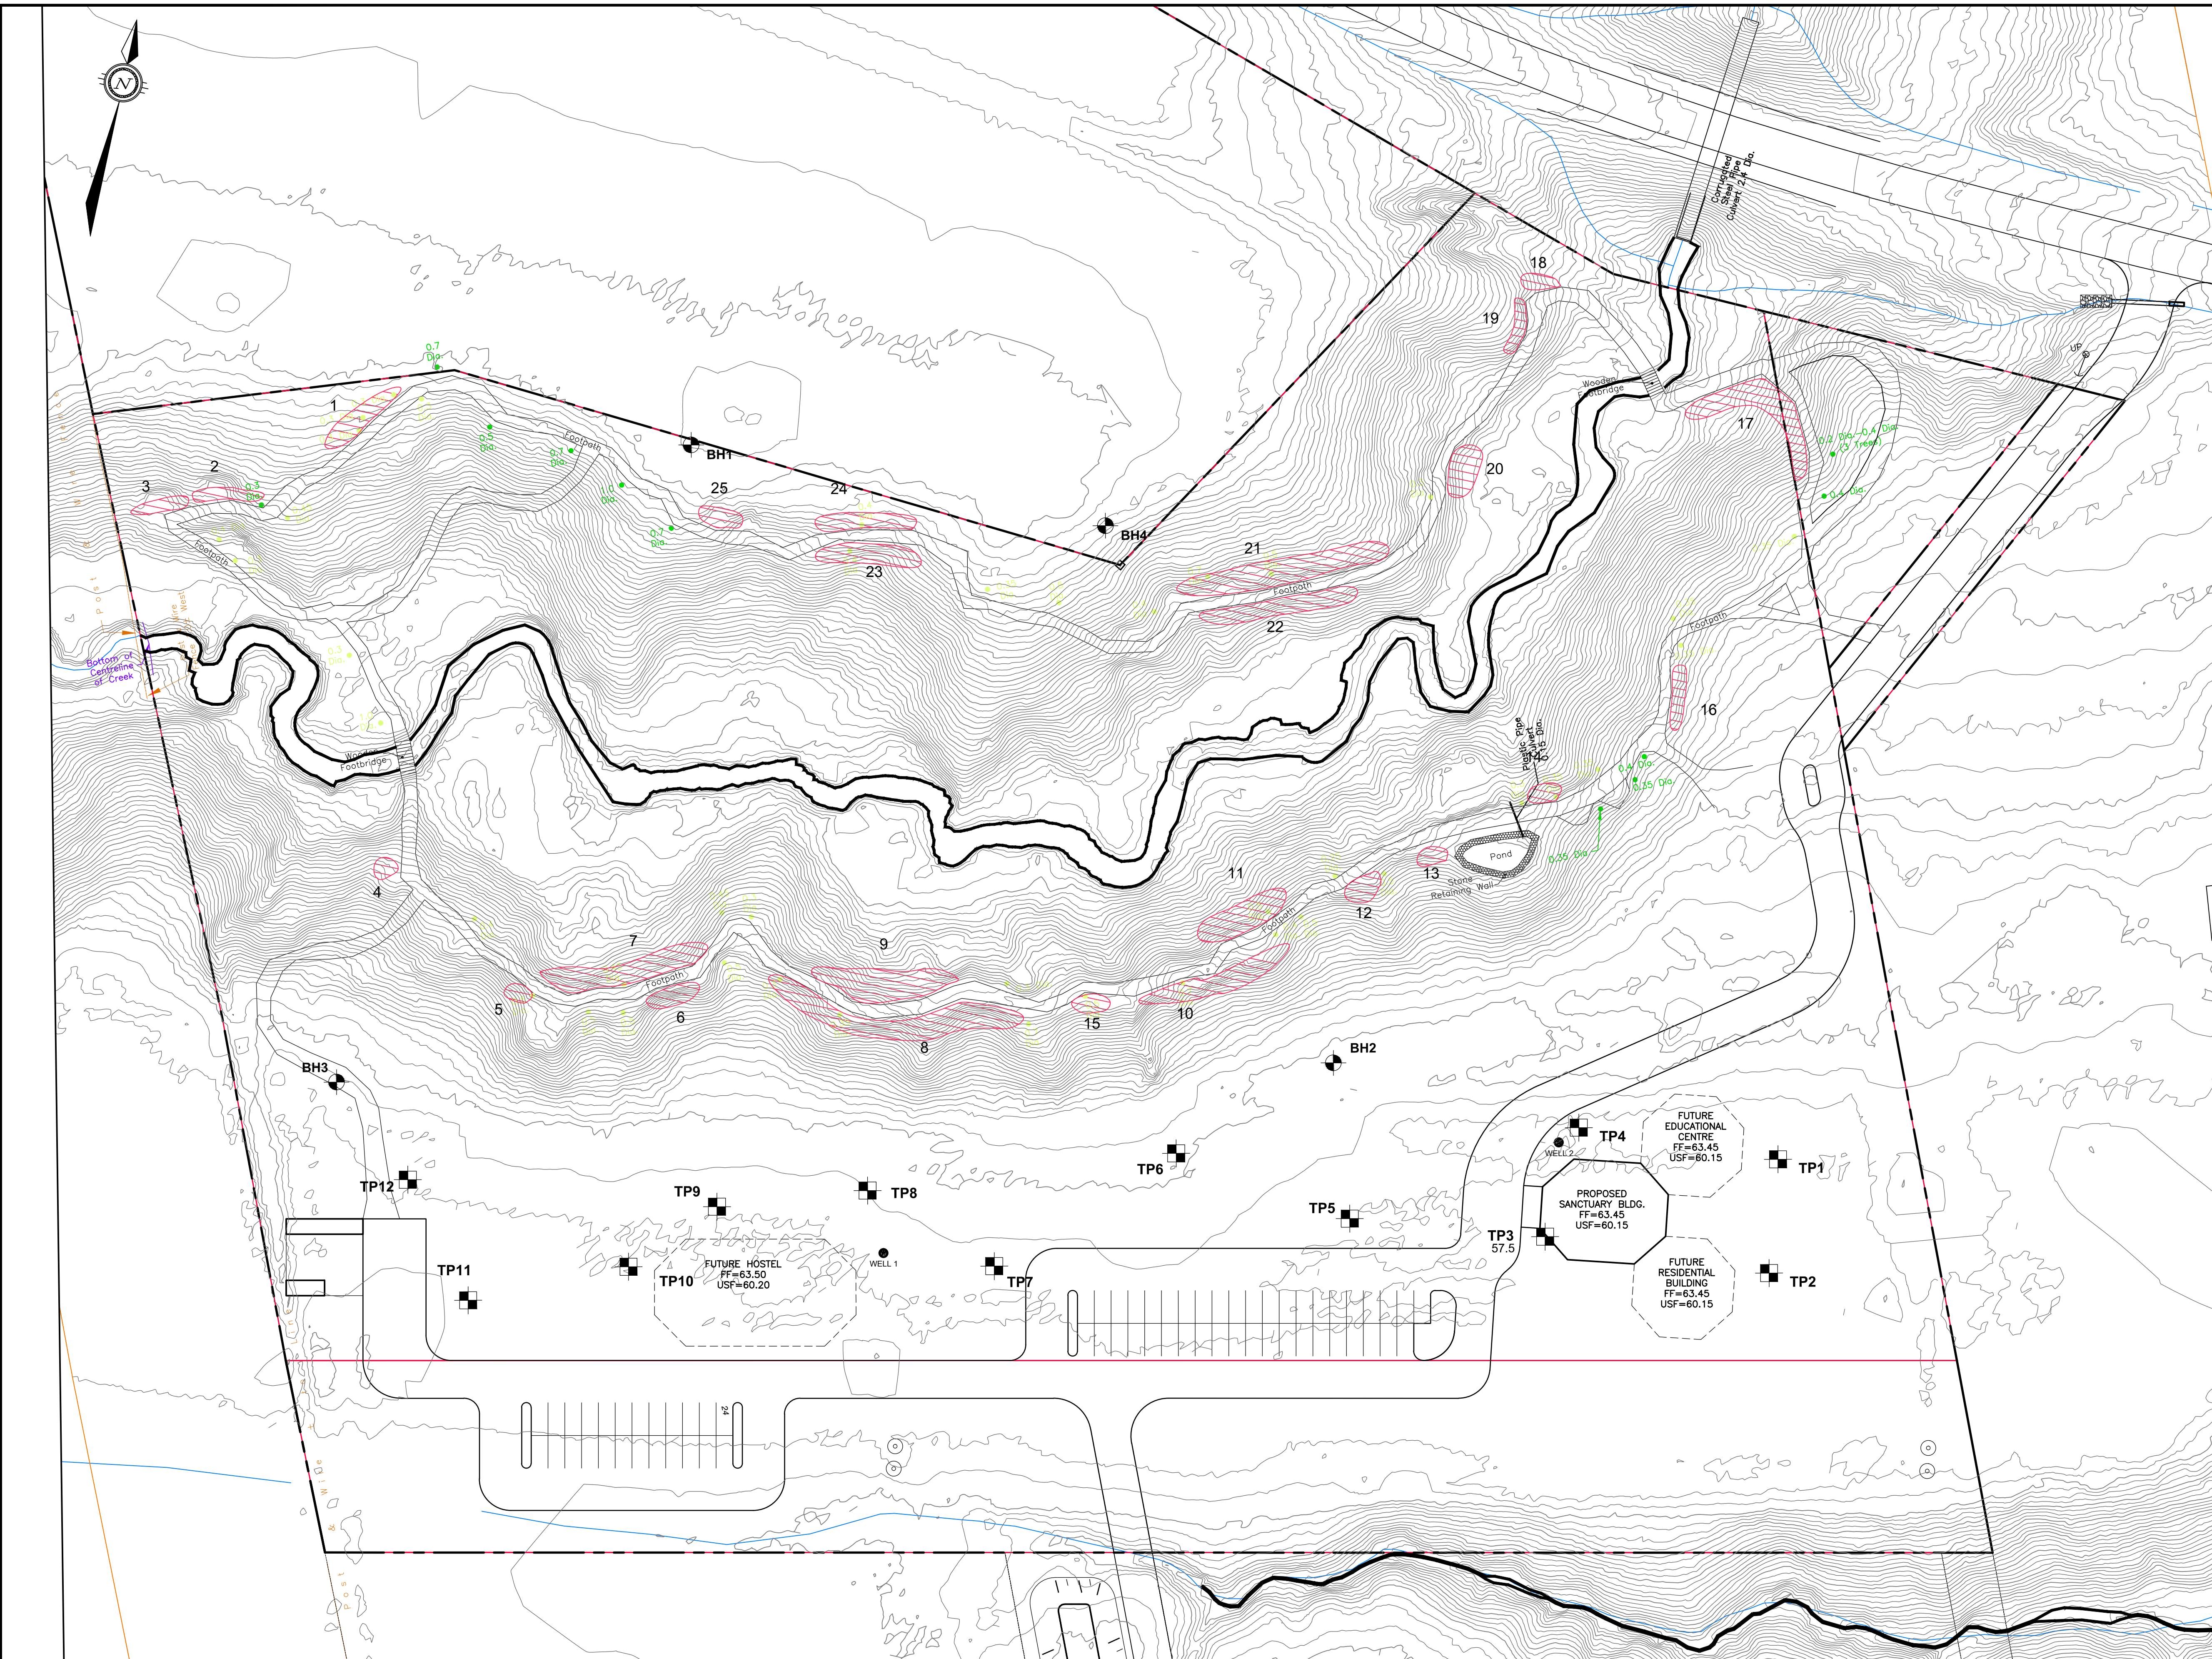
OBSERVED SLOPE EROSION AREAS AND PHOTO NO. 6

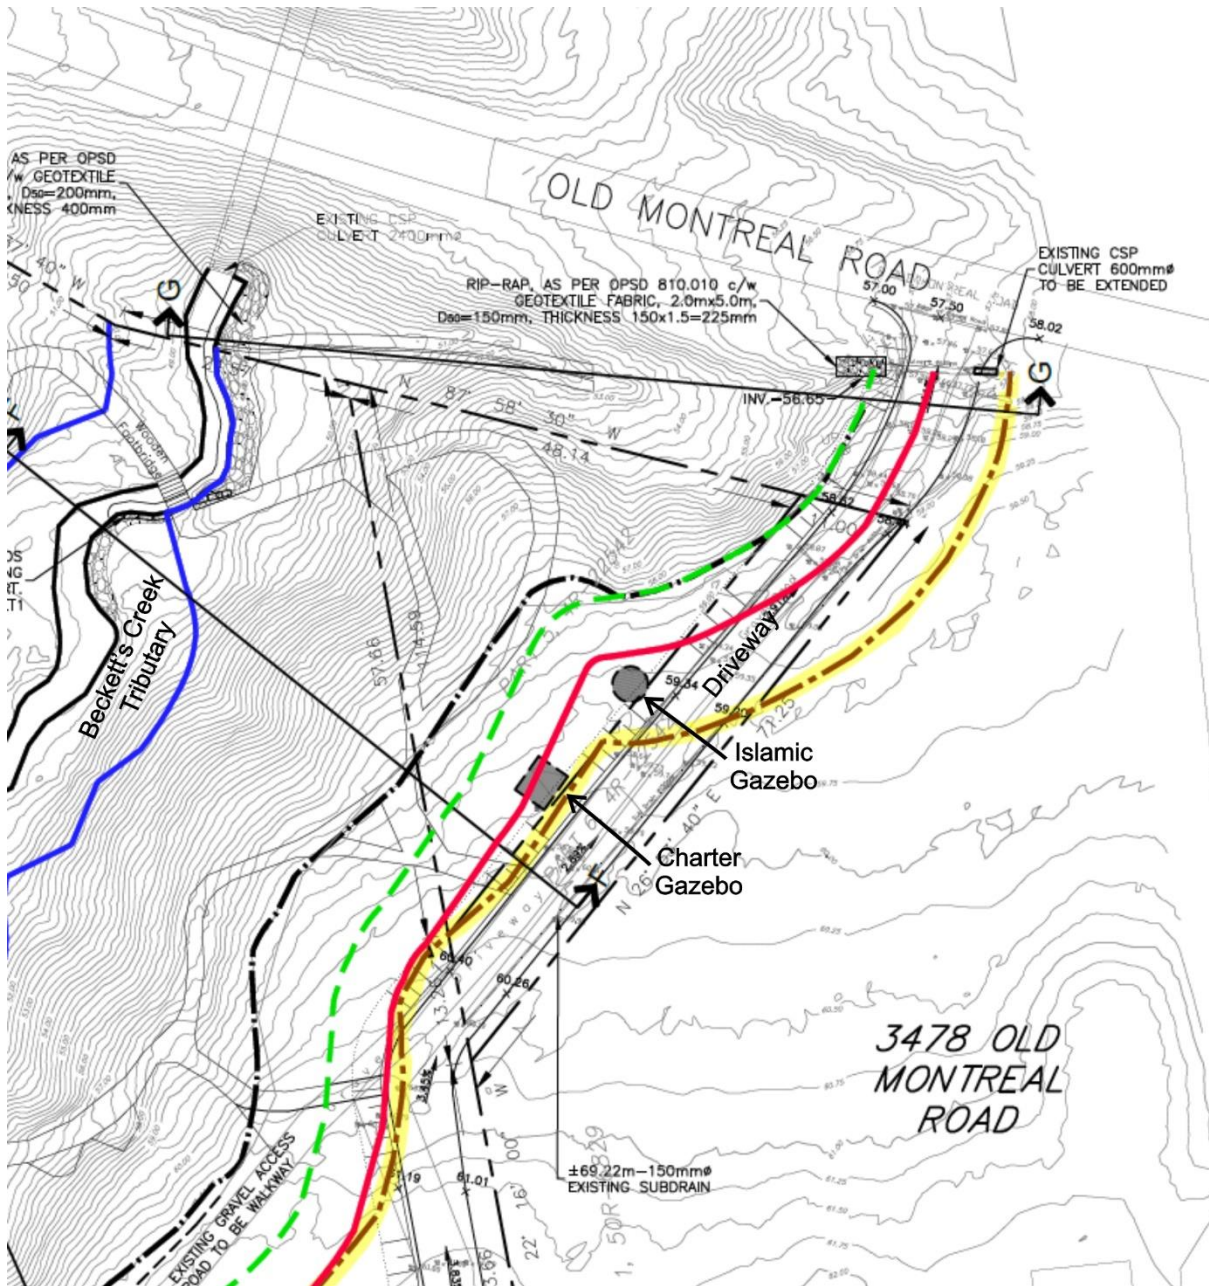
Map 1 – Portion of Grading Plan by exp Services Inc. (2021)  
With Proposed Gazebo Locations

The gazebos will be located a minimum of 10 metres from the crest of slope. The crest of slope is well treed as are the portions of the valley leading to the tributary of Beckett's Creek. The tableland setback from the crest of slope is forested closer to the crest save for the permeable pathways, with intermittent tree cover in the outer portions of the setback.
