## **Geotechnical Investigation and Slope Stability Assessment**

Proposed Humanics Sanctuary and Sculpture Park  
3400 Old Montreal Road  
Part of Lot 7, Concession 1, Old Survey  
Ottawa (Formerly Township of Cumberland), Ontario

OTT-00229886-A0

November 25, 2022

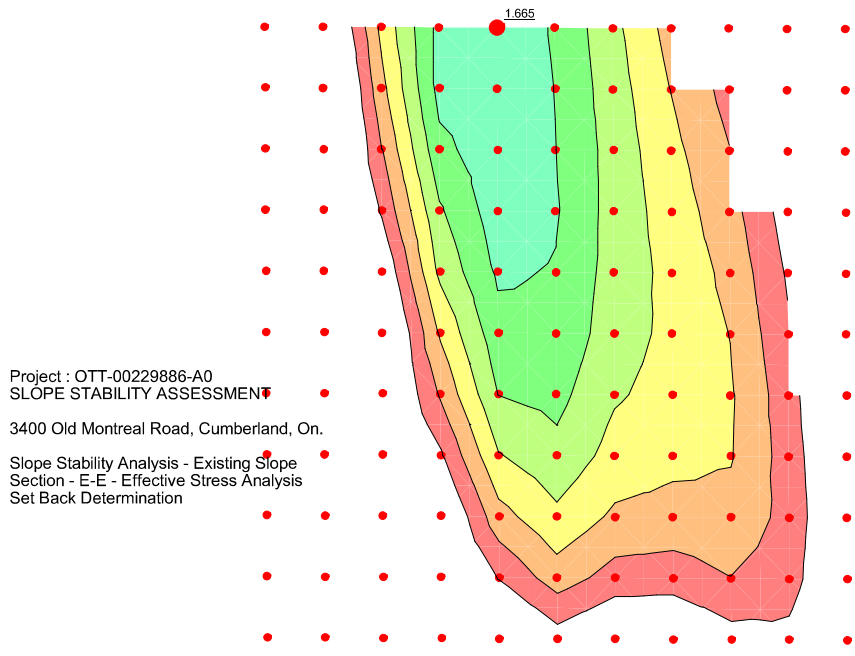
Figure 28

Project : OTT-00229886-A0  
 SLOPE STABILITY ASSESSMENT  
 3400 Old Montreal Road, Cumberland, On.  
 Slope Stability Analysis - Existing Slope  
 Section - E-E - Effective Stress Analysis  
 Set Back Determination

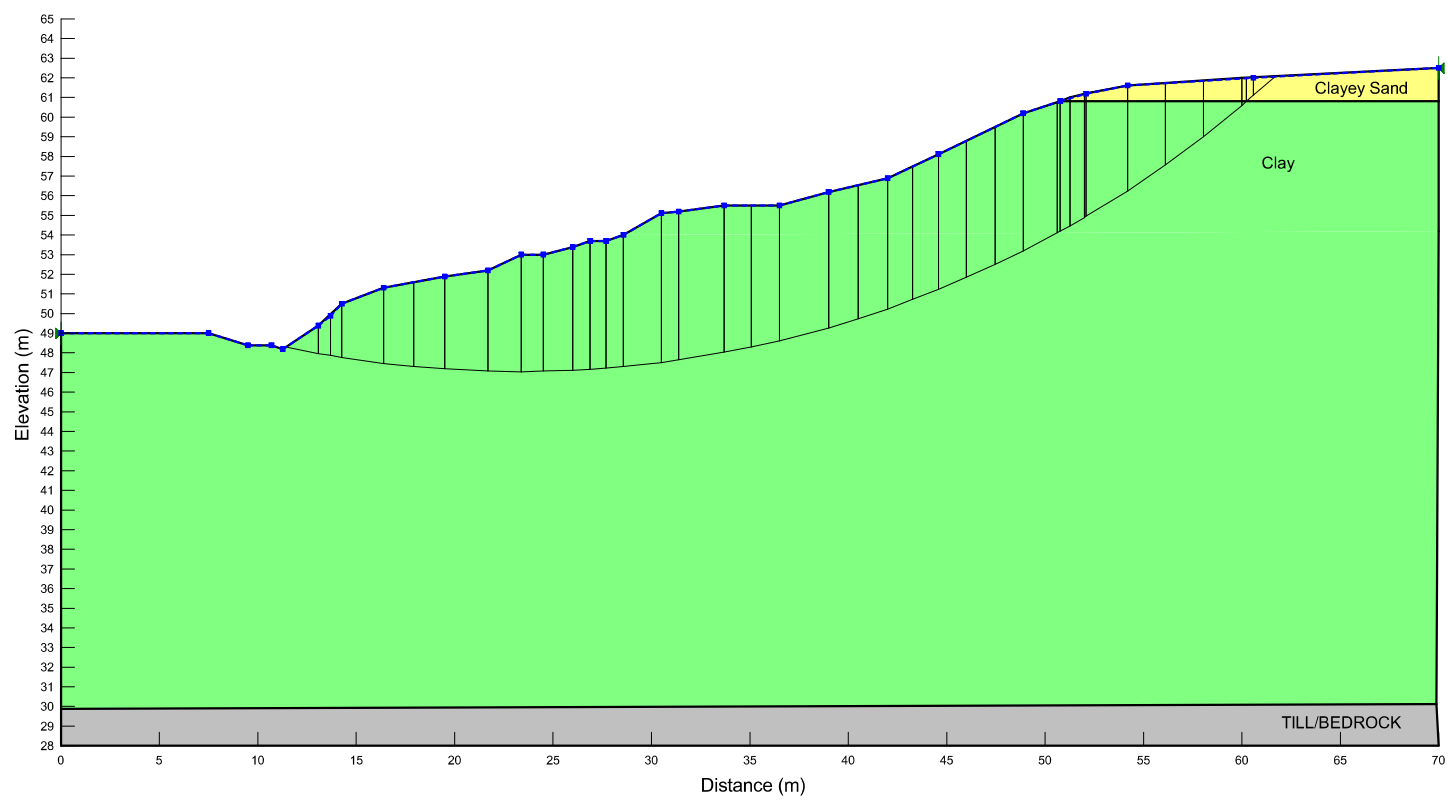
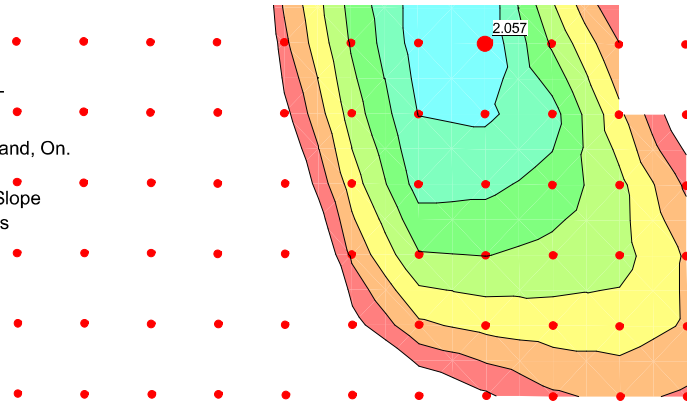
Figure 29

Slope Stability Analysis - Existing Slope  
 Section -E-E - Total Stress Analysis

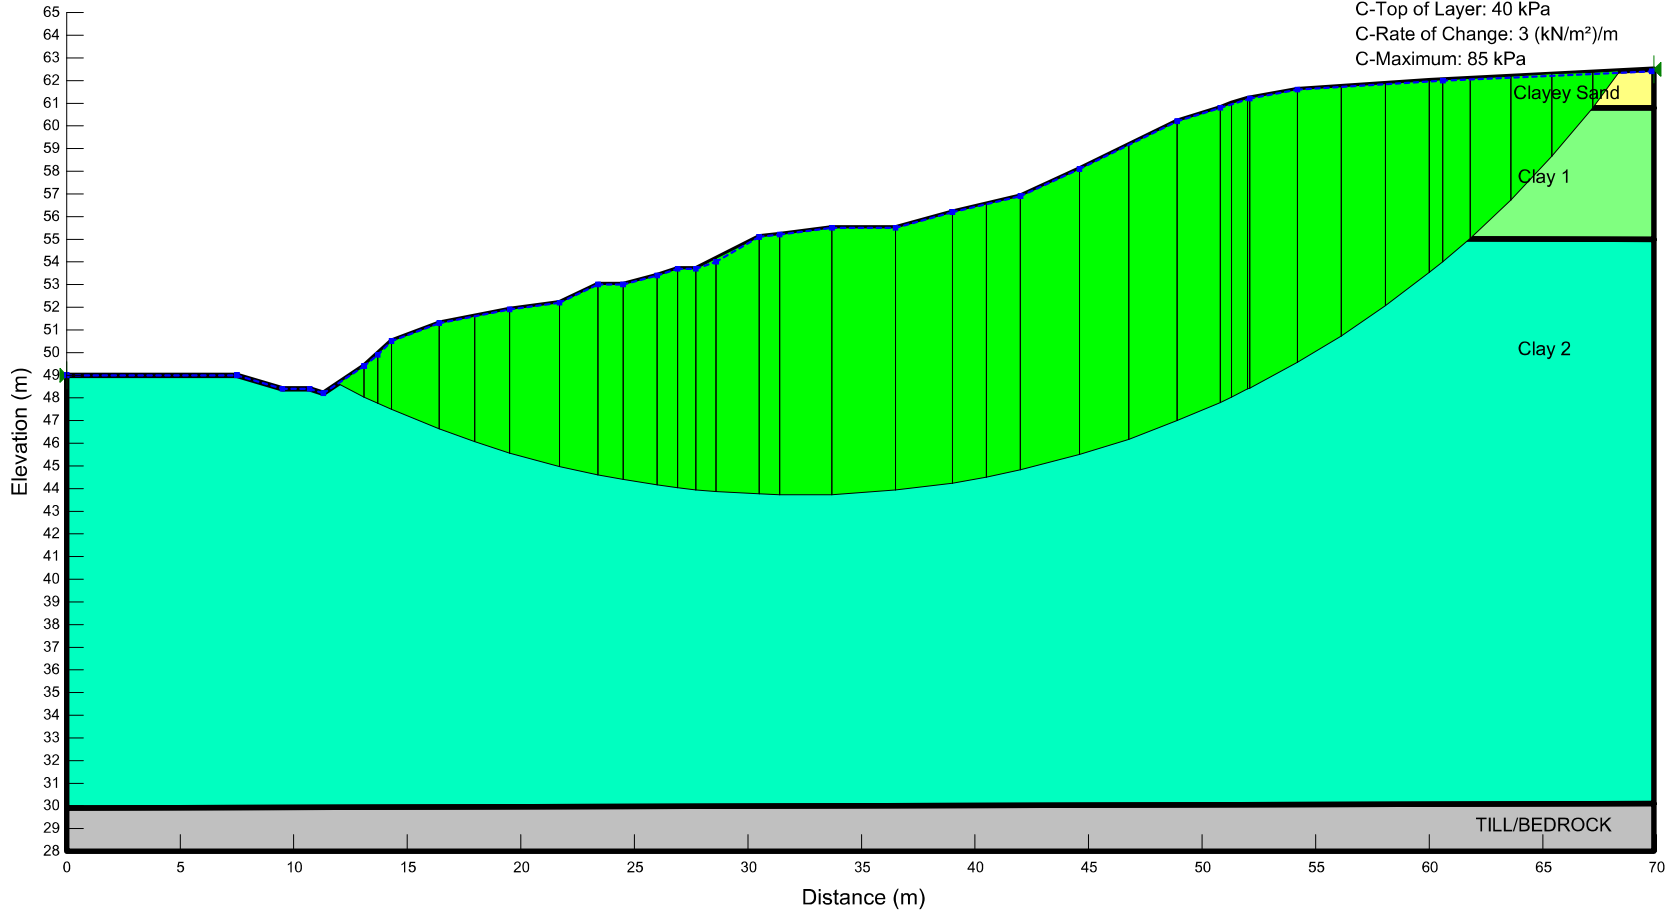
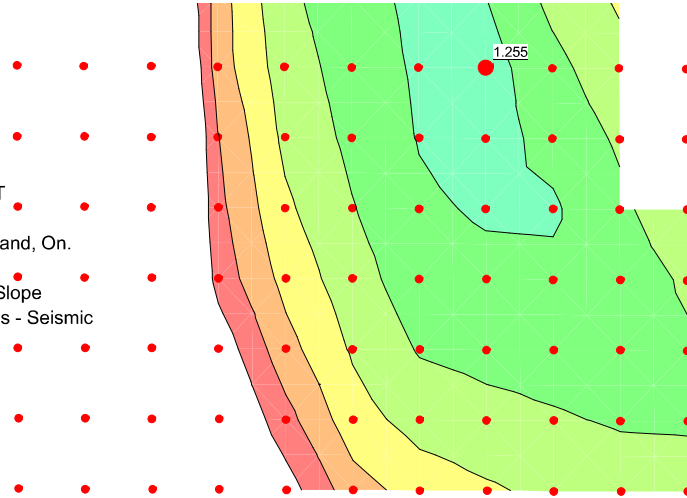
Figure 30

Slope Stability Analysis - Existing Slope  
 Section -E-E - Total Stress Analysis - Seismic

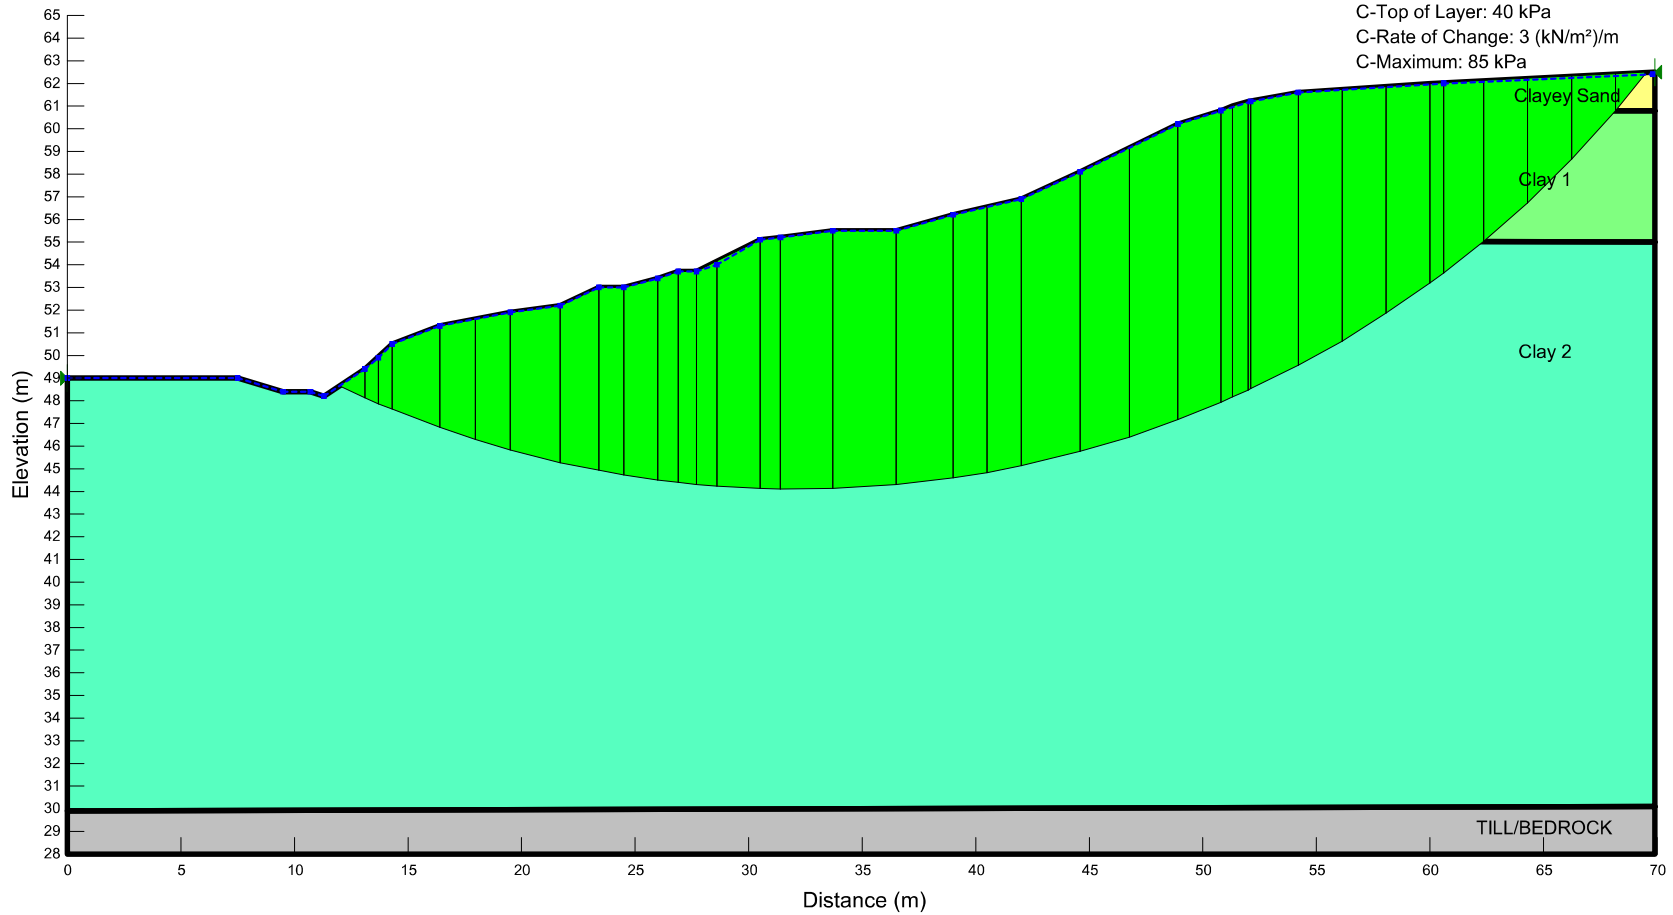
Figure 31

Project : OTT-00229886-A0  
SLOPE STABILITY ASSESSMENT  
3400 Old Montreal Road, Cumberland, On.  
Slope Stability Analysis - Existing Slope  
Section - F-F - Effective Stress Analysis  
Set Back Determination

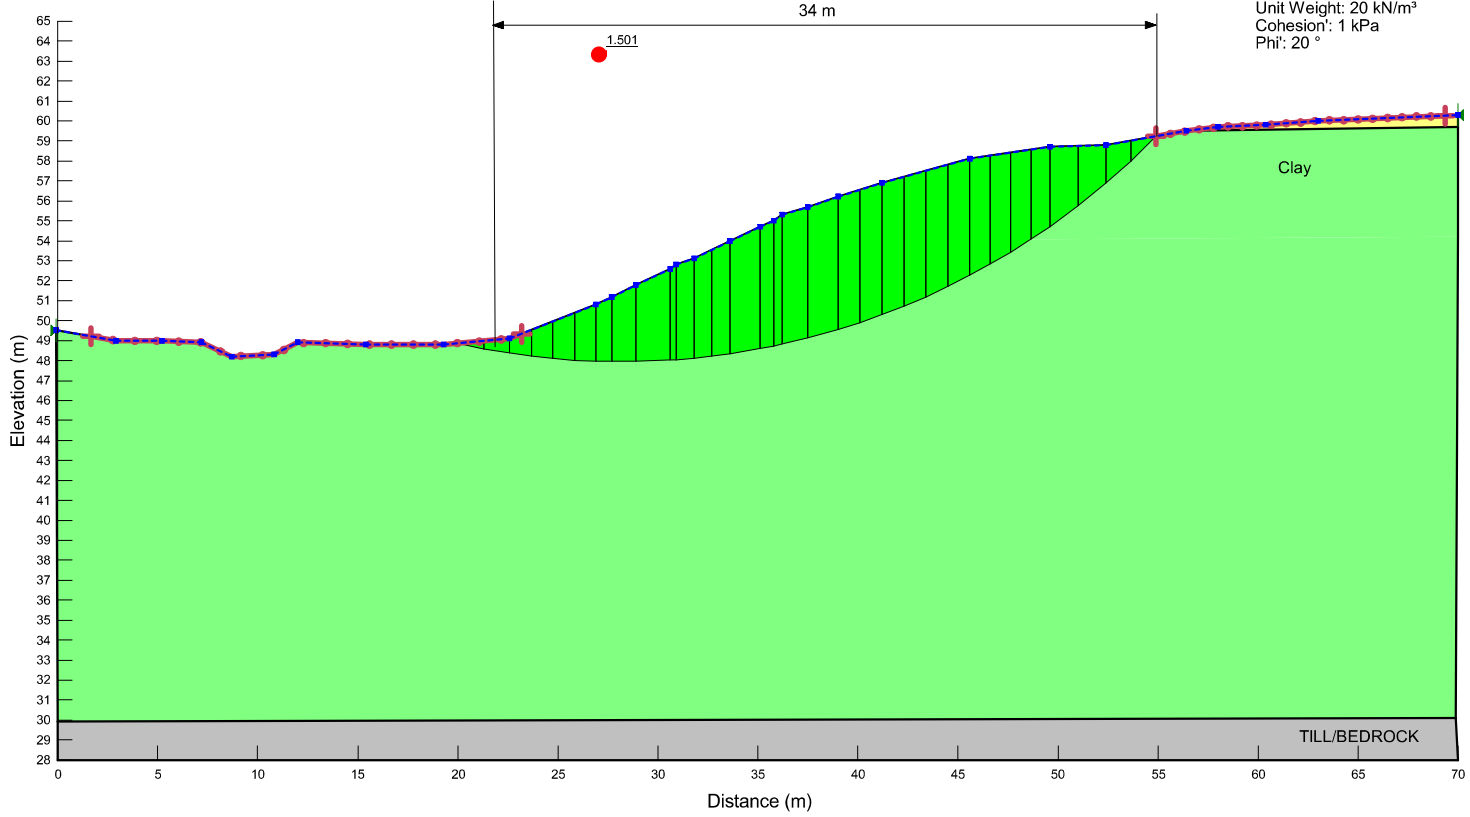
Figure 32

Project : OTT-00229886-A0  
 SLOPE STABILITY ASSESSMENT  
 3400 Old Montreal Road, Cumberland, On.  
 Slope Stability Analysis - Existing Slope  
 Section -F-F - Total Stress Analysis

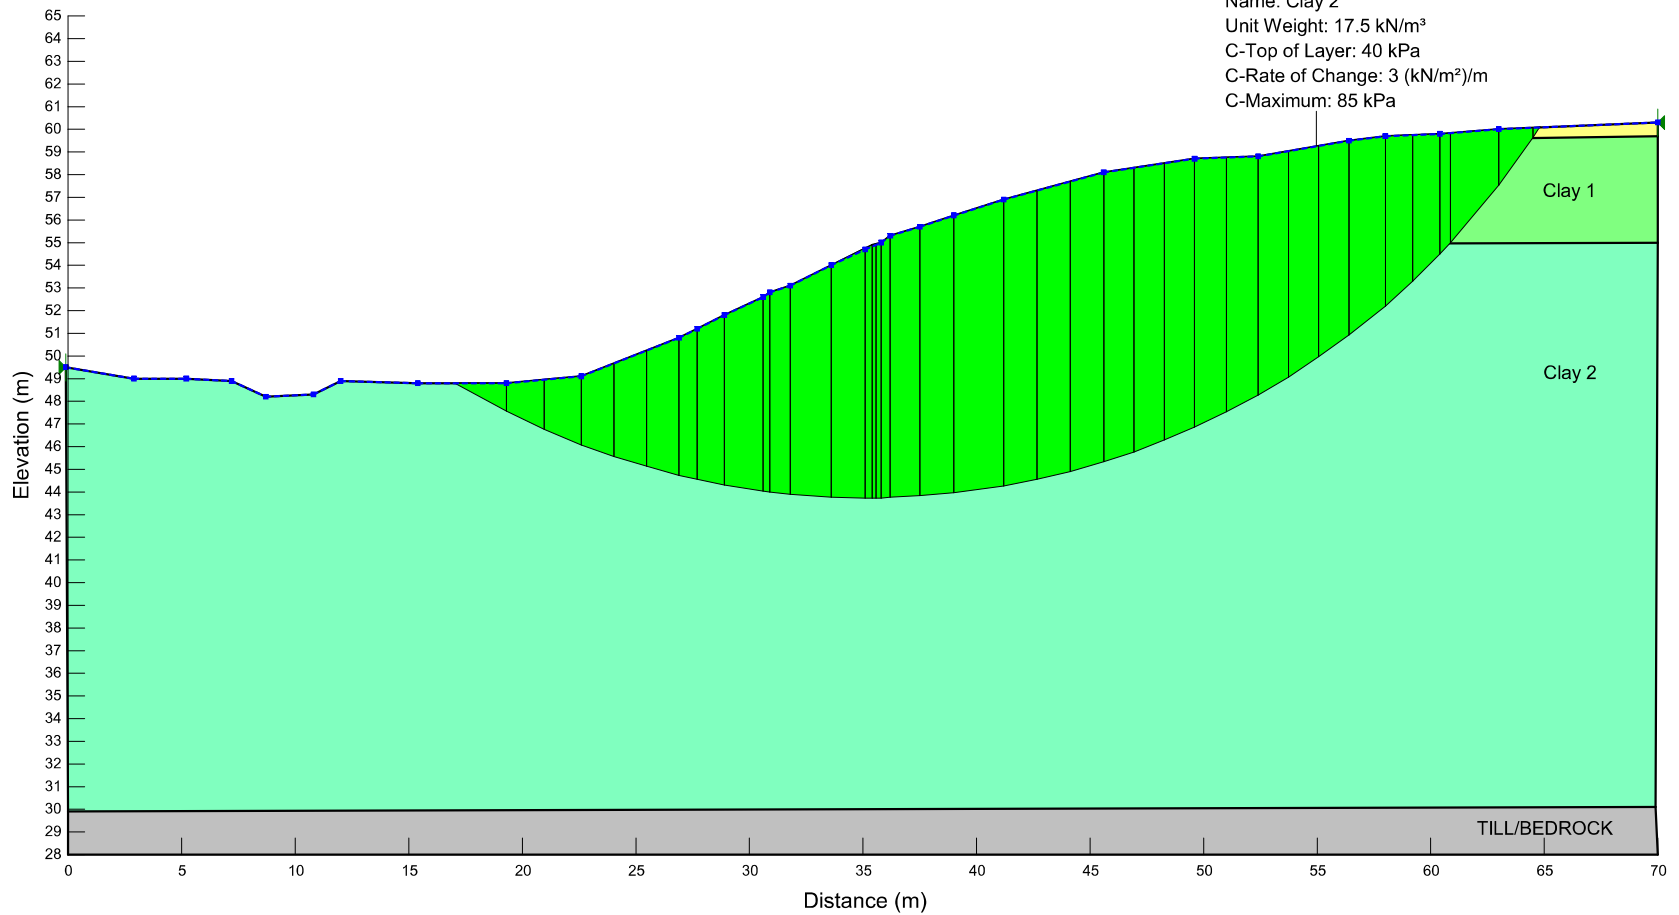
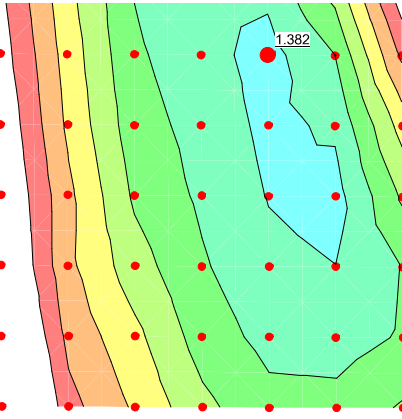
Figure 33

Project : OTT-00229886-A0  
 SLOPE STABILITY ASSESSMENT  
 3400 Old Montreal Road, Cumberland, On.  
 Slope Stability Analysis - Existing Slope  
 Section -F-F - Total Stress Analysis - Seismic

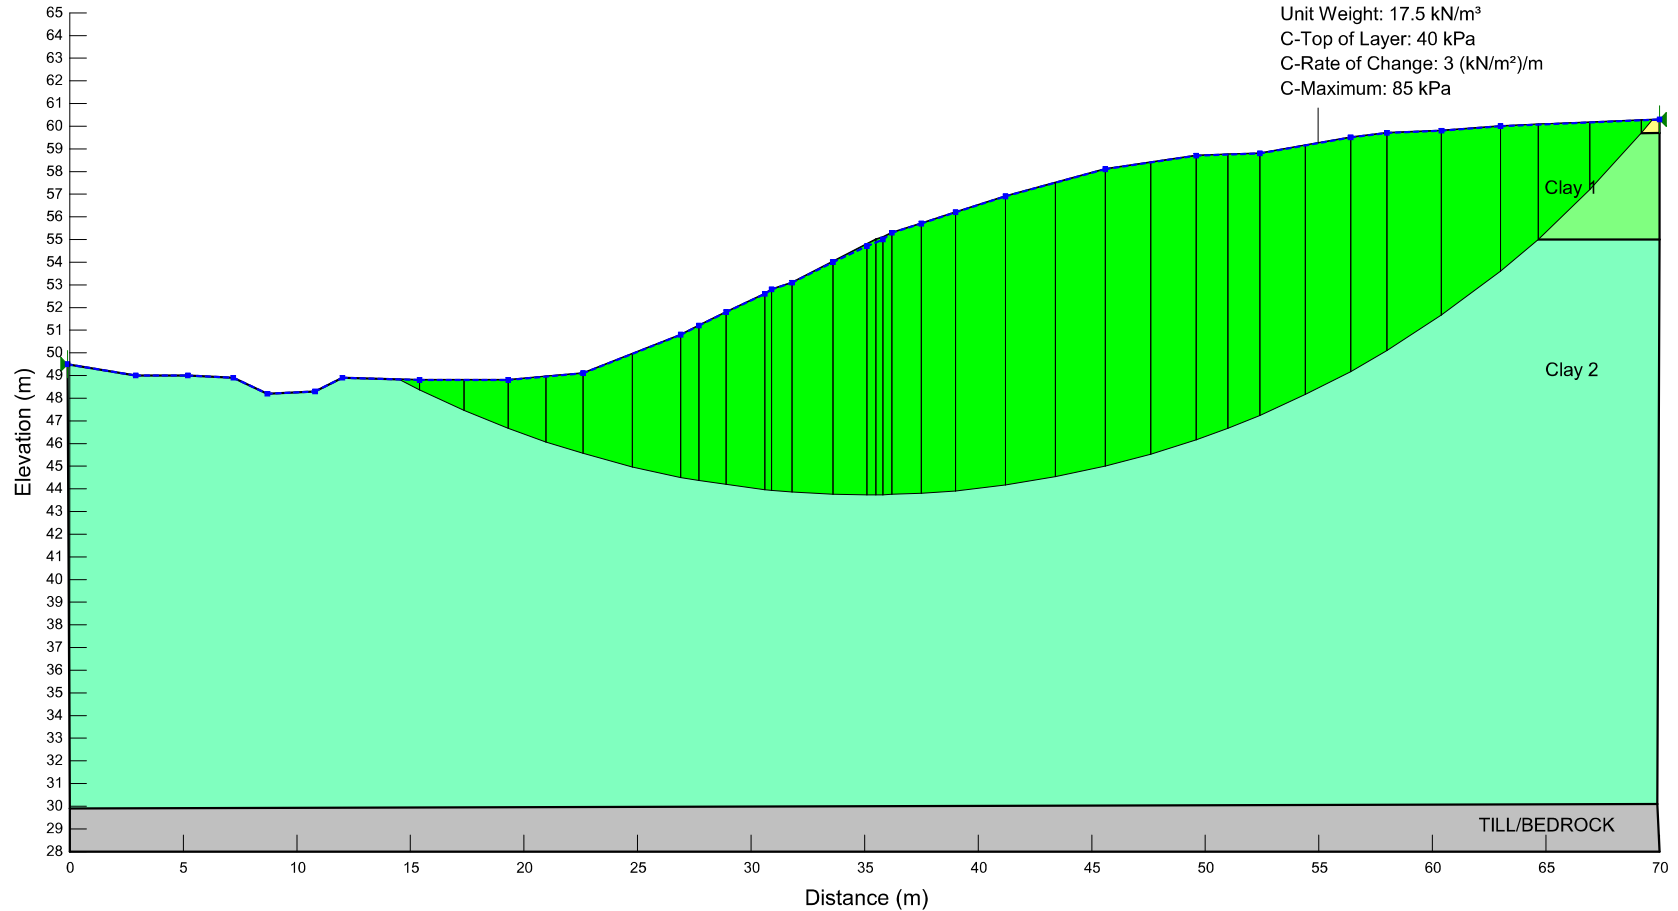
Figure 34

Slope Stability Analysis - Existing Slope & Proposed Retaining Wall  
Section - G-G - Effective Stress Analysis

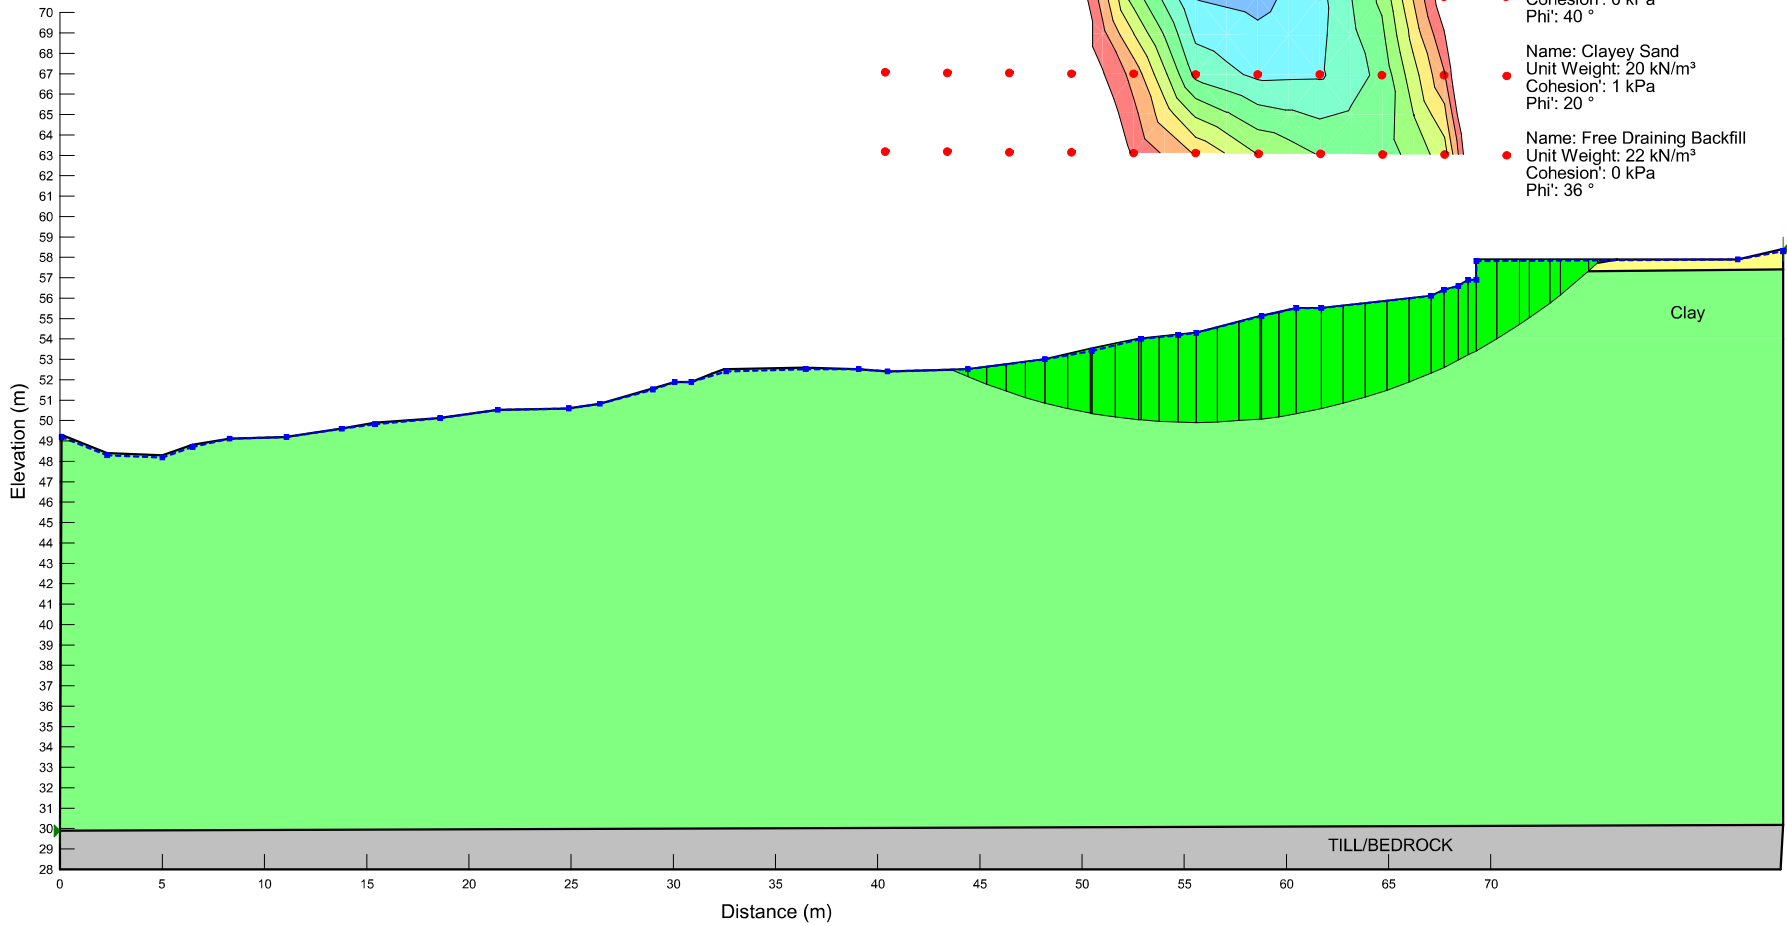
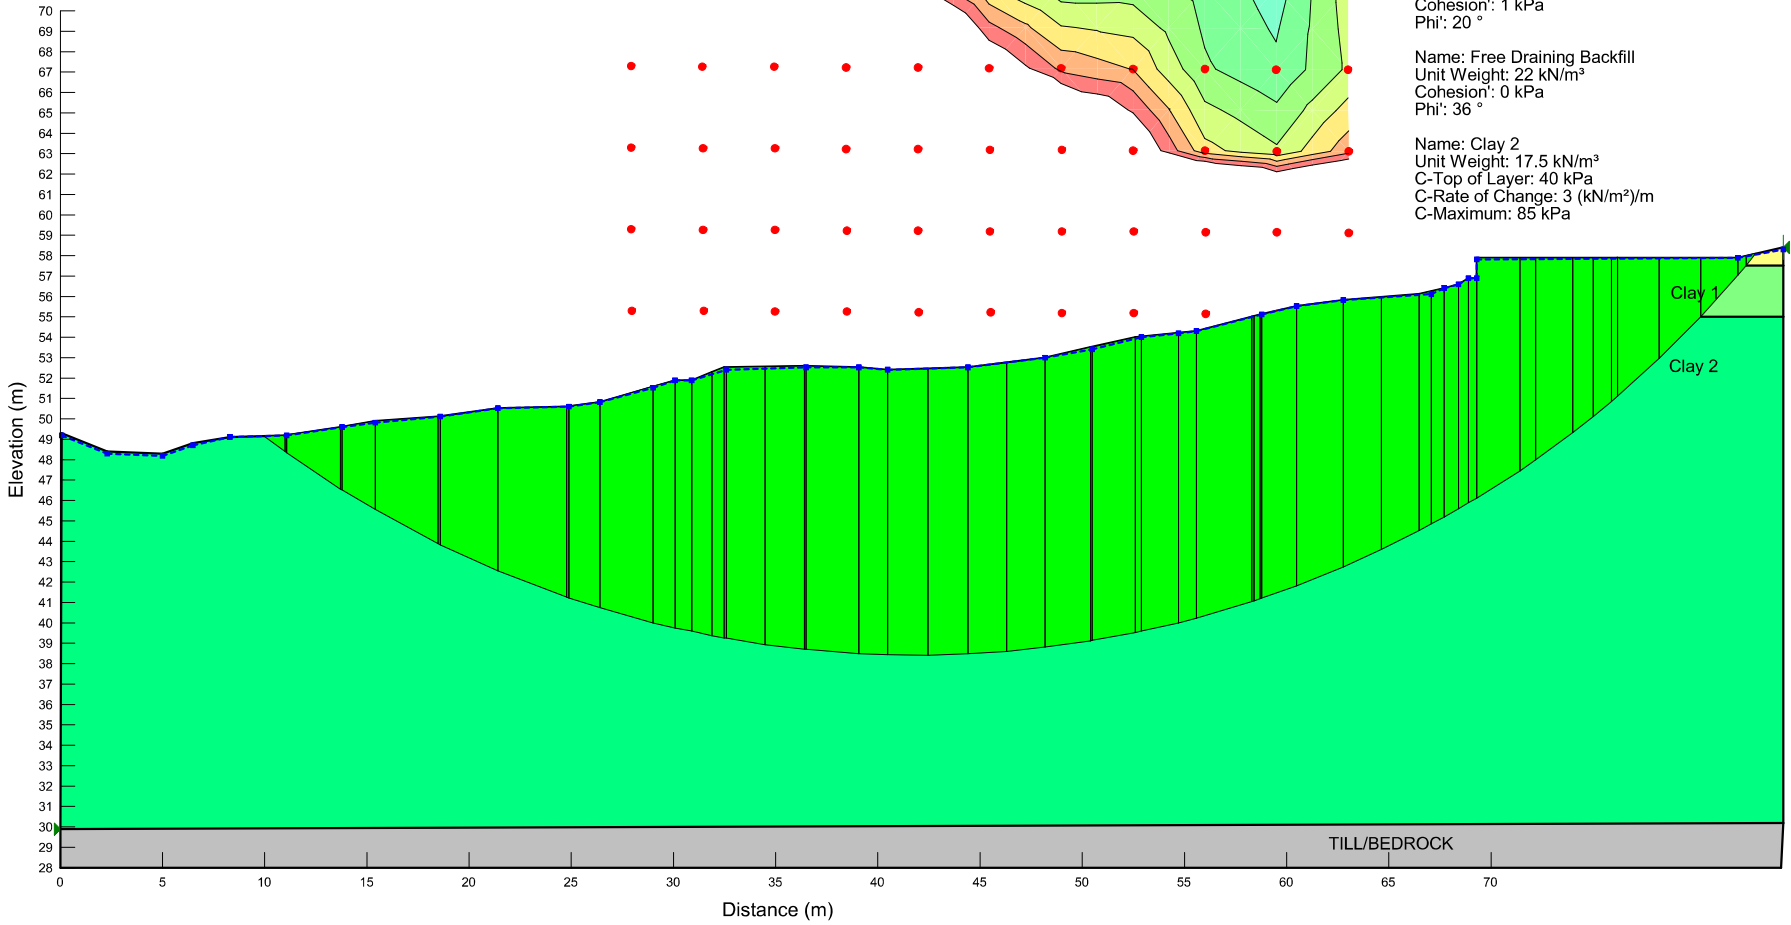
Figure 35

Slope Stability Analysis - Existing Slope & Proposed Retaining Wall  
Section - G-G - Total Stress Analysis

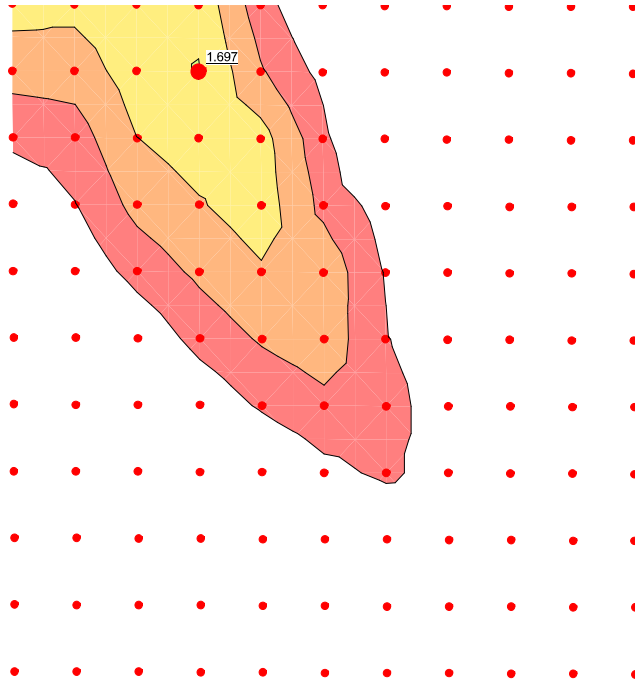
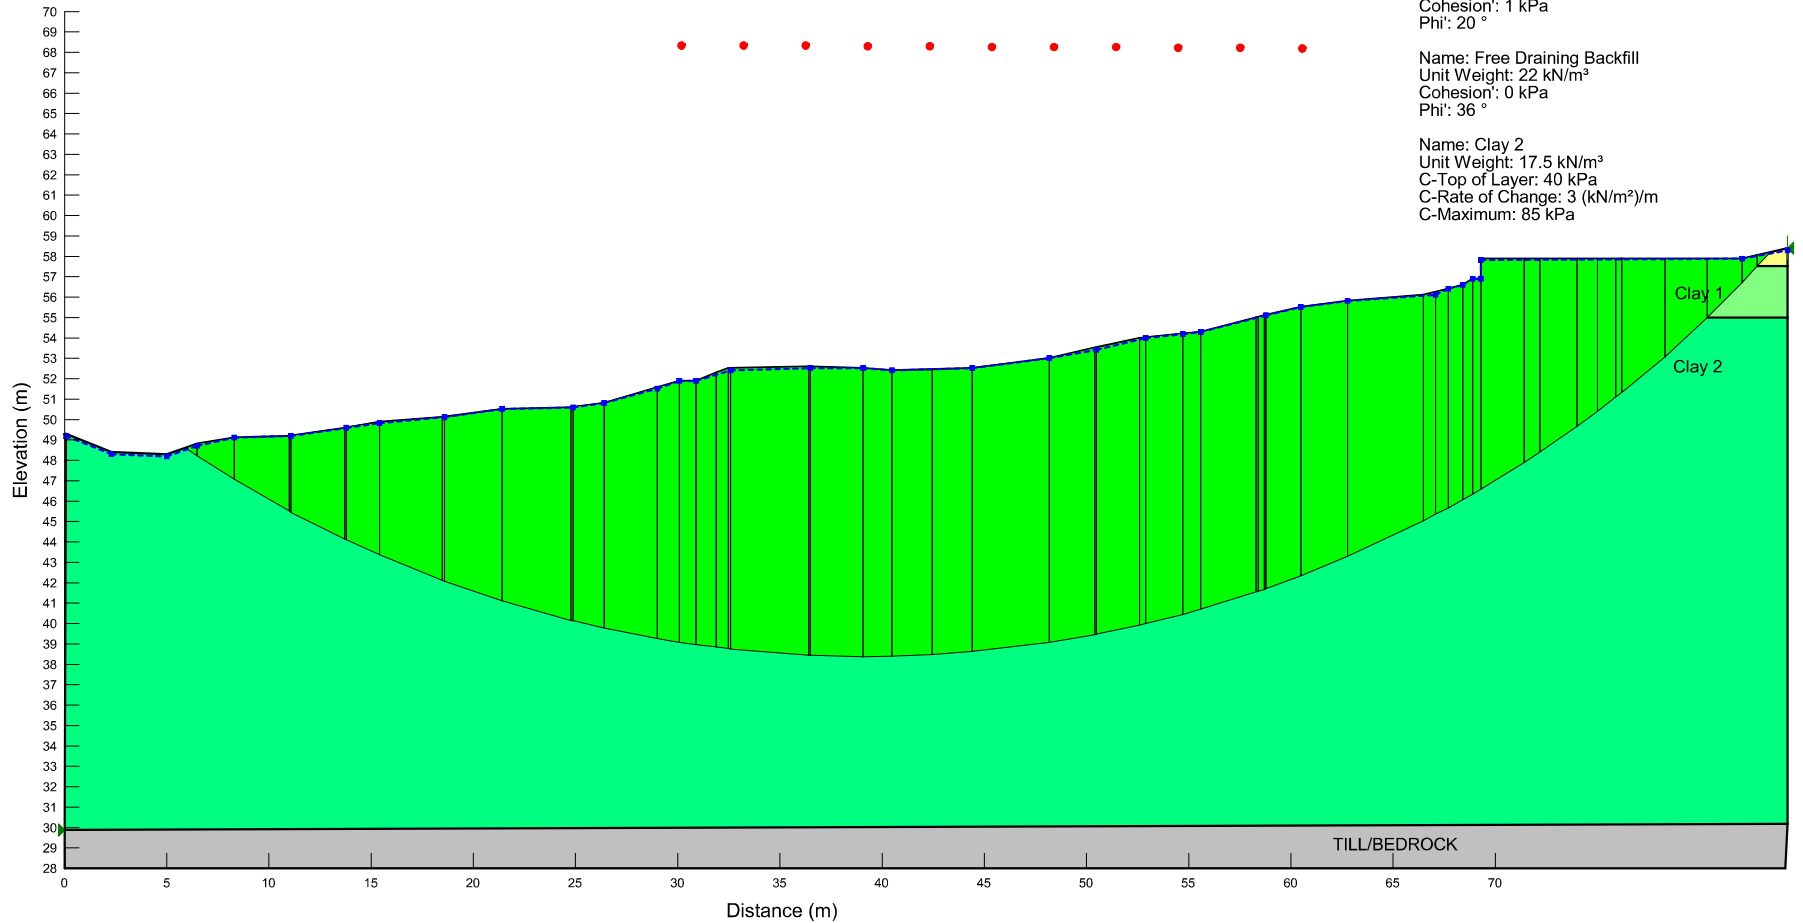
Figure 36

Slope Stability Analysis - Existing Slope & Proposed Retaining Wall  
Section - G-G - Total Stress Analysis - Seismic

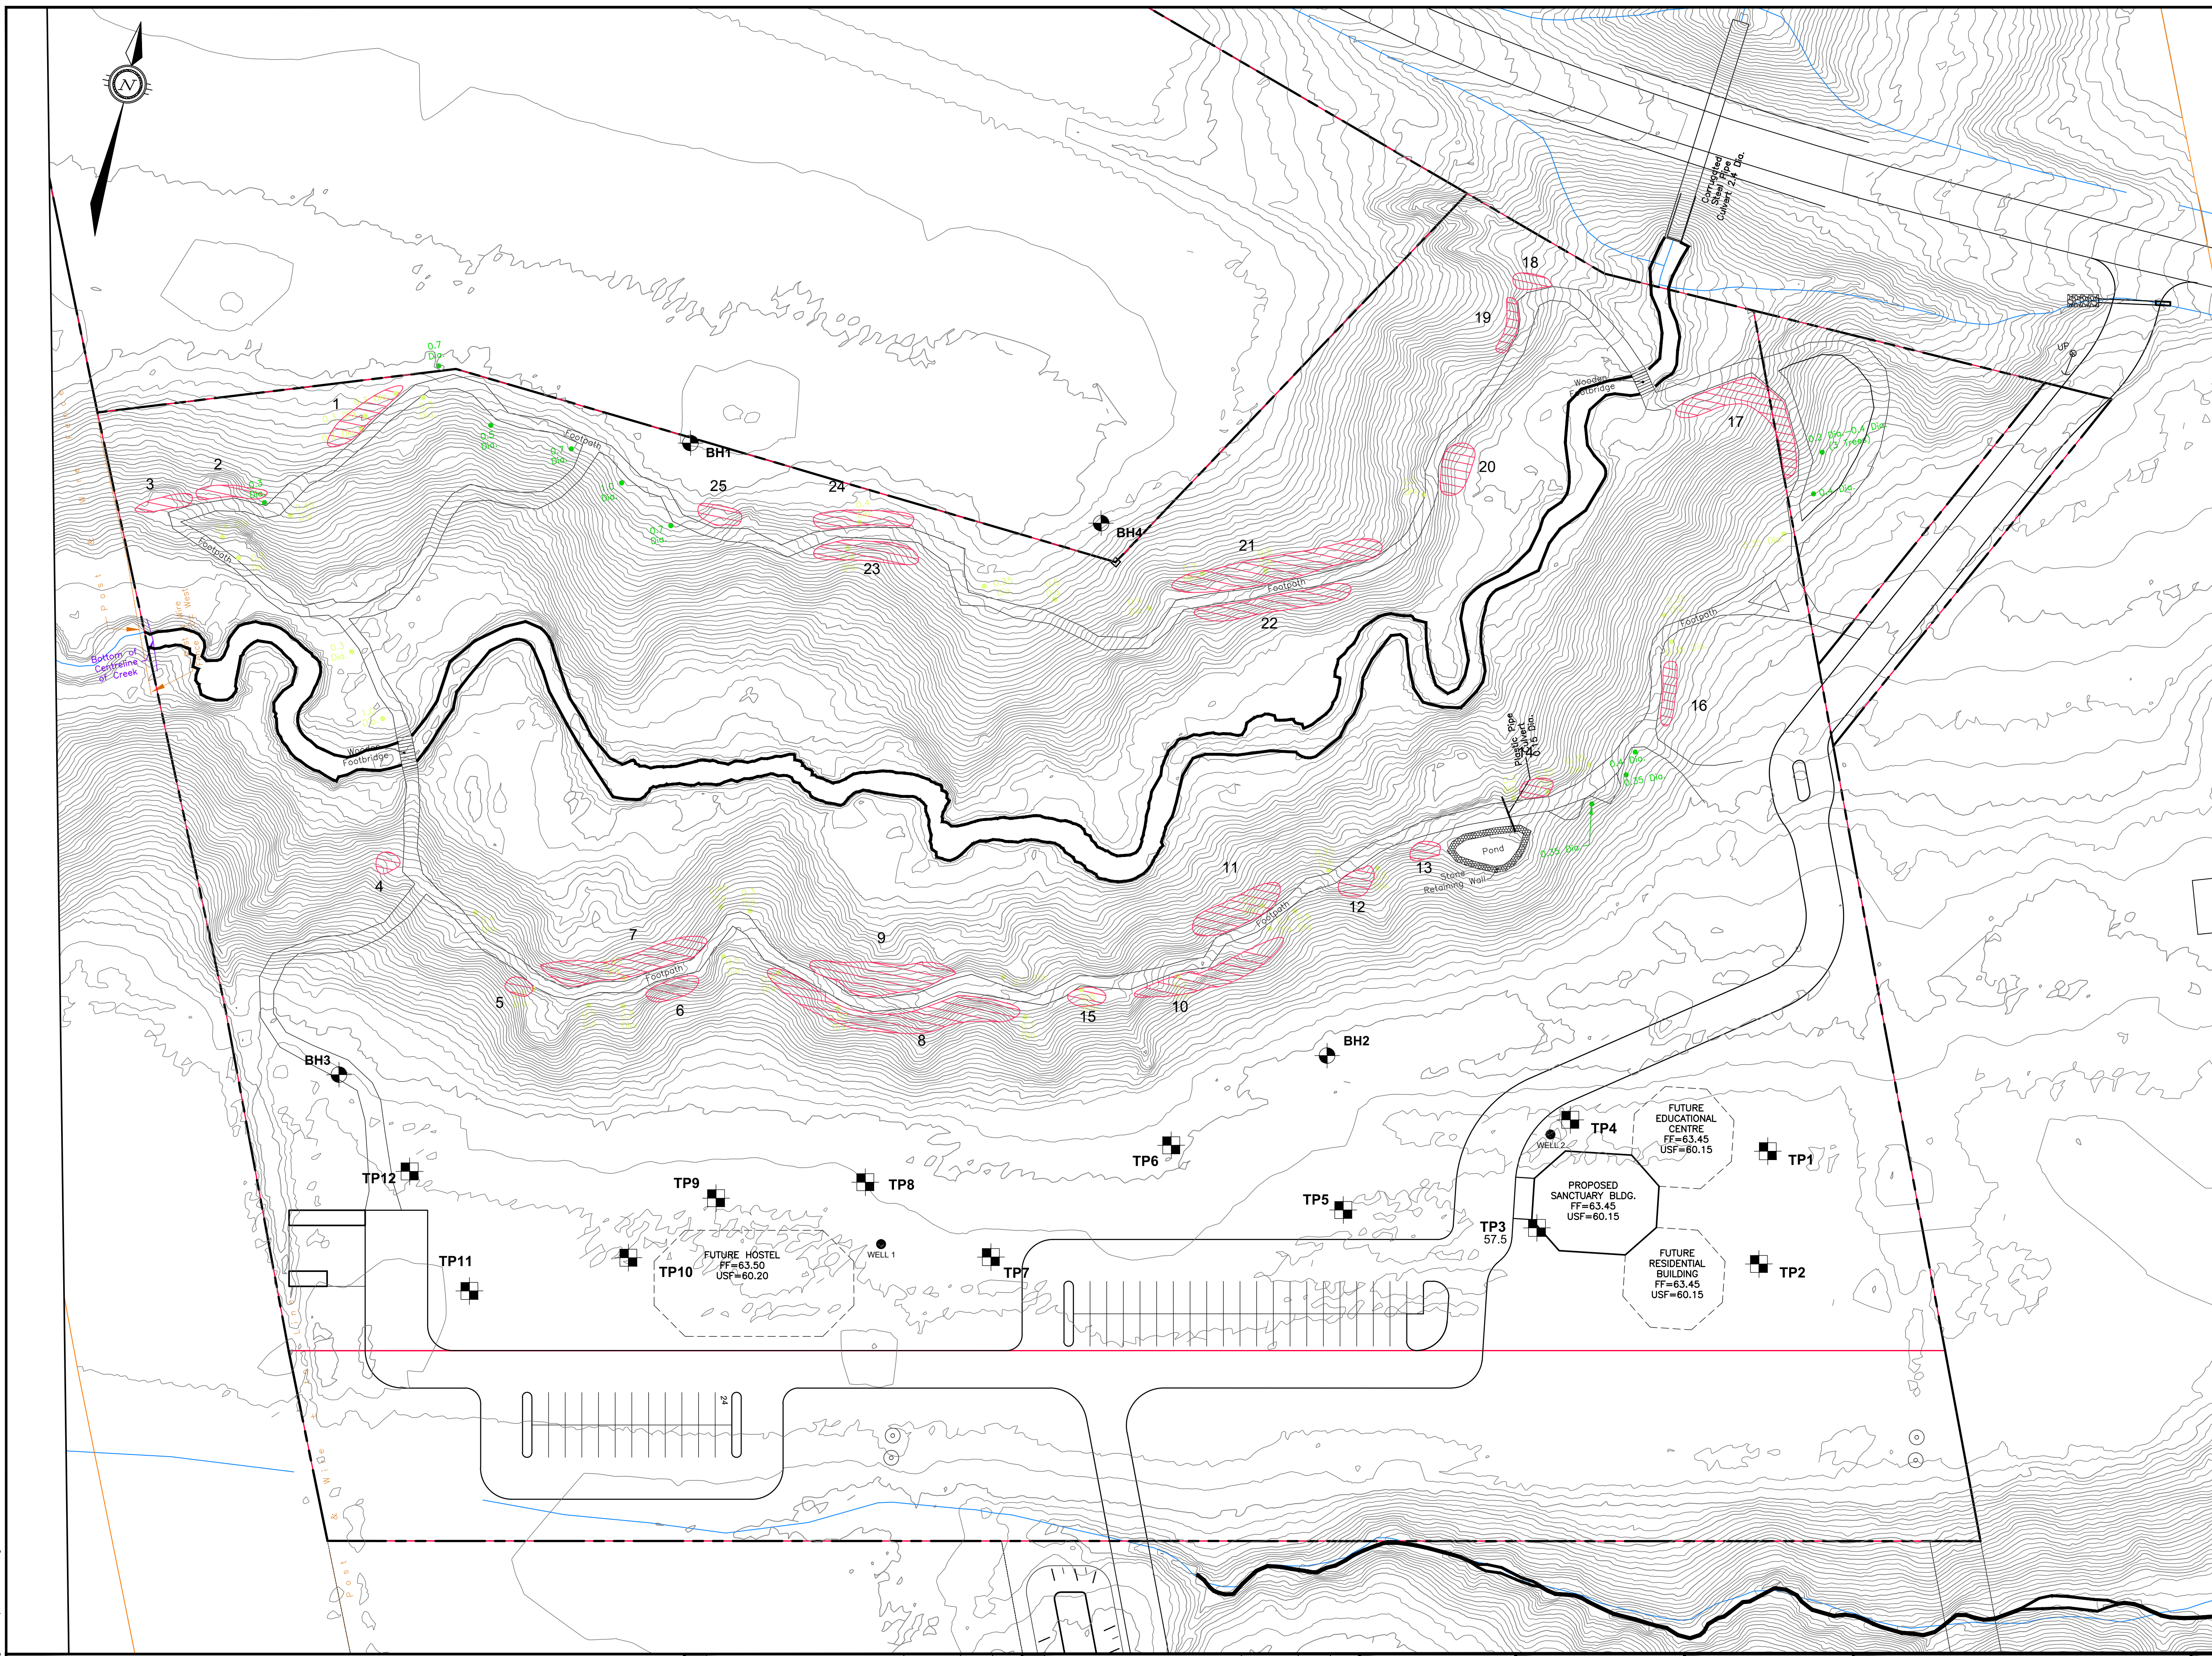
**OBSERVED SLOPE EROSION AREAS & PHOTO NO.**

OBSERVED SLOPE EROSION AREAS AND PHOTO NO.

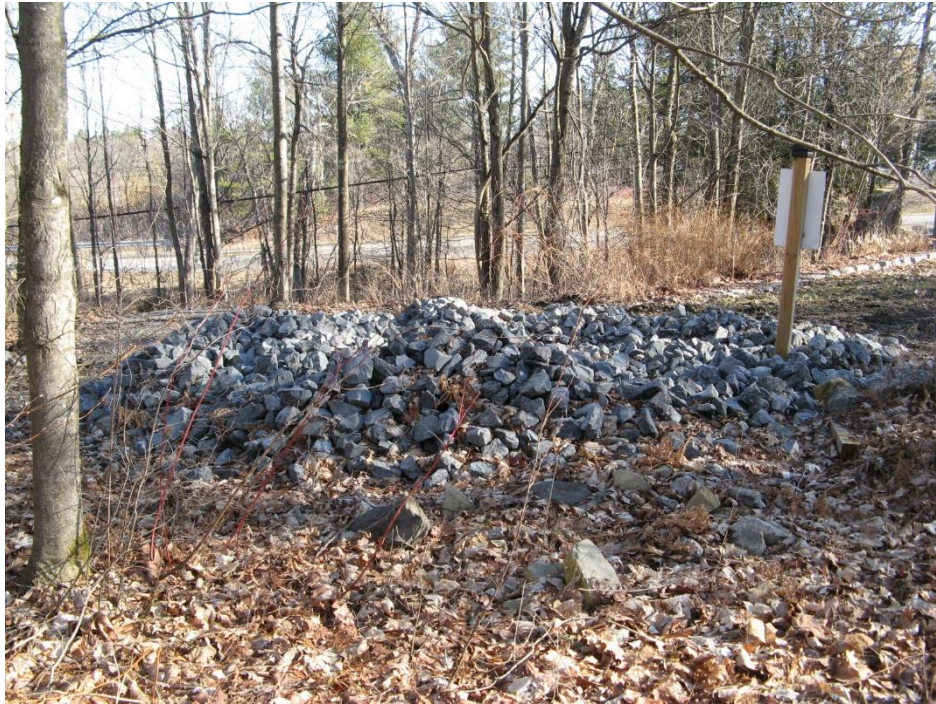
*Photo 1 – Proposed location of the Islamic gazebo (north gazebo).  
View looking north towards Old Montreal Road*

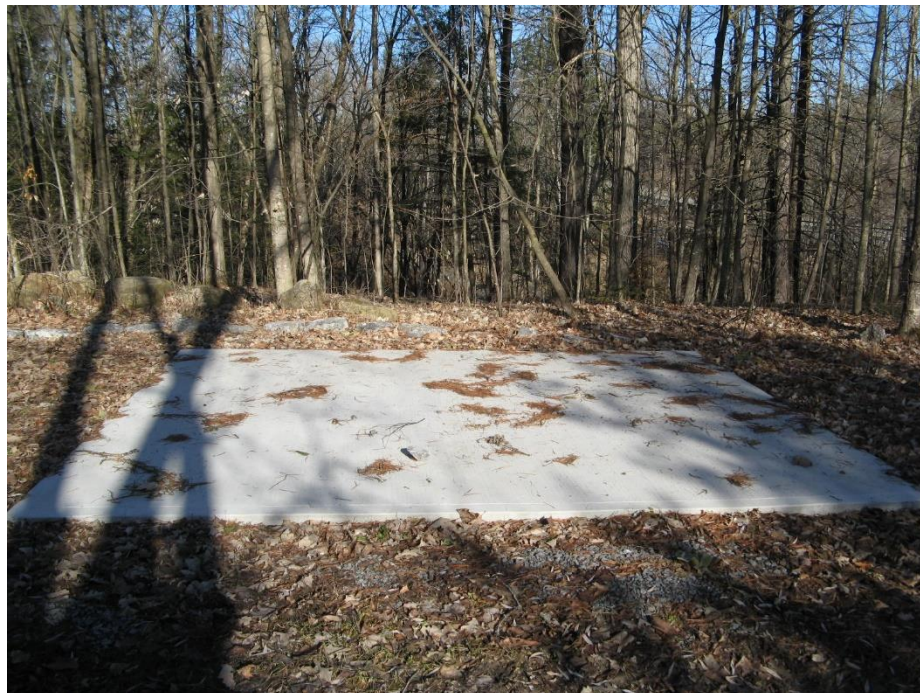
The footprint of both gazebos will be at the outer edge of an upland mixed forest. This forest was described by McIntosh Perry (2017) as a dry-fresh hardwood – hemlock mixed forest. The concrete slab for the south gazebo is existing (Photo 2) and the location of the north gazebo currently contains a small stockpiling area of larger cobbles (Photo 1). No additional trees will be removed for the gazebo construction. Examples of the larger adjacent trees to be retained include sugar maples up to 25cm diameter at breast height (dbh), bur oaks and white spruce in the 35 – 40cm dbh range and a 50cm dbh white pine. Smaller yellow birch, red maple, and poplars are also present. There are dirt and wood chip pathways in the vicinity of the gazebo locations (Photo 3), along with the gravel driveway entrance south off Old Montreal Road to the east of the gazebo locations. The driveway, parking areas, and pathways are all made of permeable material.

*Photo 2 – Proposed location of the Canadian Charter of Rights and Freedoms gazebo (south gazebo).  
View looking west towards the crest of slope and Beckett's Creek tributary ravine*
