**Slope Stability Assessment  
Ottawa-Carleton Detention Centre  
Parking Lot Expansion - 2244 Innes Road  
Ottawa, Ontario**

July 29, 2022  
Project: 100009.037 R0

**Re: Slope Stability Assessment  
Ottawa-Carleton Detention Centre  
Parking Lot Expansion - 2244 Innes Road  
Ottawa, Ontario**

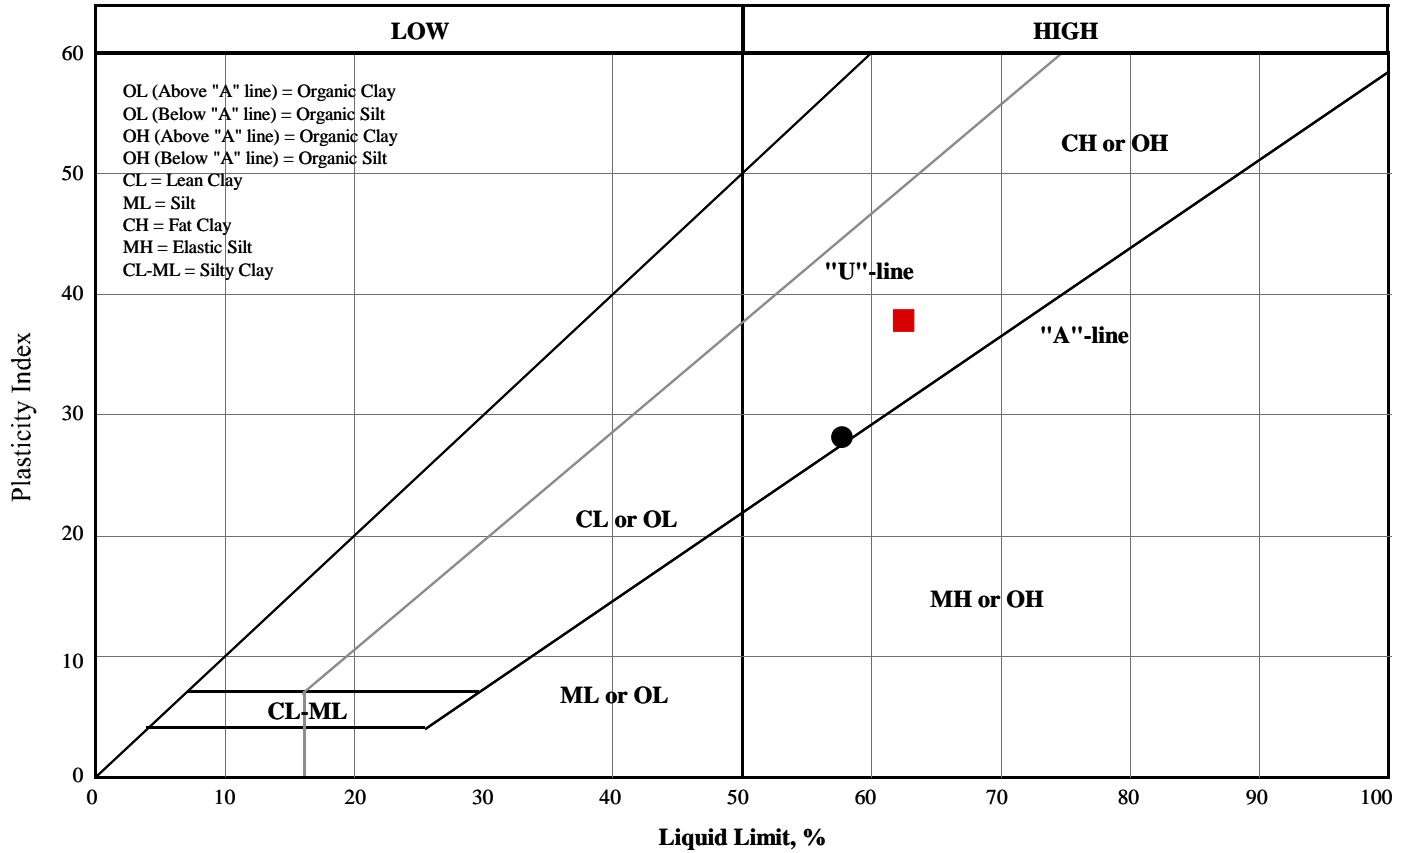
Borehole	Sample Number	Depth (m)	Liquid Limit (%)	Plastic Limit (%)	Plasticity Index	Moisture Content (%)
22-1	7	6.1 – 6.7	57.7	29.6	28.2	75.3
	10	21.3 – 21.9	62.5	24.7	37.8	70.0

Moisture content testing carried out on selected samples of the clay indicate a moisture content ranging between about 47 and 75 percent. The moisture content is generally above the liquid limit value.
