**PATERSON
GROUP**

July 19, 2022
File: PE4937-LET.04

Subject: **Phase II - Environmental Site Assessment Update
Navan at Renaud Road
Ottawa, Ontario**

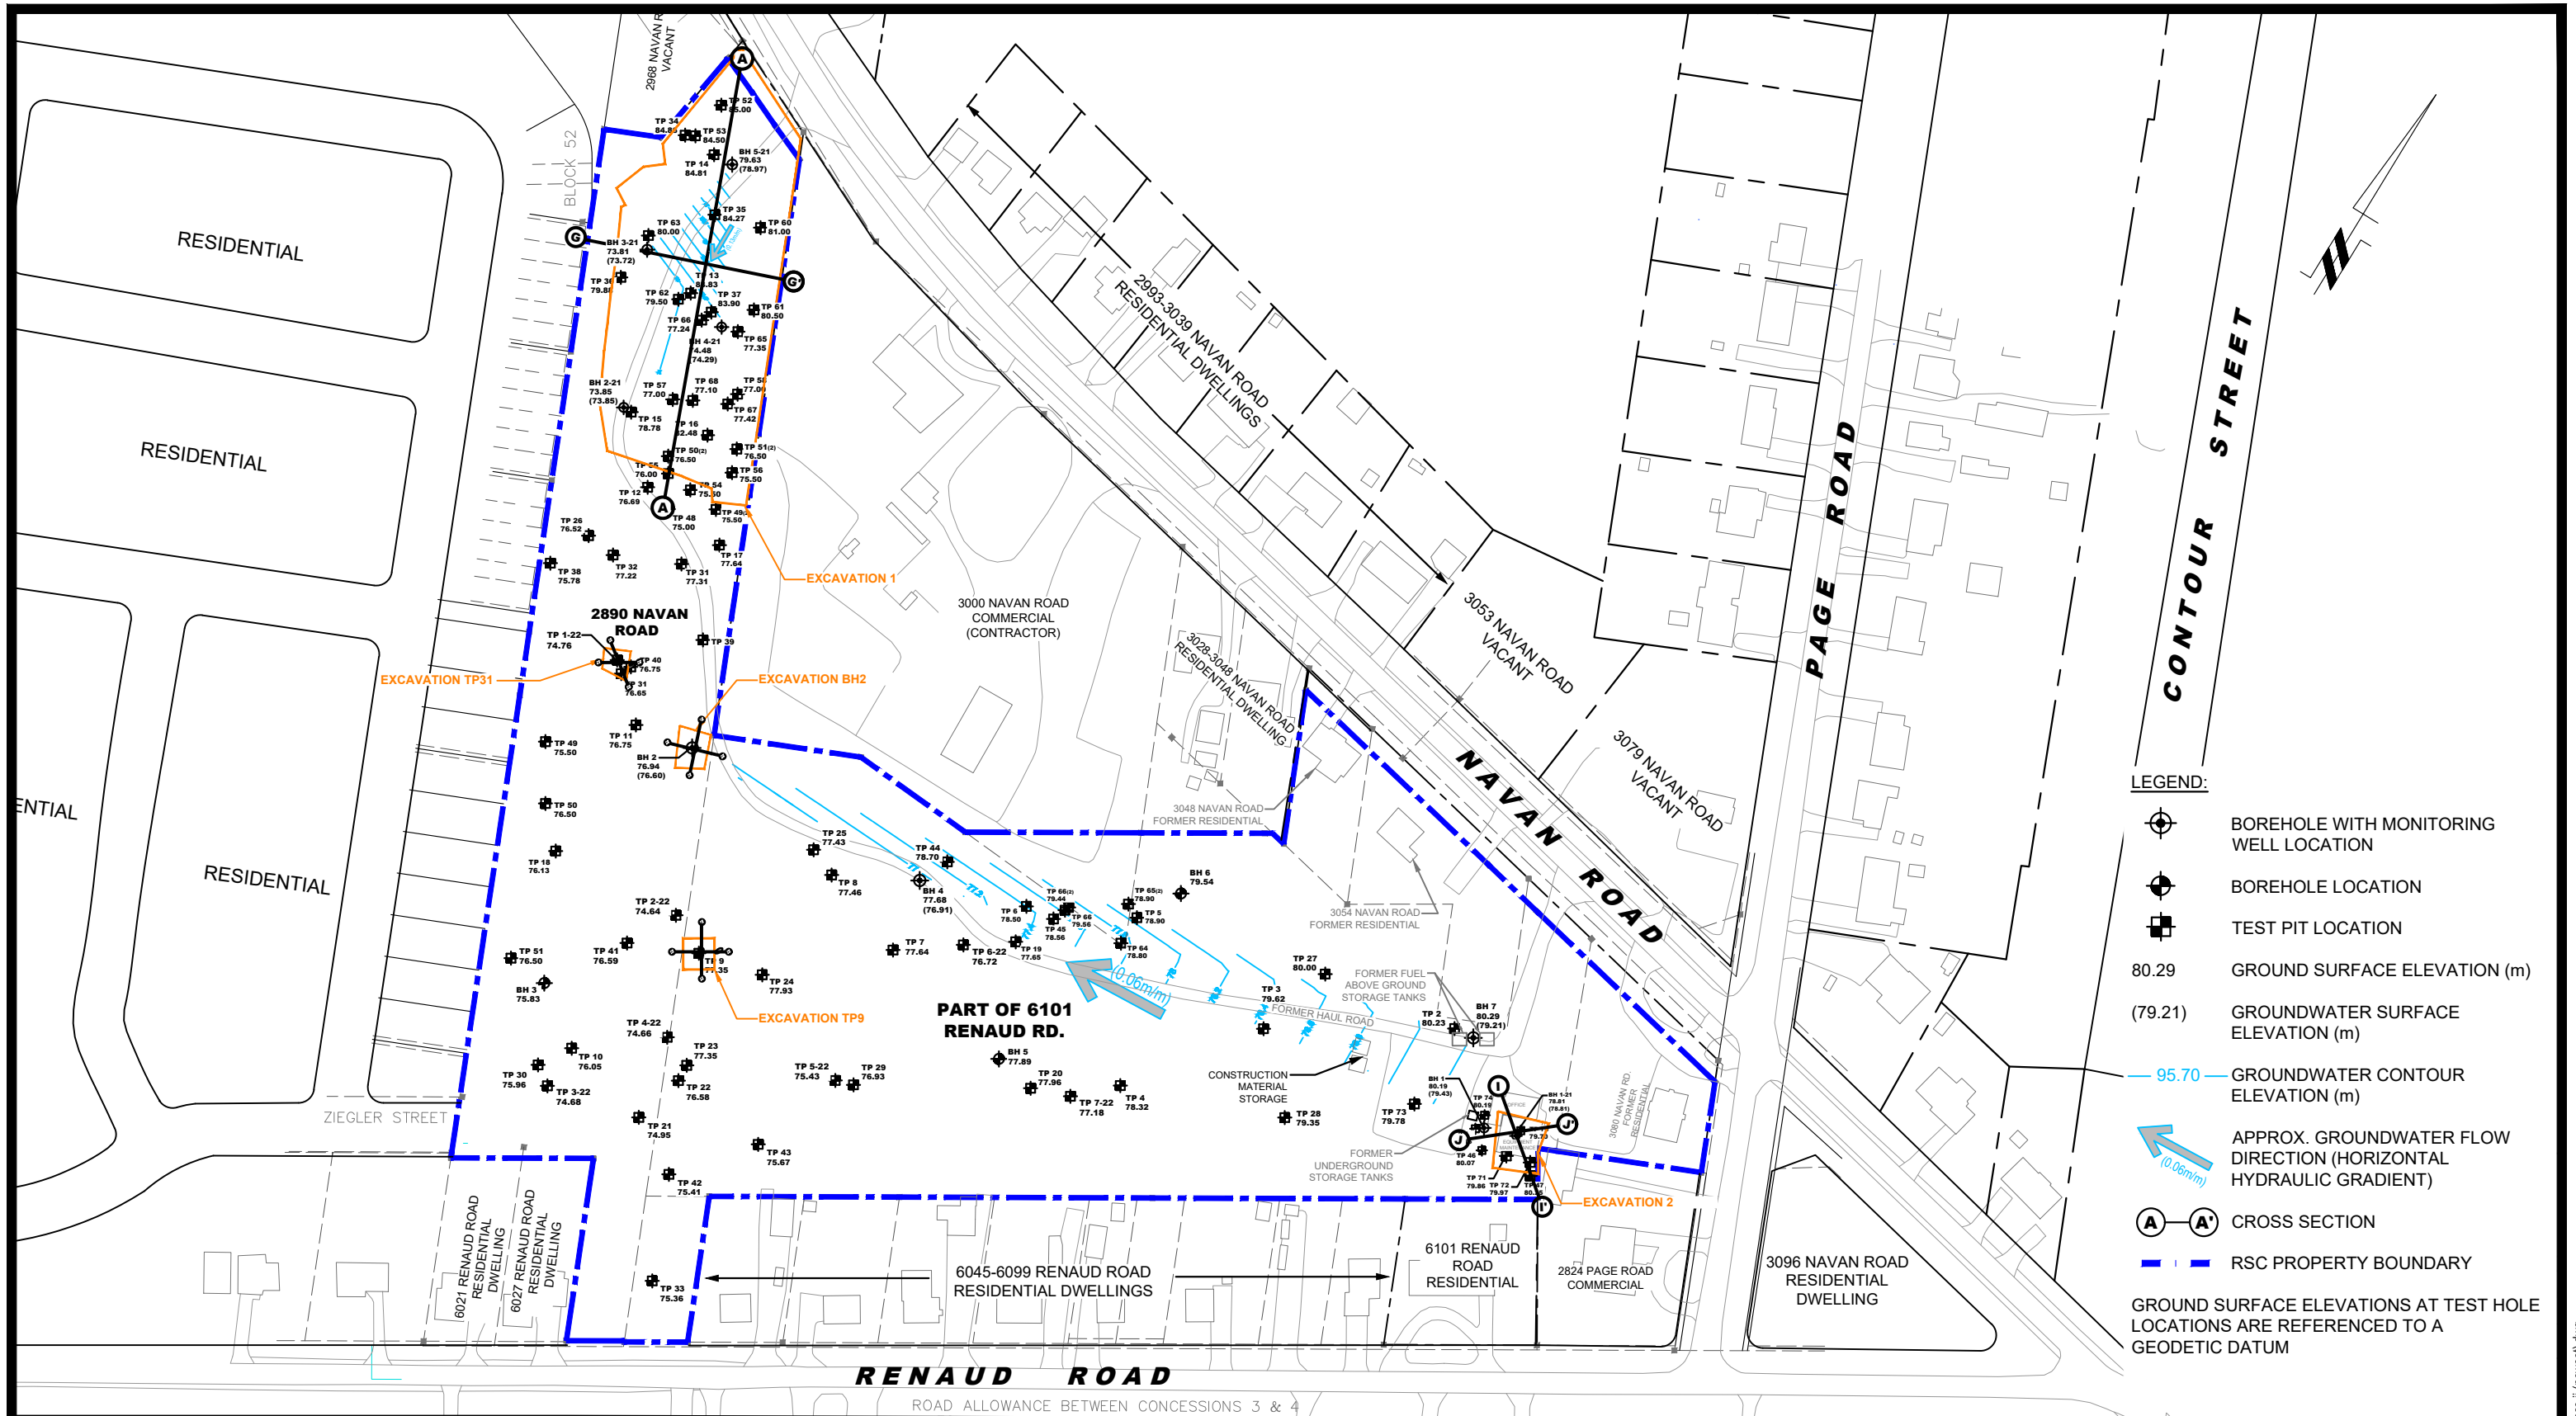
Scale: 1:1000	Report No.: PE4937
Drawn by: RG	Drawing No.:
Checked by: JC	PE4937-4
Approved by: MB	Revision No.: 0
Date: 03/2021

As shown on Drawing PE4937-4, samples from across the RSC property exceeded the Site Condition Standards (SCS) for Barium, Cobalt, and Vanadium, however the remaining metals parameters listed above only exceeded the site condition standards in the northwest corner of the RSC property.
