**PATERSON  
GROUP**

July 19, 2022  
File: PE4937-LET.04

Subject: **Phase I - Environmental Site Assessment Update  
Navan at Renaud Road  
Ottawa, Ontario**

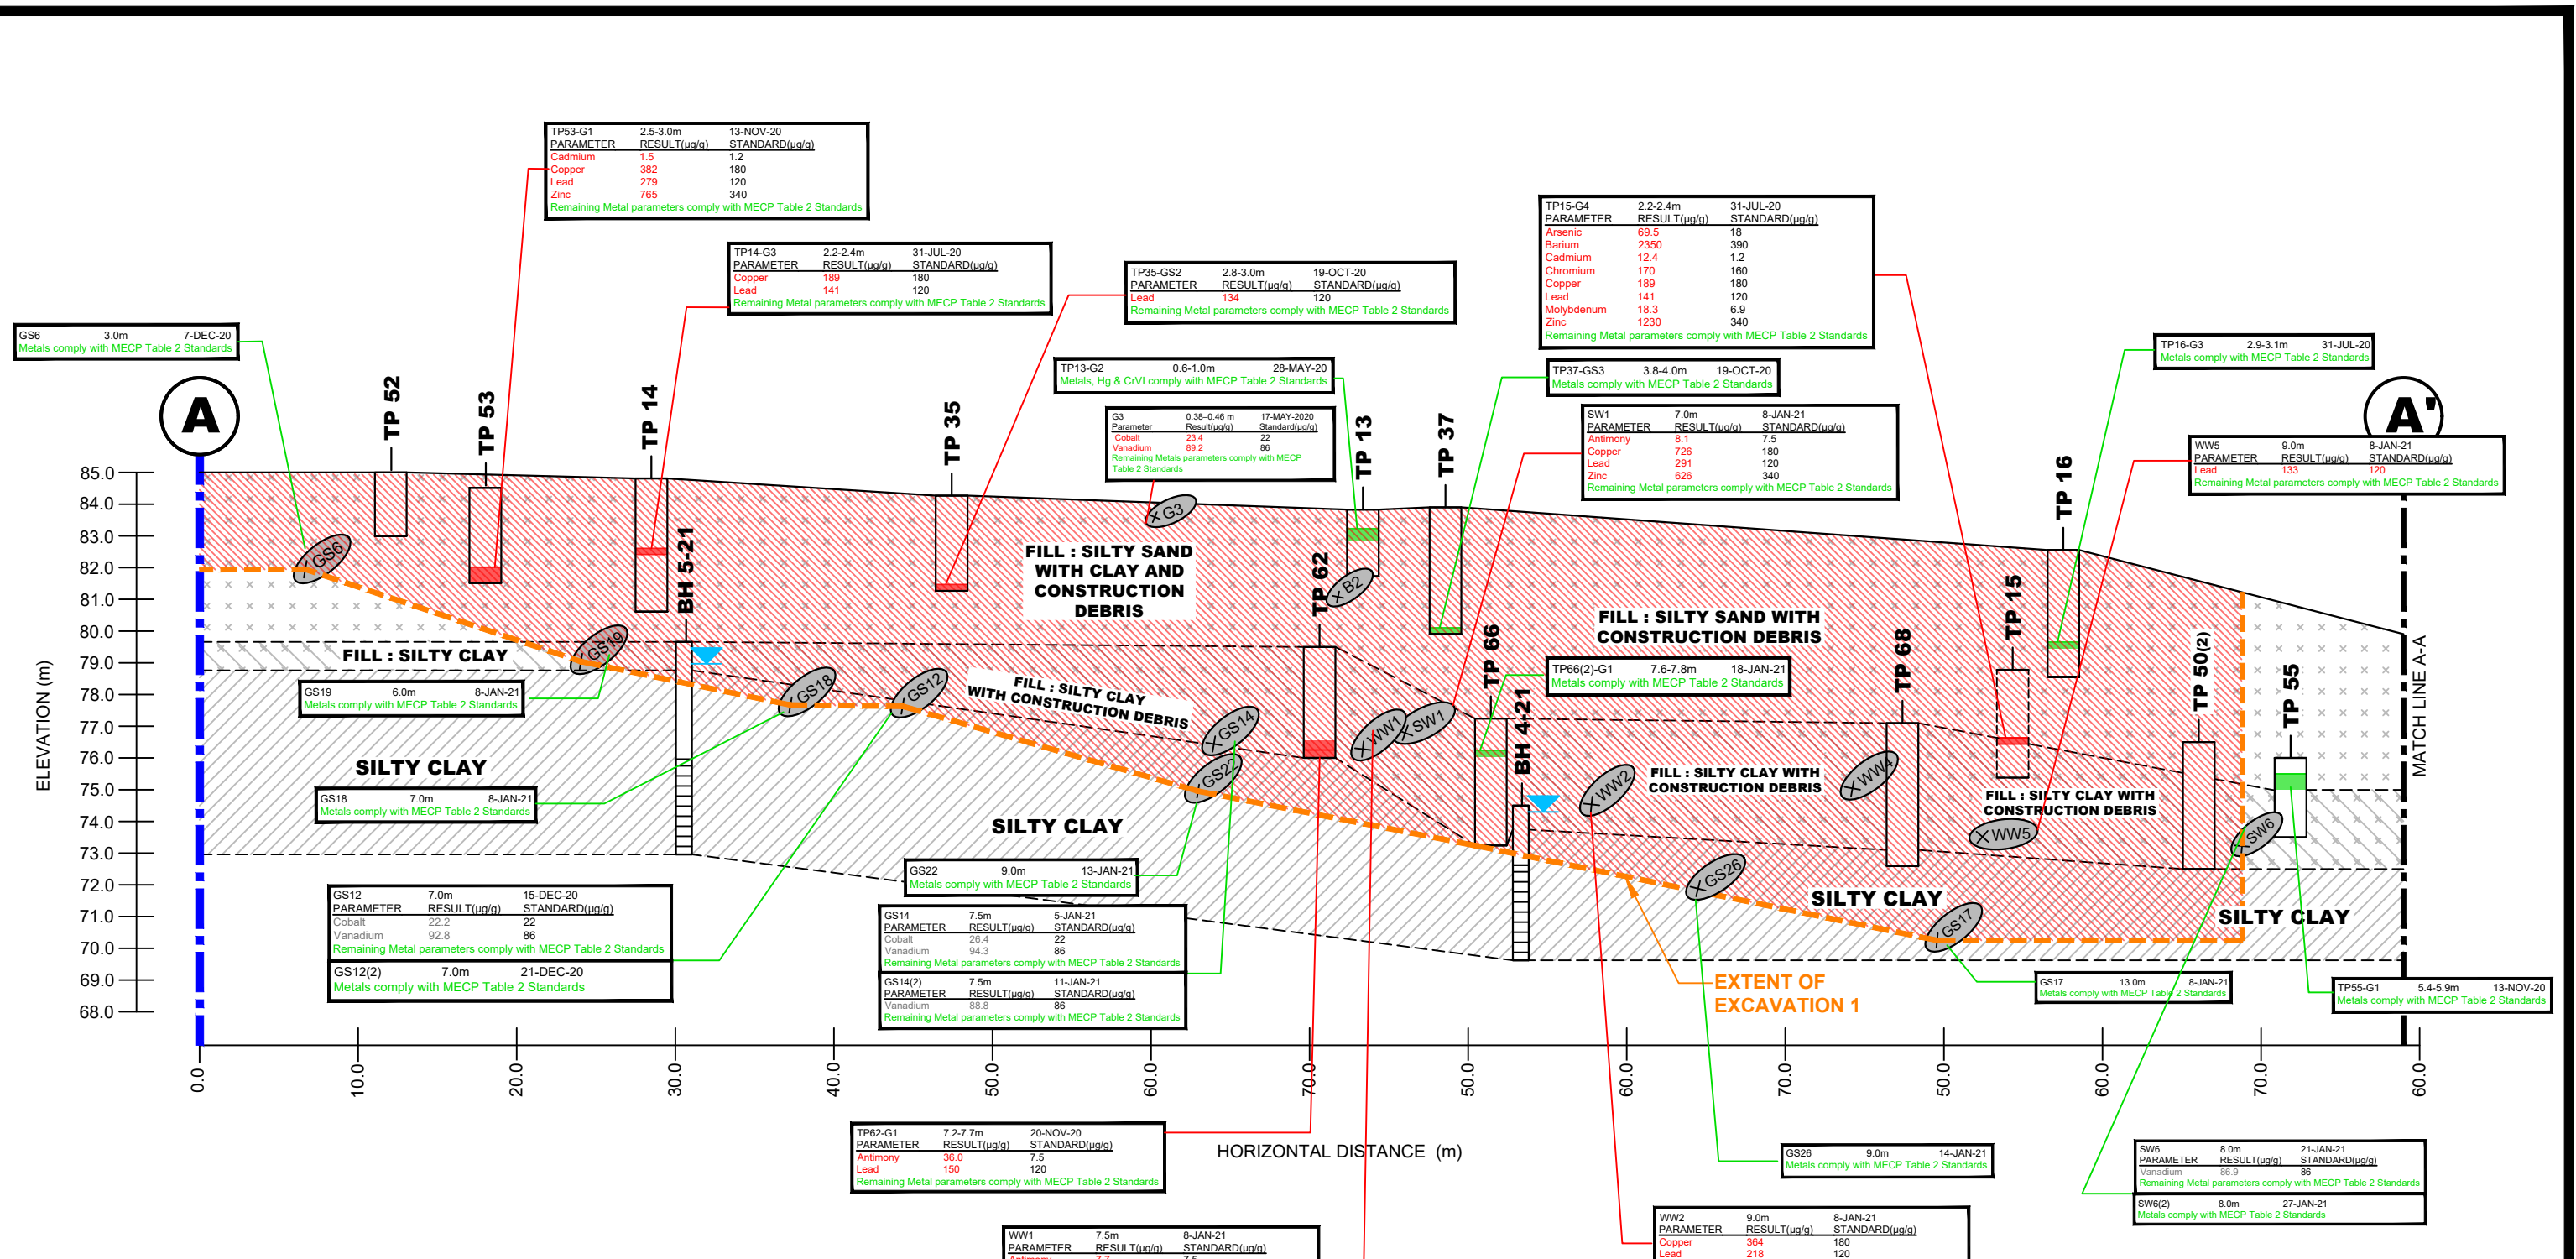
**CAIVAN COMMUNITIES**  
**PHASE II - ENVIRONMENTAL SITE ASSESSMENT**  
**RENAUD ROAD AT NAVAN ROAD**  
 OTTAWA, ONTARIO  
 Title: **CROSS SECTION A-A' - SOIL (METALS)**

APPROXIMATE EXTENT OF SOIL WITH CONCENTRATIONS OF METALS EXCEEDING THE MECP TABLE 2 STANDARDS  
 CONCENTRATIONS OF NATURALLY OCCURRING METALS EXCEEDING THE SITE CONDITION STANDARDS ARE SHOWN IN GREY AND ARE NOT CONSIDERED TO BE A CONTAMINANT.

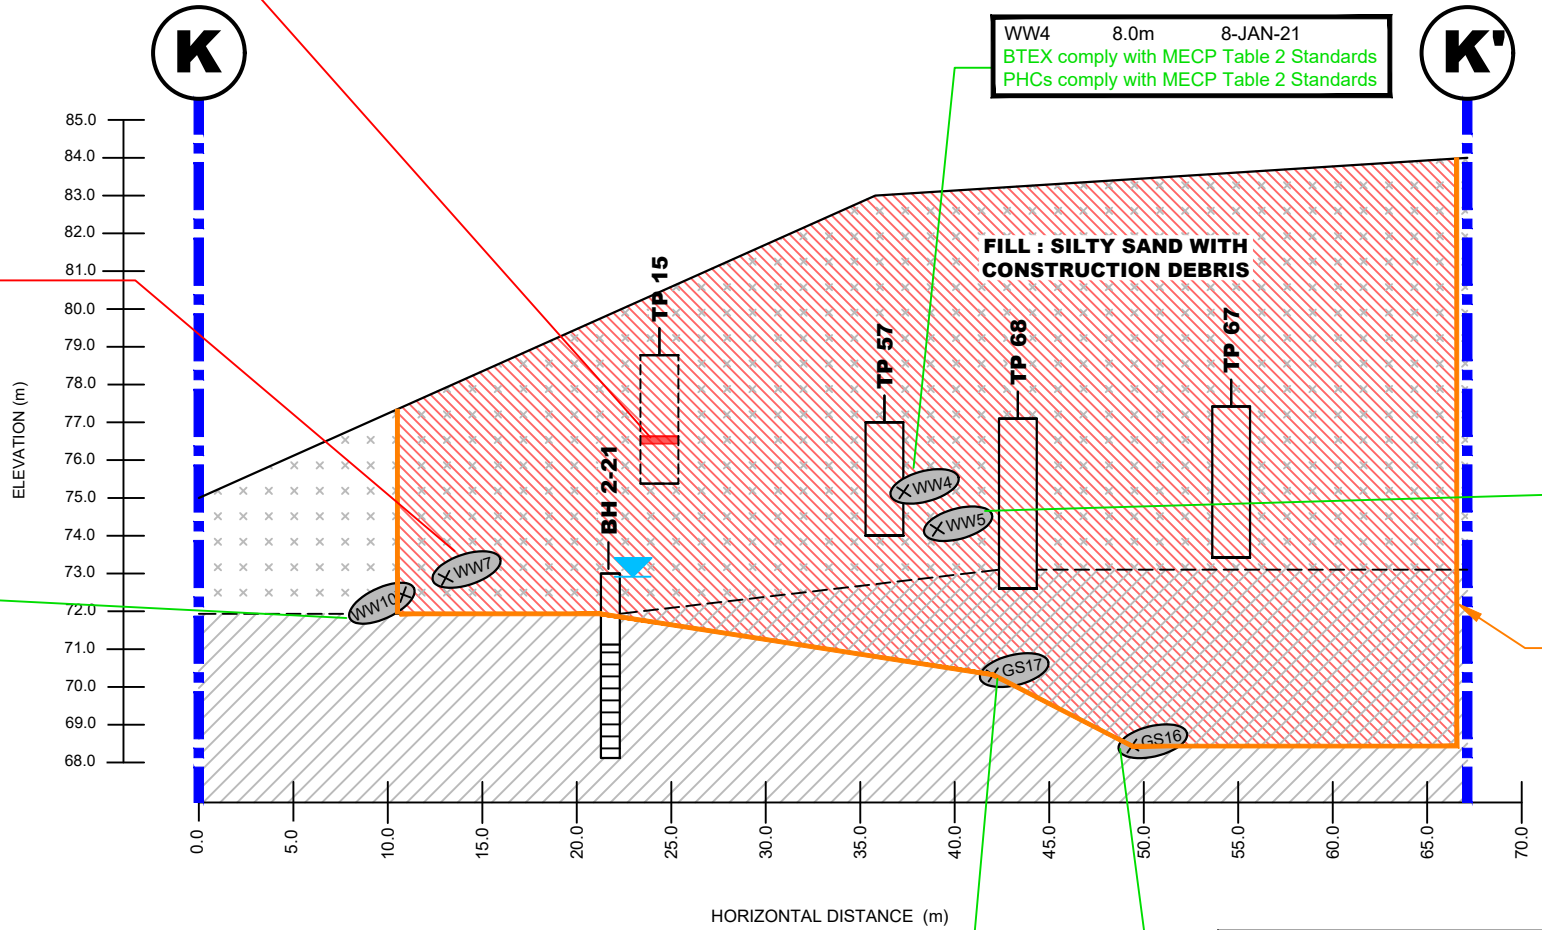
Scale:	AS SHOWN	Date:	03/2022
Drawn by:	RCG	Report No.:	PE4937-2
Checked by:	MB	Dwg. No.:	<b>PE4937-5K</b>
Approved by:	MB	Revision No.:

GS17	13.0m	8-JAN-21
BTEX comply with MECP Table 2 Standards		
PHCs comply with MECP Table 2 Standards

GS16	15.0m	8-JAN-21
BTEX comply with MECP Table 2 Standards		
PHCs comply with MECP Table 2 Standards

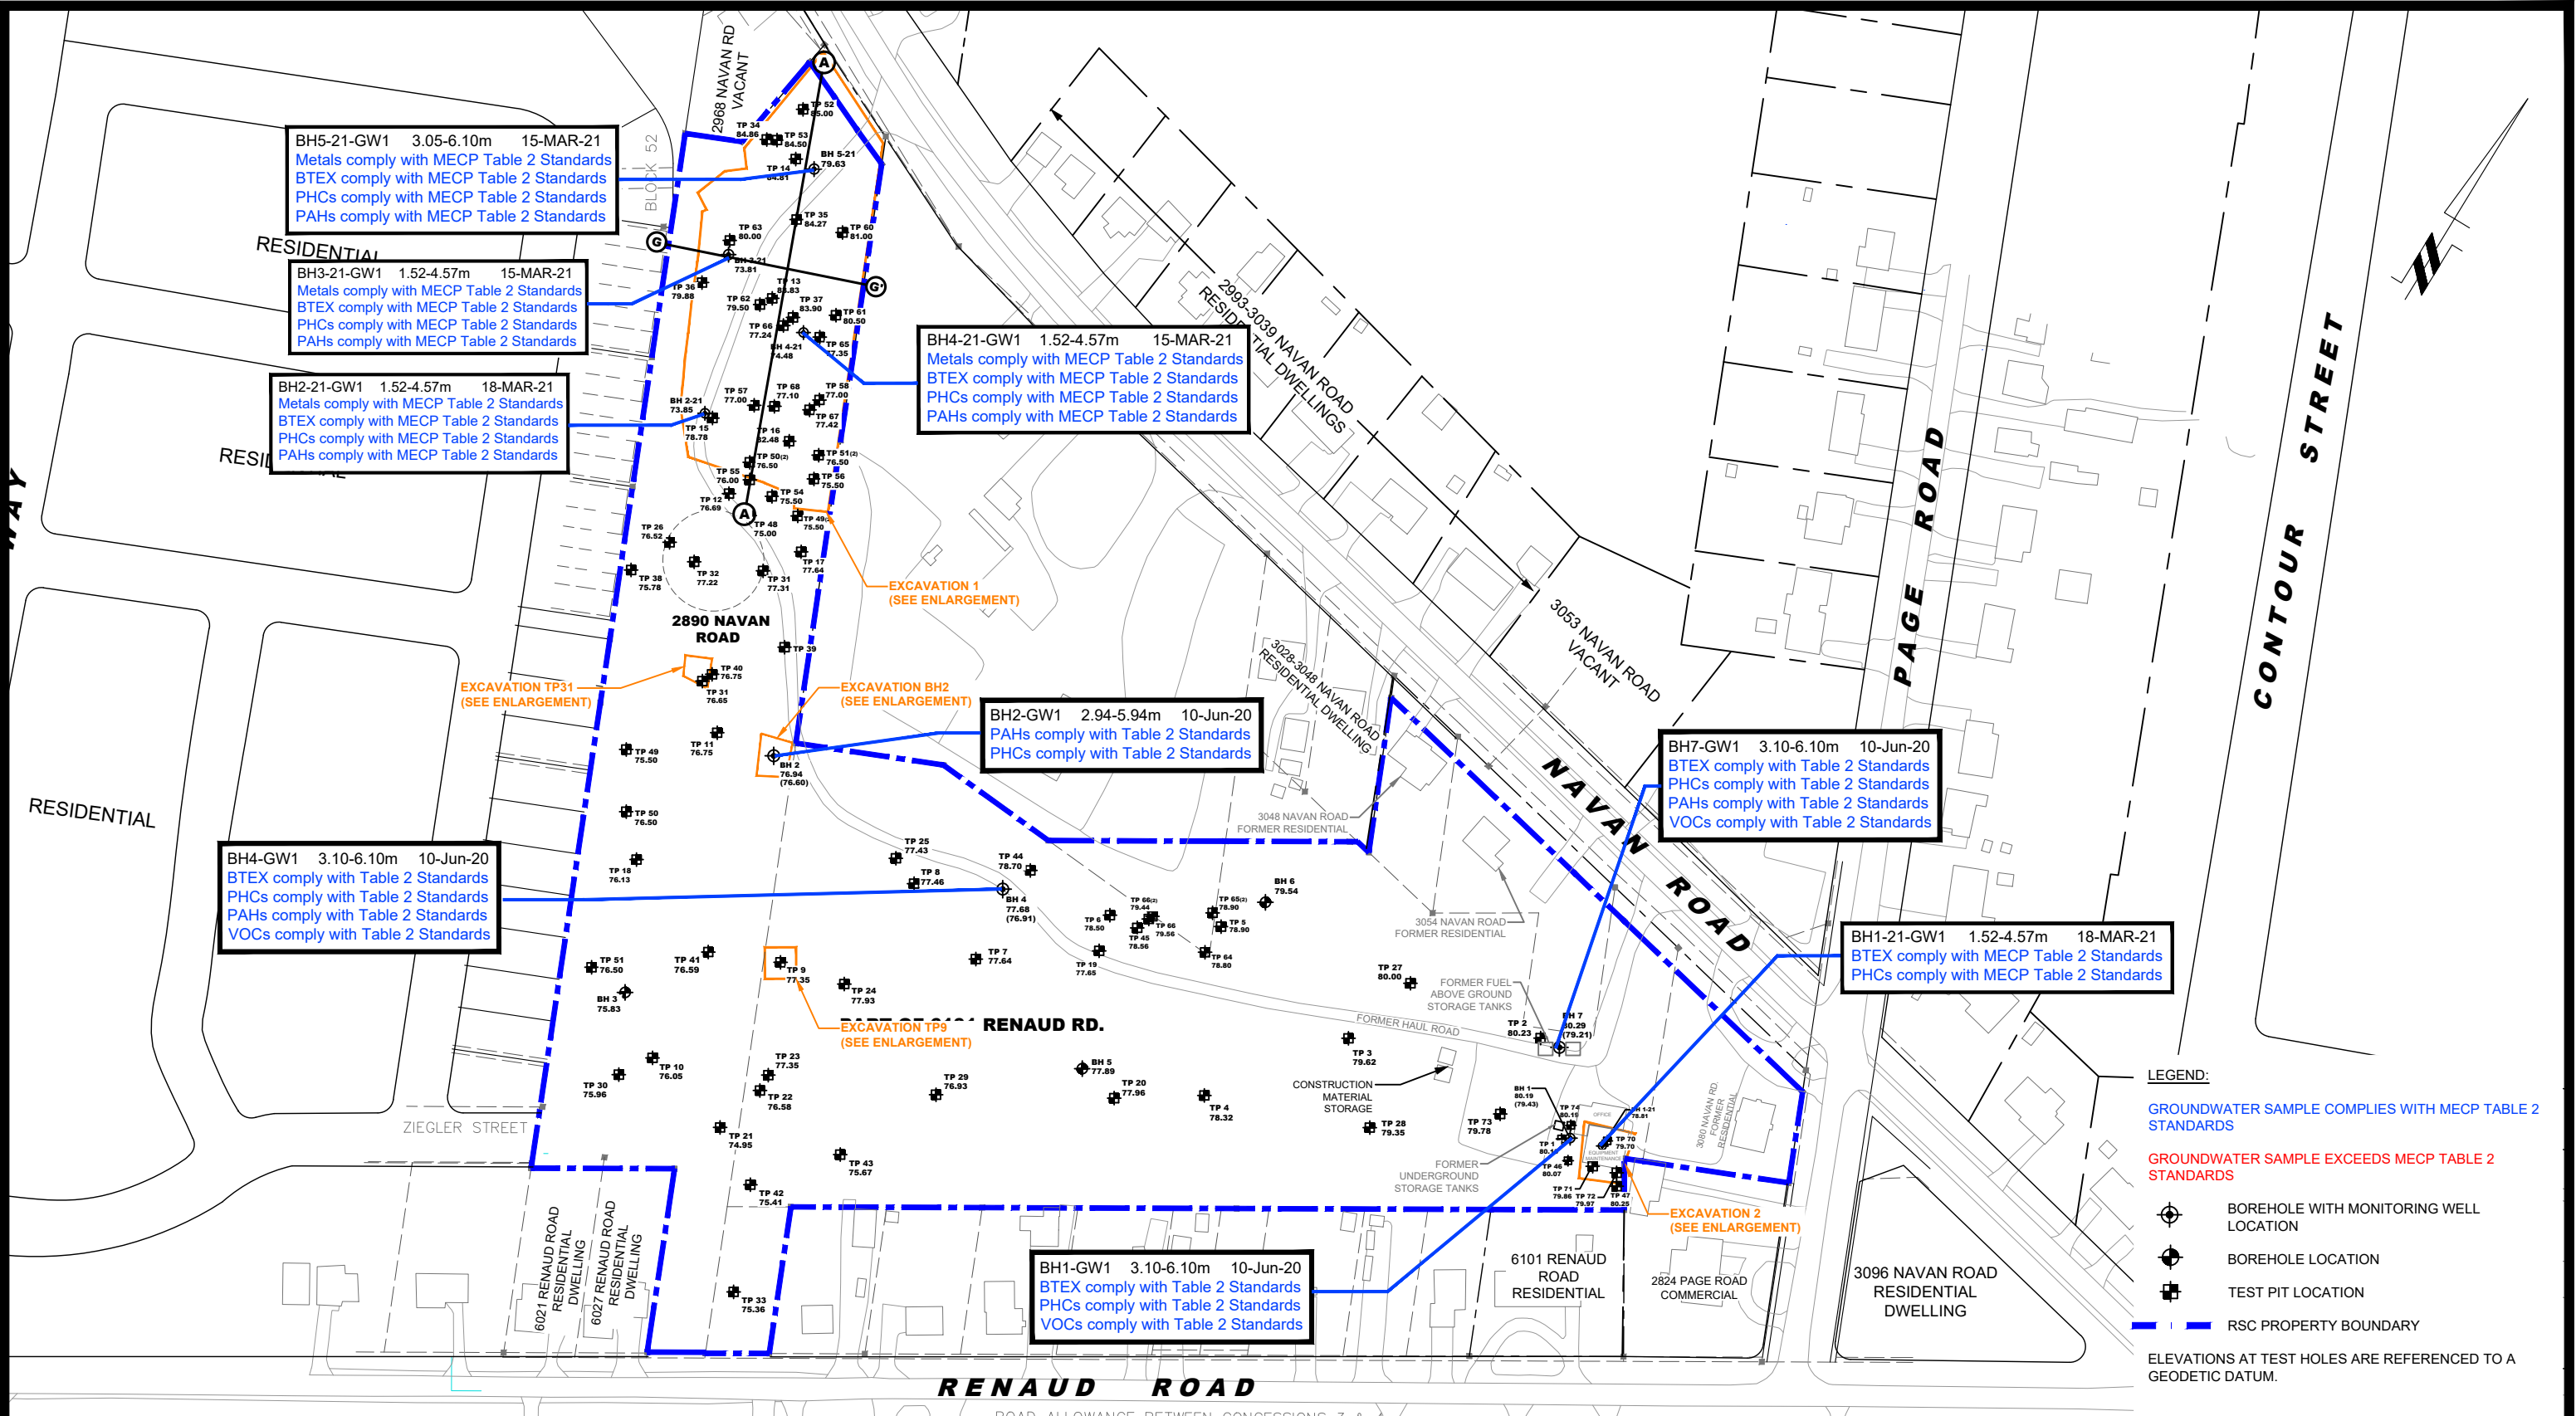
Scale:	1:2000	Date:	03/2022
Drawn by:	YA	Report No.:	PE4937-2
Checked by:	MB	Dwg. No.:	<b>PE4937-7</b>
Approved by:	MB	Revision No.:

**BH5-21-GW1** 3.05-6.10m 15-MAR-21  
 Metals comply with MECP Table 2 Standards  
 BTEX comply with MECP Table 2 Standards  
 PHCs comply with MECP Table 2 Standards  
 PAHs comply with MECP Table 2 Standards

**BH3-21-GW1** 1.52-4.57m 15-MAR-21  
 Metals comply with MECP Table 2 Standards  
 BTEX comply with MECP Table 2 Standards  
 PHCs comply with MECP Table 2 Standards  
 PAHs comply with MECP Table 2 Standards

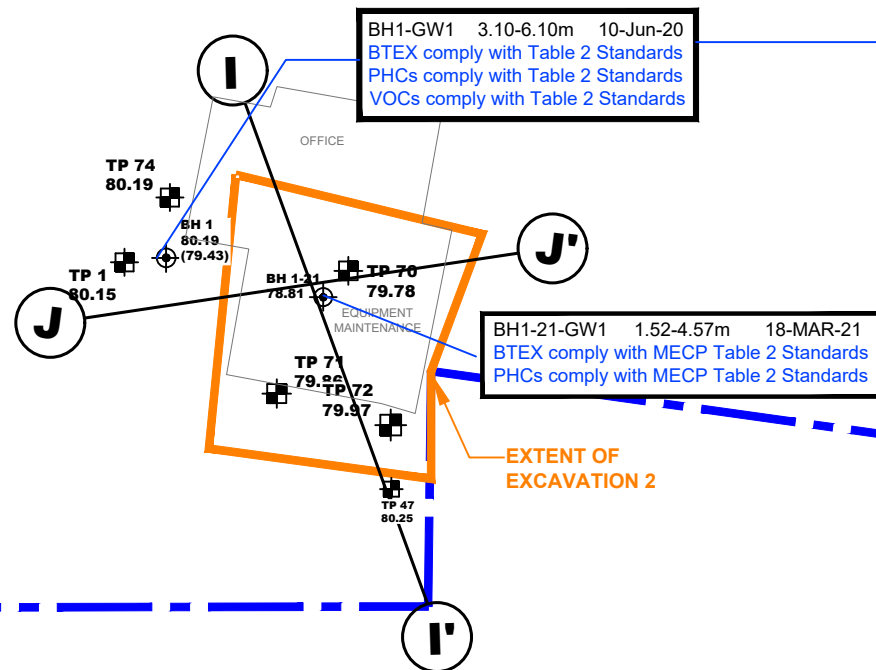
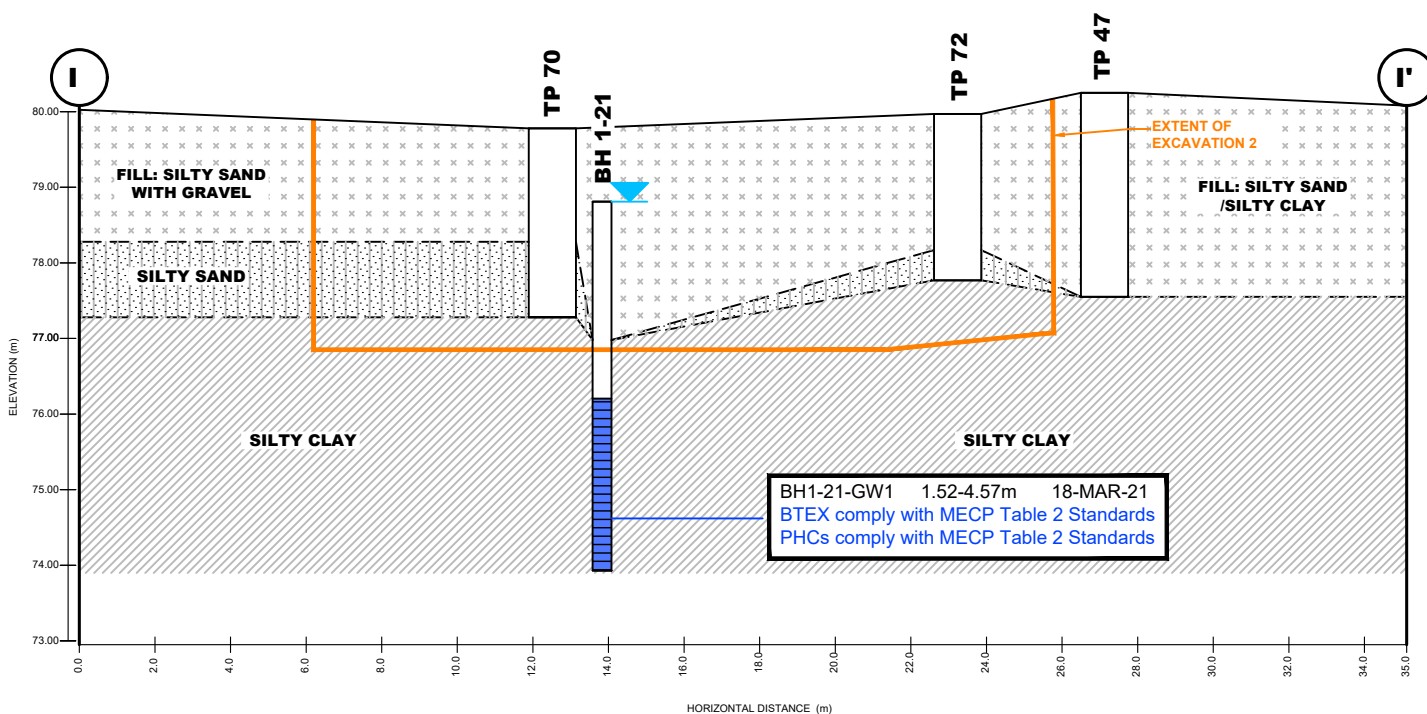
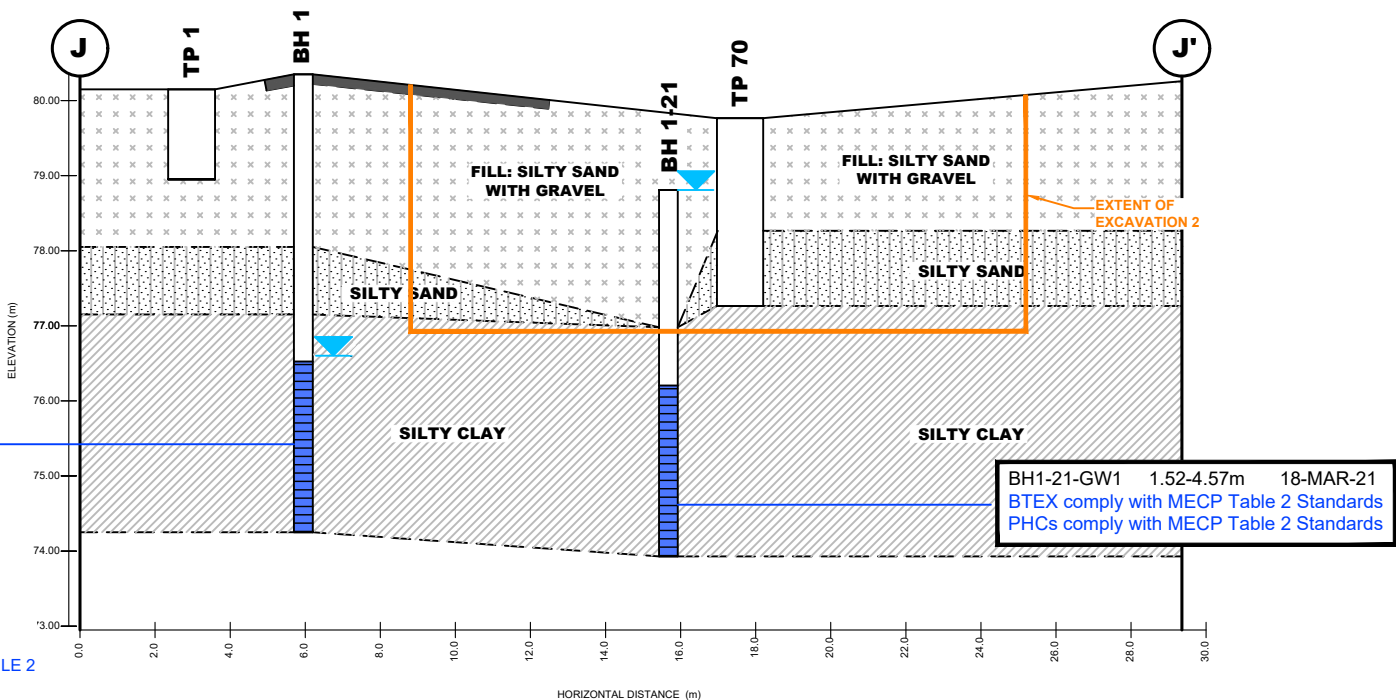
**BH1-GW1** 3.10-6.10m 10-Jun-20  
BTEX comply with Table 2 Standards  
PHCs comply with Table 2 Standards  
VOCs comply with Table 2 Standards

**BH1-21-GW1** 1.52-4.57m 18-MAR-21  
BTEX comply with MECP Table 2 Standards  
PHCs comply with MECP Table 2 Standards
