June 5, 2023

RE: TREE CONSERVATION REPORT FOR 400 COVENTRY ROAD, OTTAWA

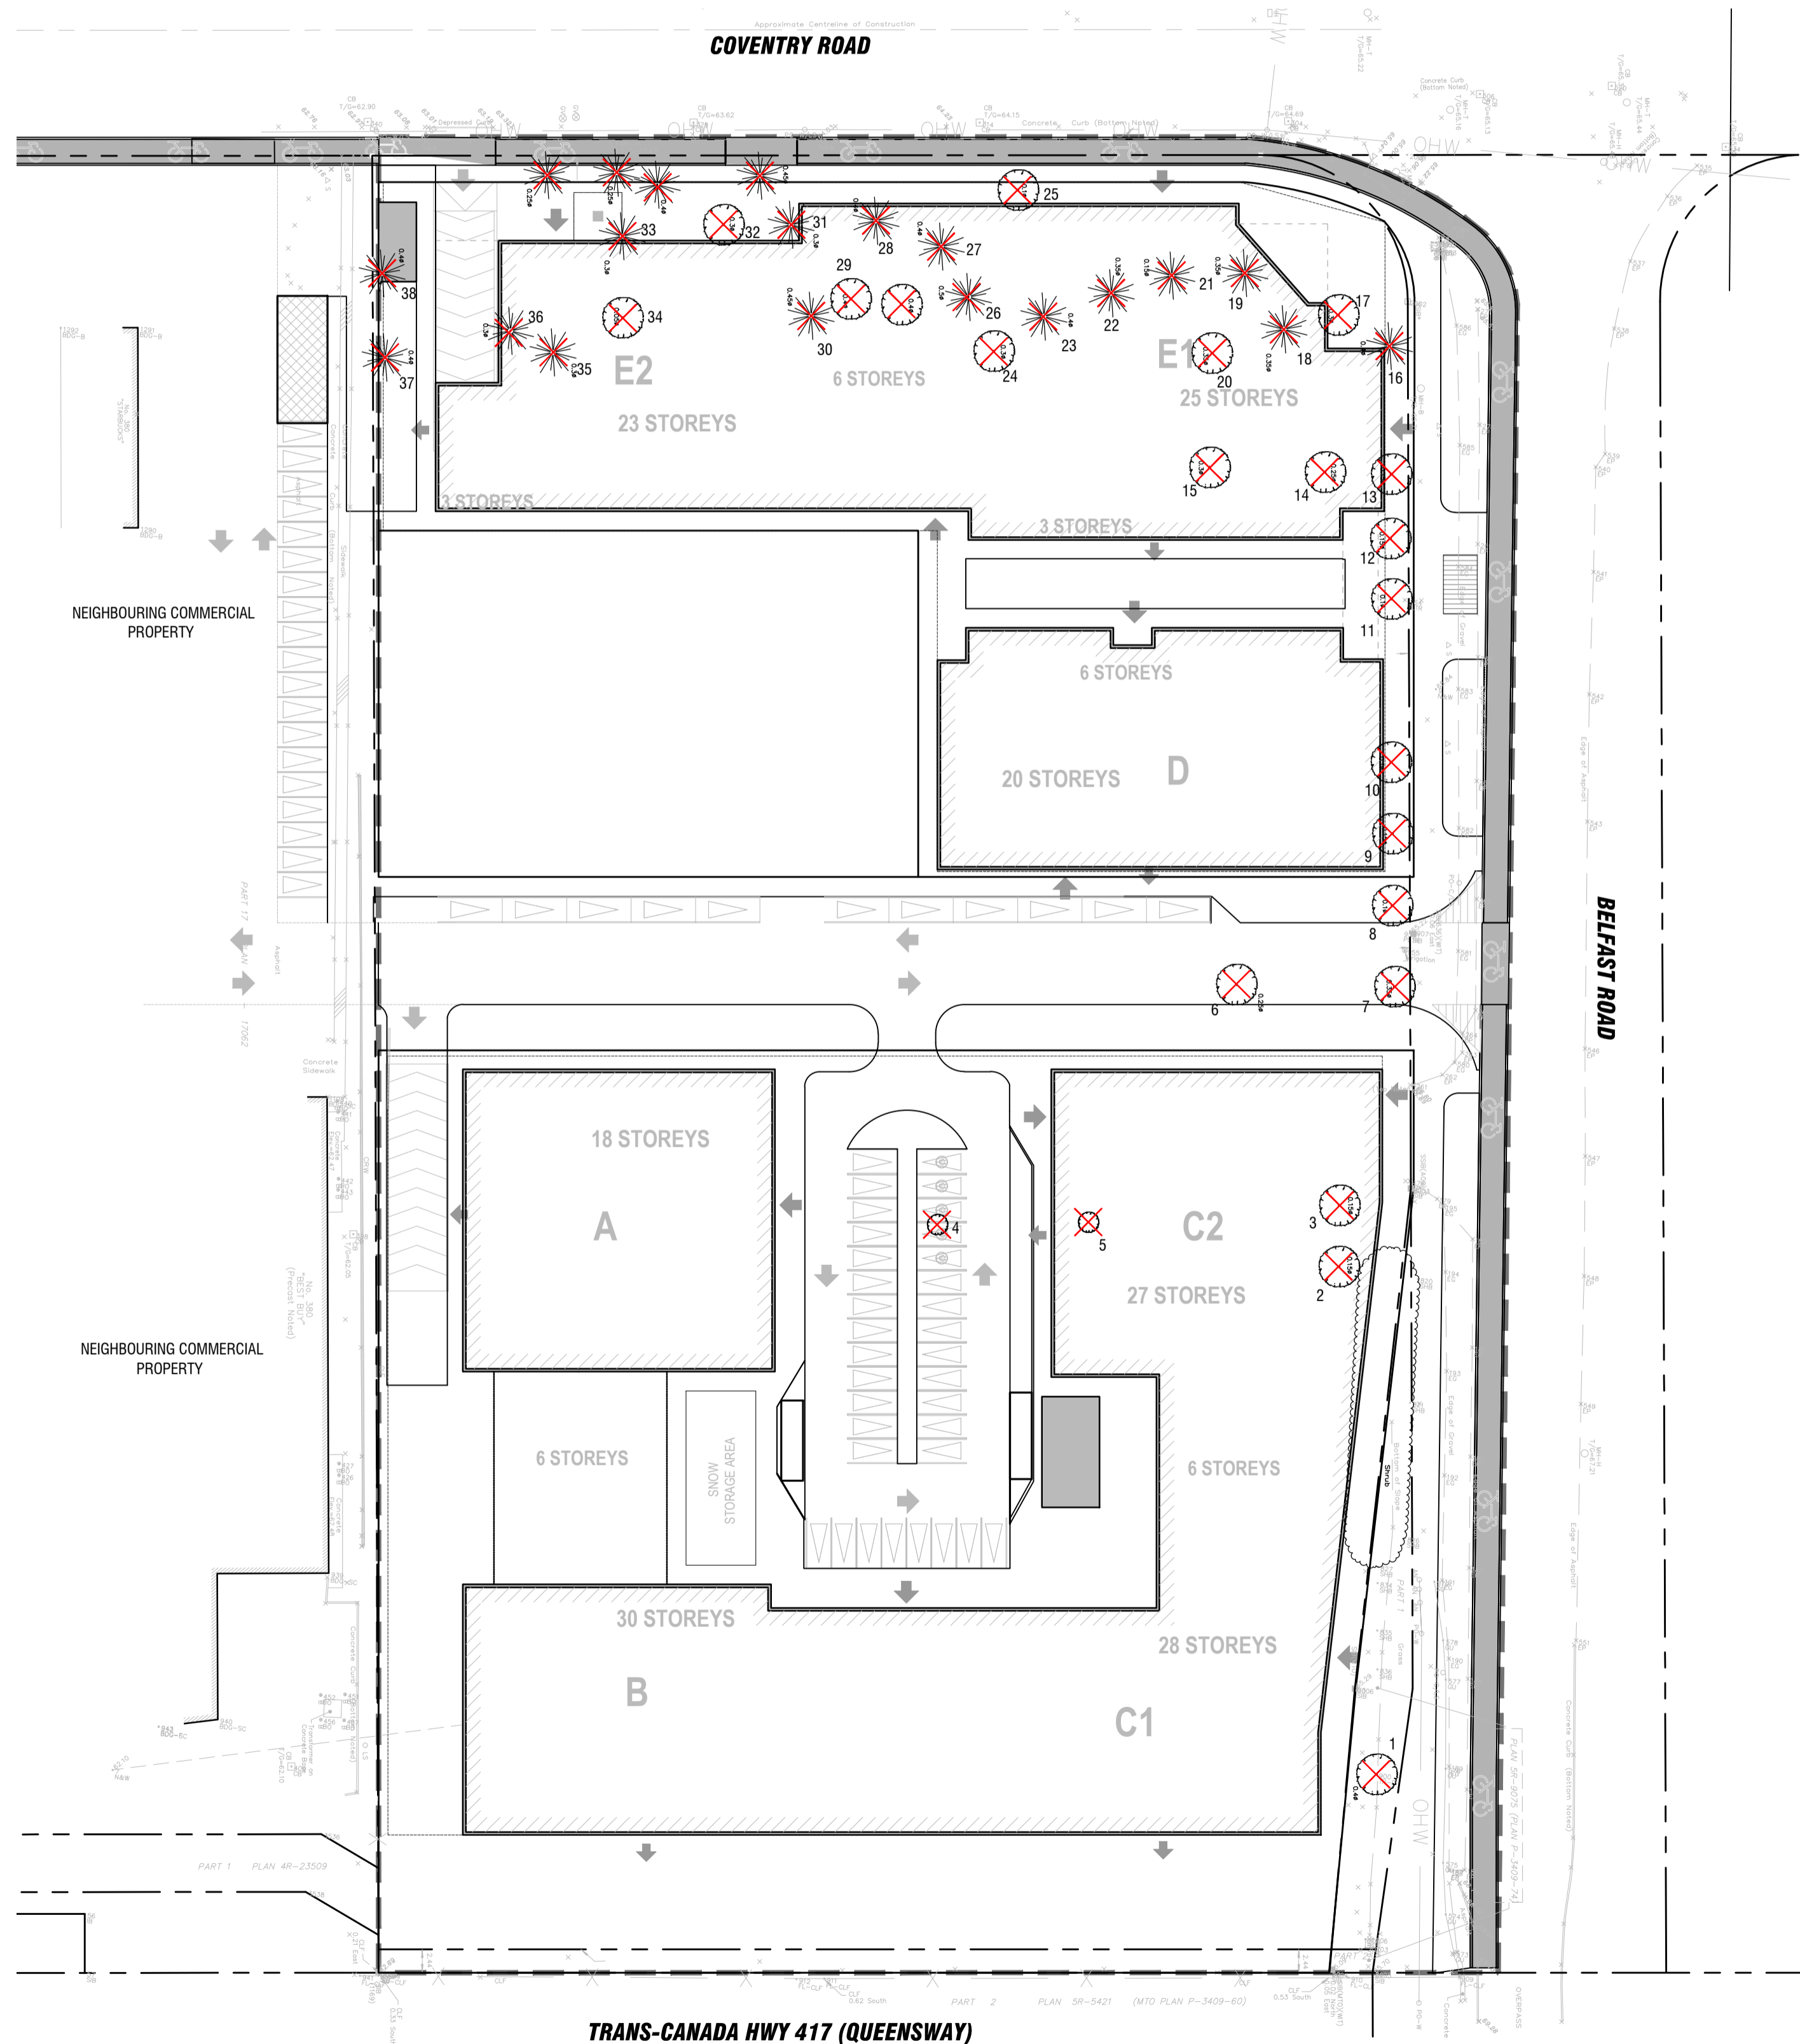
1 TREE CONSERVATION PLAN
L1 1:500

- REFER TO THE TREE CONSERVATION REPORT PREPARED BY IFS ASSOCIATES FOR CORRESPONDING TREE #, SPECIES, CONDITION, OWNERSHIP, REMOVAL STATUS AND PRESERVATION TECHNIQUES;
- DO NOT SCALE DRAWINGS;
- NOTES ARE APPLICABLE TO ALL DRAWINGS IN THE SET;
- Fotenn Consultants Inc. IS NOT RESPONSIBLE FOR ACCURACY OF BASE INFORMATION;
