Muncaster  
Environmental  
Planning Inc.

**RE: 2983 Navan Road (at Brian Coburn Boulevard)**  
**Block 16 (Gas Station) - Review of Boundary Trees - Updated**

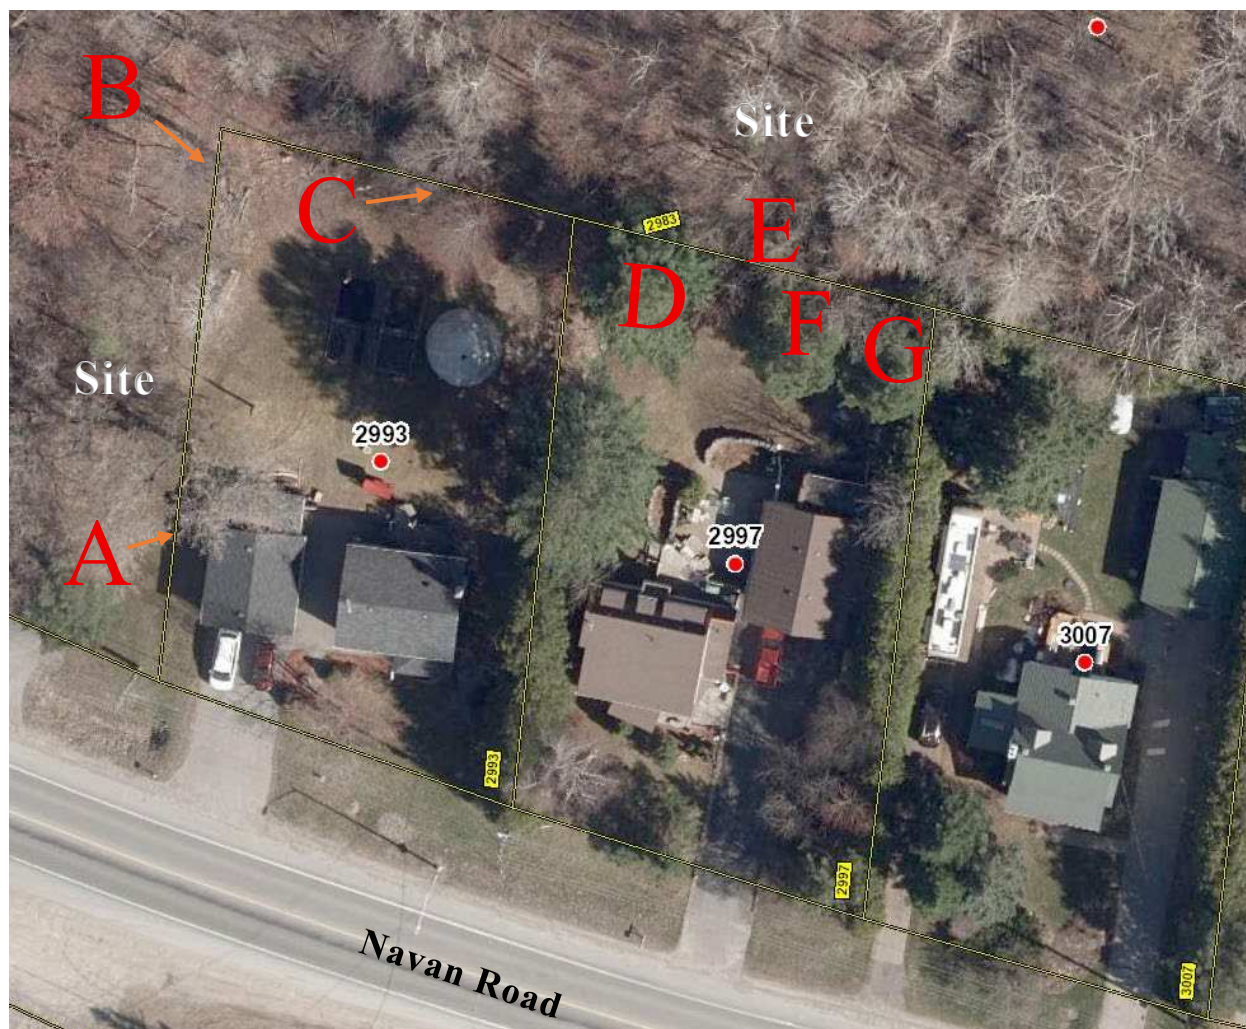
Map 1 – Location of Trees Described in Table 1

| Tree Letter | Species | dbh (cm) | Condition and Comments | Location |
|---|---|---|---|---|
| A | Manitoba maple<br>(Photos 1, 2, and 3) | 50 and 56 | Twin stem. Major trunk damage at base of east stem but leaf-out is good. The dominant leaders are in good condition for a mature Manitoba maple. Adjacent property owner prefers retention of the tree. No root exposure of note following adjacent initial regrading on site. Gravel fill from the adjacent development property surrounds the trunk (Photo 1), with minor trunk damage at base | Co-owned. Silt fencing to the west of the tree |
| B | Red maple | 42 | Appears to be in good condition, with good leaf-out. Protected with silt fencing during initial regrading and no root exposure of note observed. | On-site, to be removed (Photo 4) |

| Tree Letter | Species | dbh (cm) | Condition and Comments | Location |
|---|---|---|---|---|
| E | Manitoba maple | 18 | Good leaf-out and appears to be in good condition | On-site, to be removed |
| G | Scot's pine (Photo 7) | 40 | Good needle coverage and structure, with some trunk leaning. No root exposure of note after adjacent on-site initial regrading | 3cm south of site, with additional 70cm to silt fencing |
