Landslide Hazard Assessment

Proposed Residential Development

2983, 3053 and 3079 Navan Road
Ottawa, Ontario

Report PG6142-1 Revision 2 dated January 30, 2025

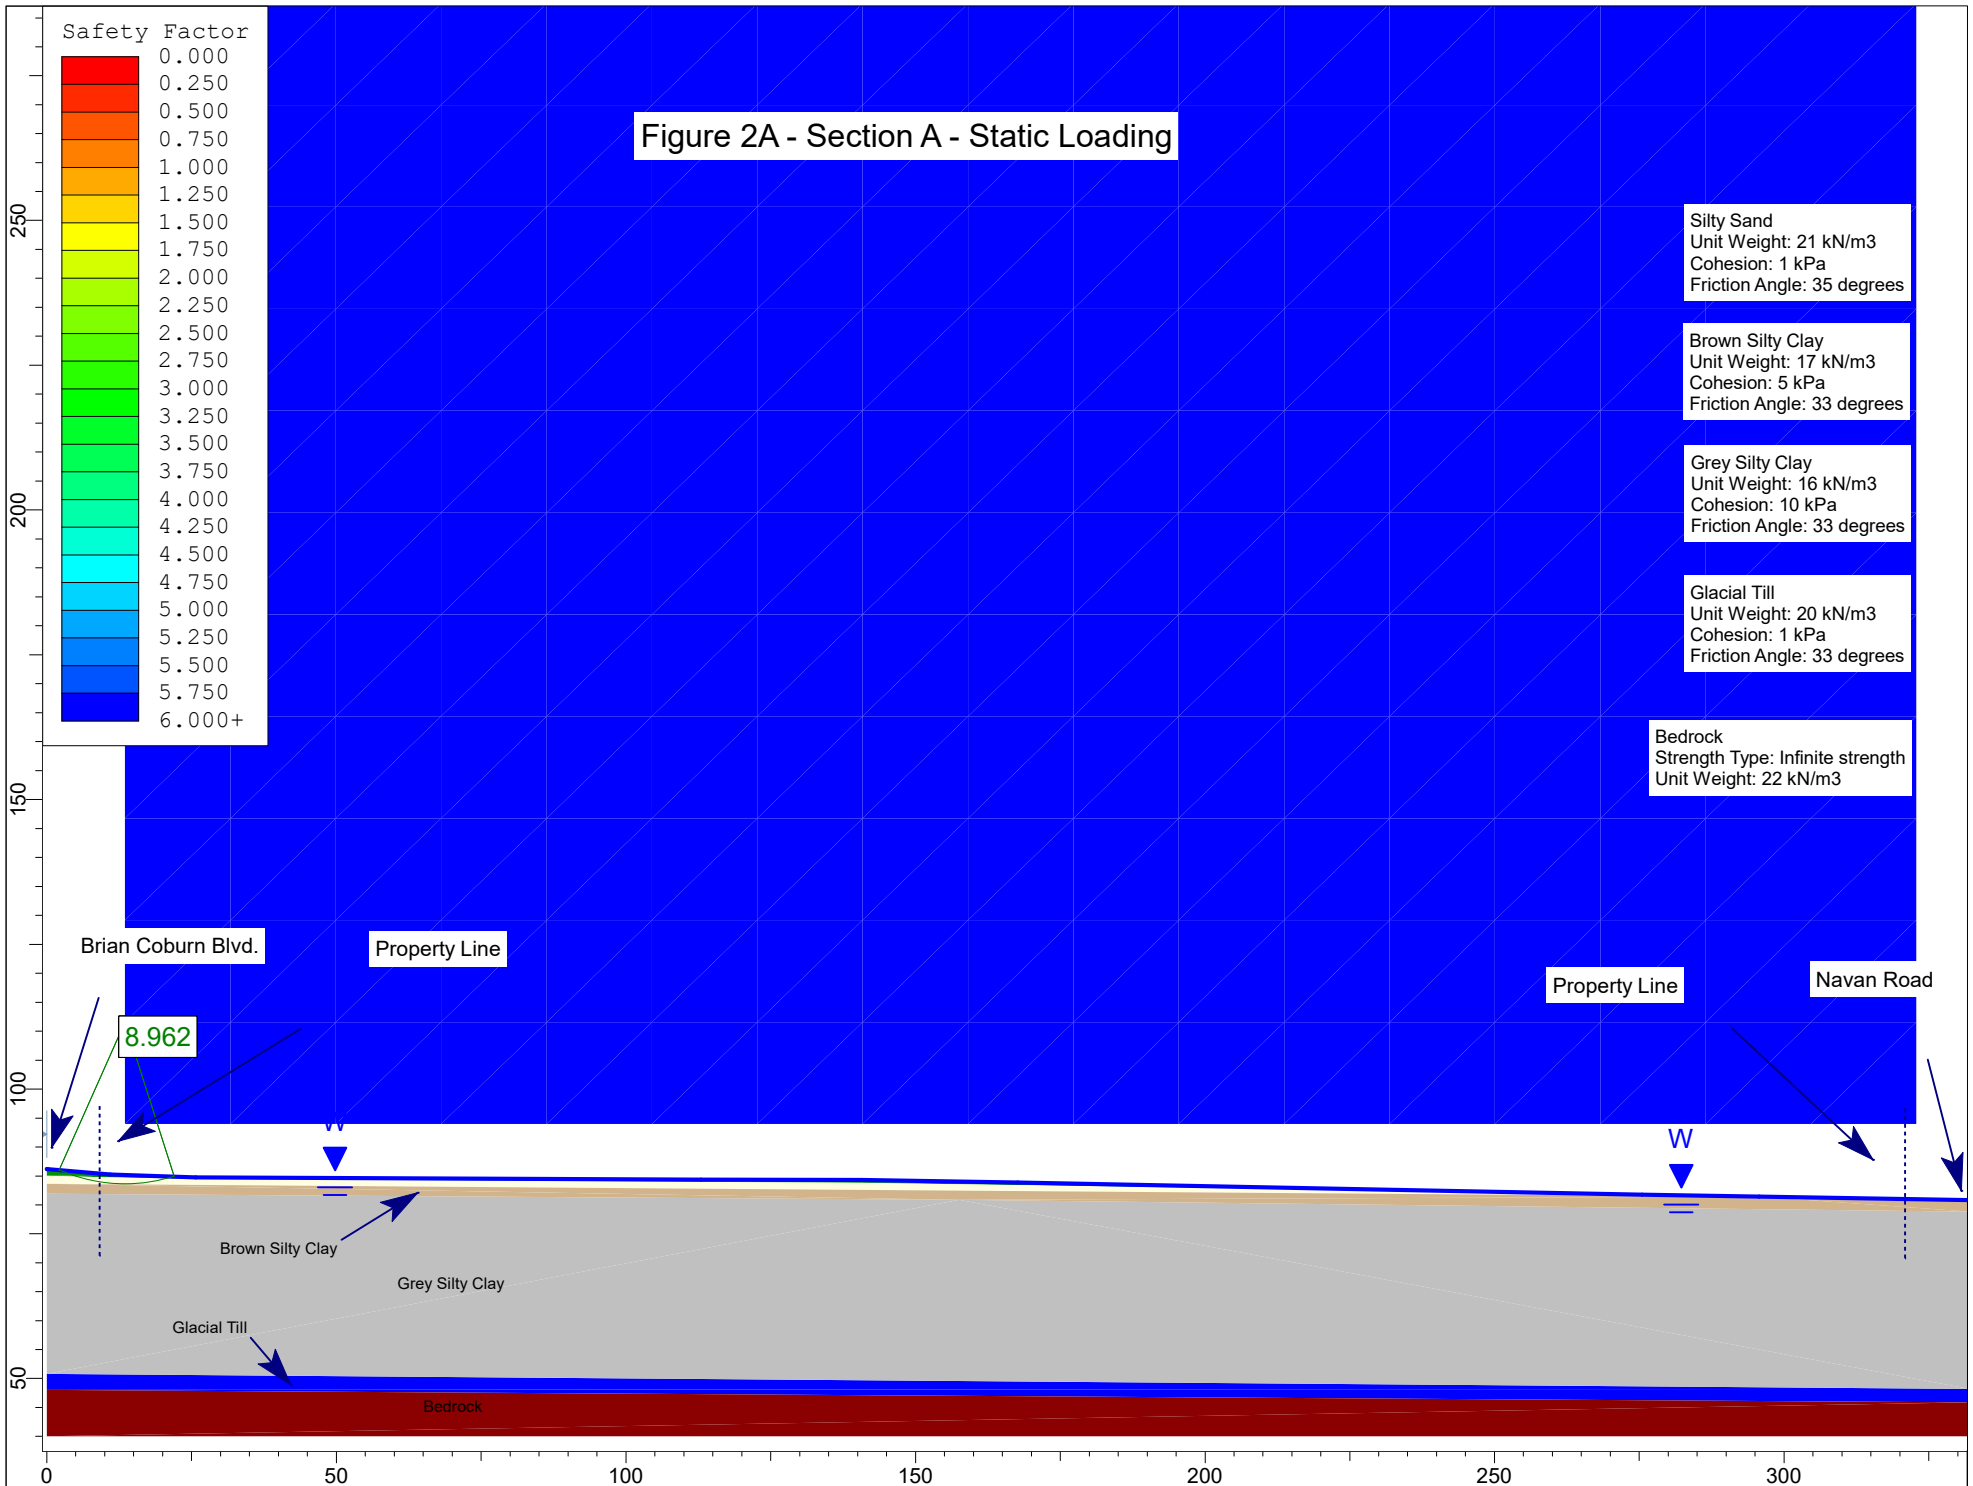
The results of the static analysis for the proposed slope under fully saturated conditions (worst-case-scenario) are shown in Figure 2A and 3A attached to the current report. The minimum analysed slope stability factor of safety under fully saturated conditions (worst case scenario) were calculated to be greater than 1.5.
