ADDENDUM #1: CONSERVATION PLAN

John Stewart Commonwealth
June 20, 2024

1.0 CONSERVATION PLAN FOR 168 & 174 MURRAY STREET

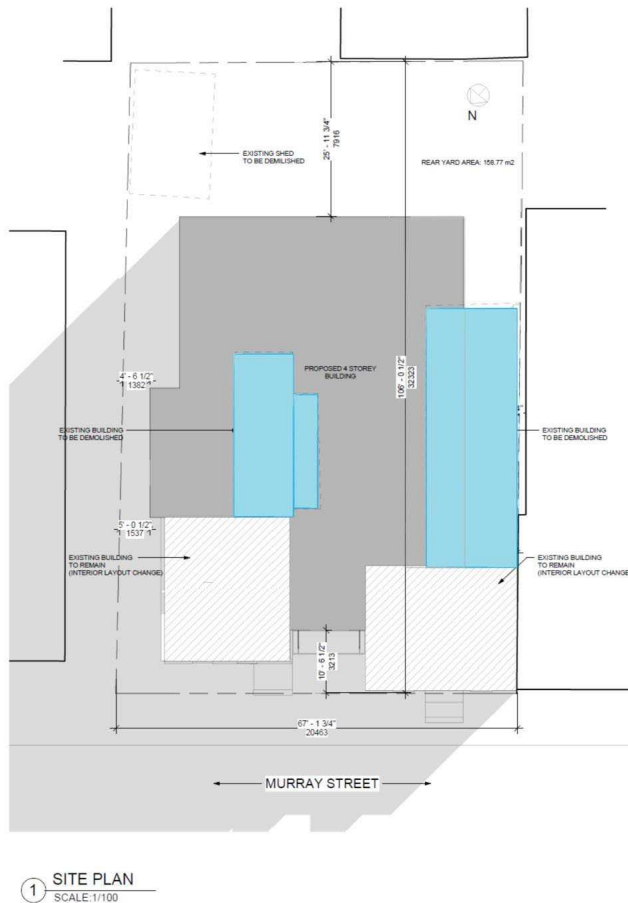
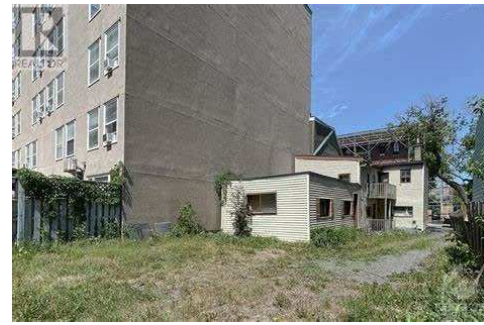
Figure 2: Preliminary site plan of the proposed development. The footprints of the existing buildings have a floor plate of approximately 500sq.ft. (48msq.). Note the relationship of the building at 168 Murray with the adjacent two-storey row house, illustrating the development footprint. The two existing buildings are rendered in light grey, and the rear sections that will be demolished are in blue. The 4-storey apartment block appears as a darker grey.

Demolition is not considered a conservation activity and will be limited to the removal of the rear additions of both buildings and the removal of the second storey at 168 Murray Street and re-roofed with a 1.5 side gable. Figure 2 delineates structures that will be demolished (shown in turquoise); they are both in poor condition. They will be replaced with the 4-storey apartment shown in the darker grey.

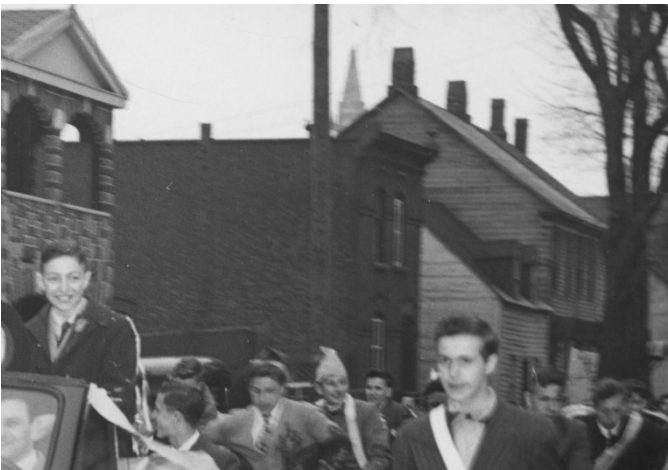
Figure 8: A c. 1949 picture with the two houses in the background clearly documents the brick siding of 174 Murray Street and the cottage form of the neighbouring 168 Murray. Source: Marc Aubin's collection

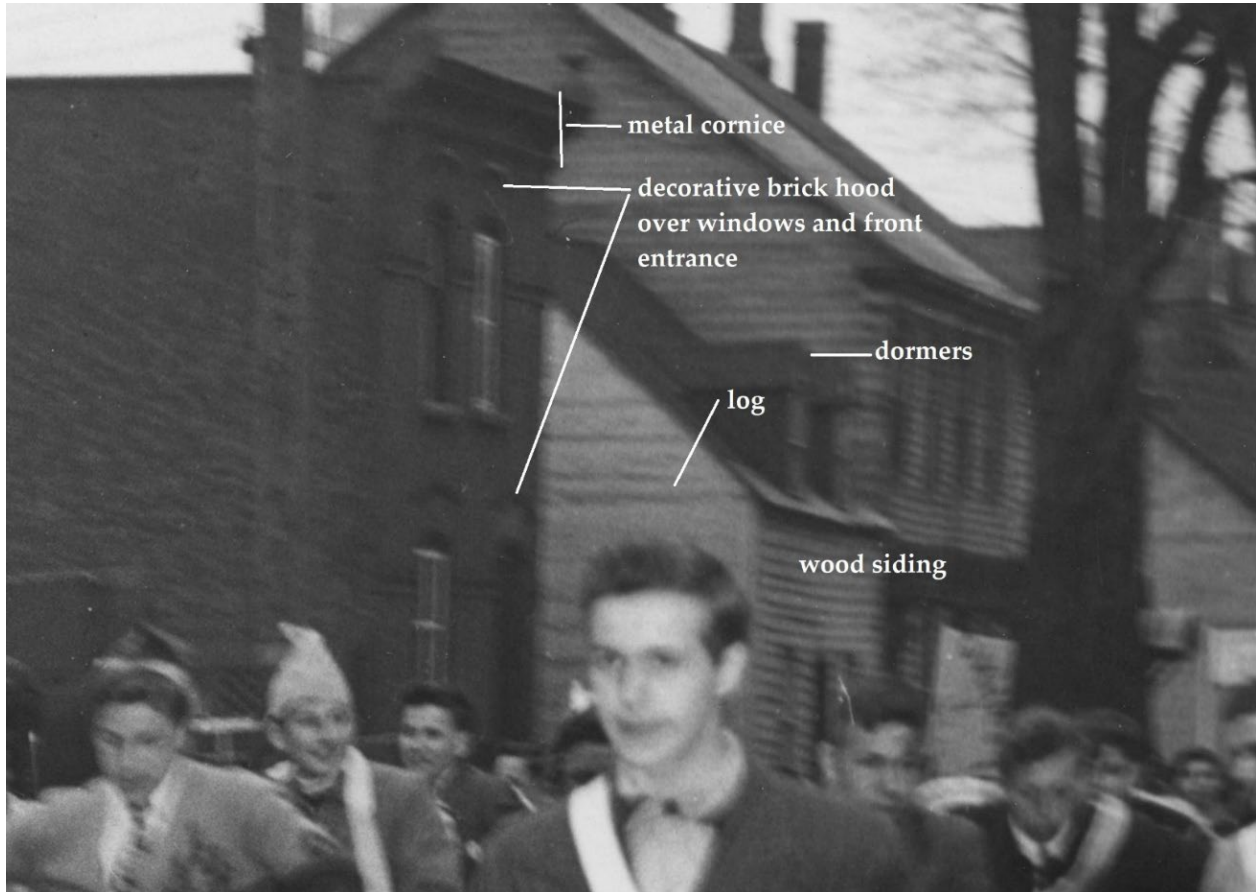
Figure 11: A c.1949 photograph clearly documents the 2-storey brick siding of 174 Murray Street with its off-set door and decorative arched headers over the door and windows. The cottage form of the neighbouring 168 Murray with the textured log sidewall of squared log. The log has been covered over on the front façade with a horizontal siding. Source: Marc Aubin's collection
