# **TREE CONSERVATION REPORT V5.0**

**6600 Rue Carrière**

Tree Conservation Report prepared as Partial  
Requirements for a Site Plan Control  
Application, September 11, 2025

**Dendron Forestry Services**

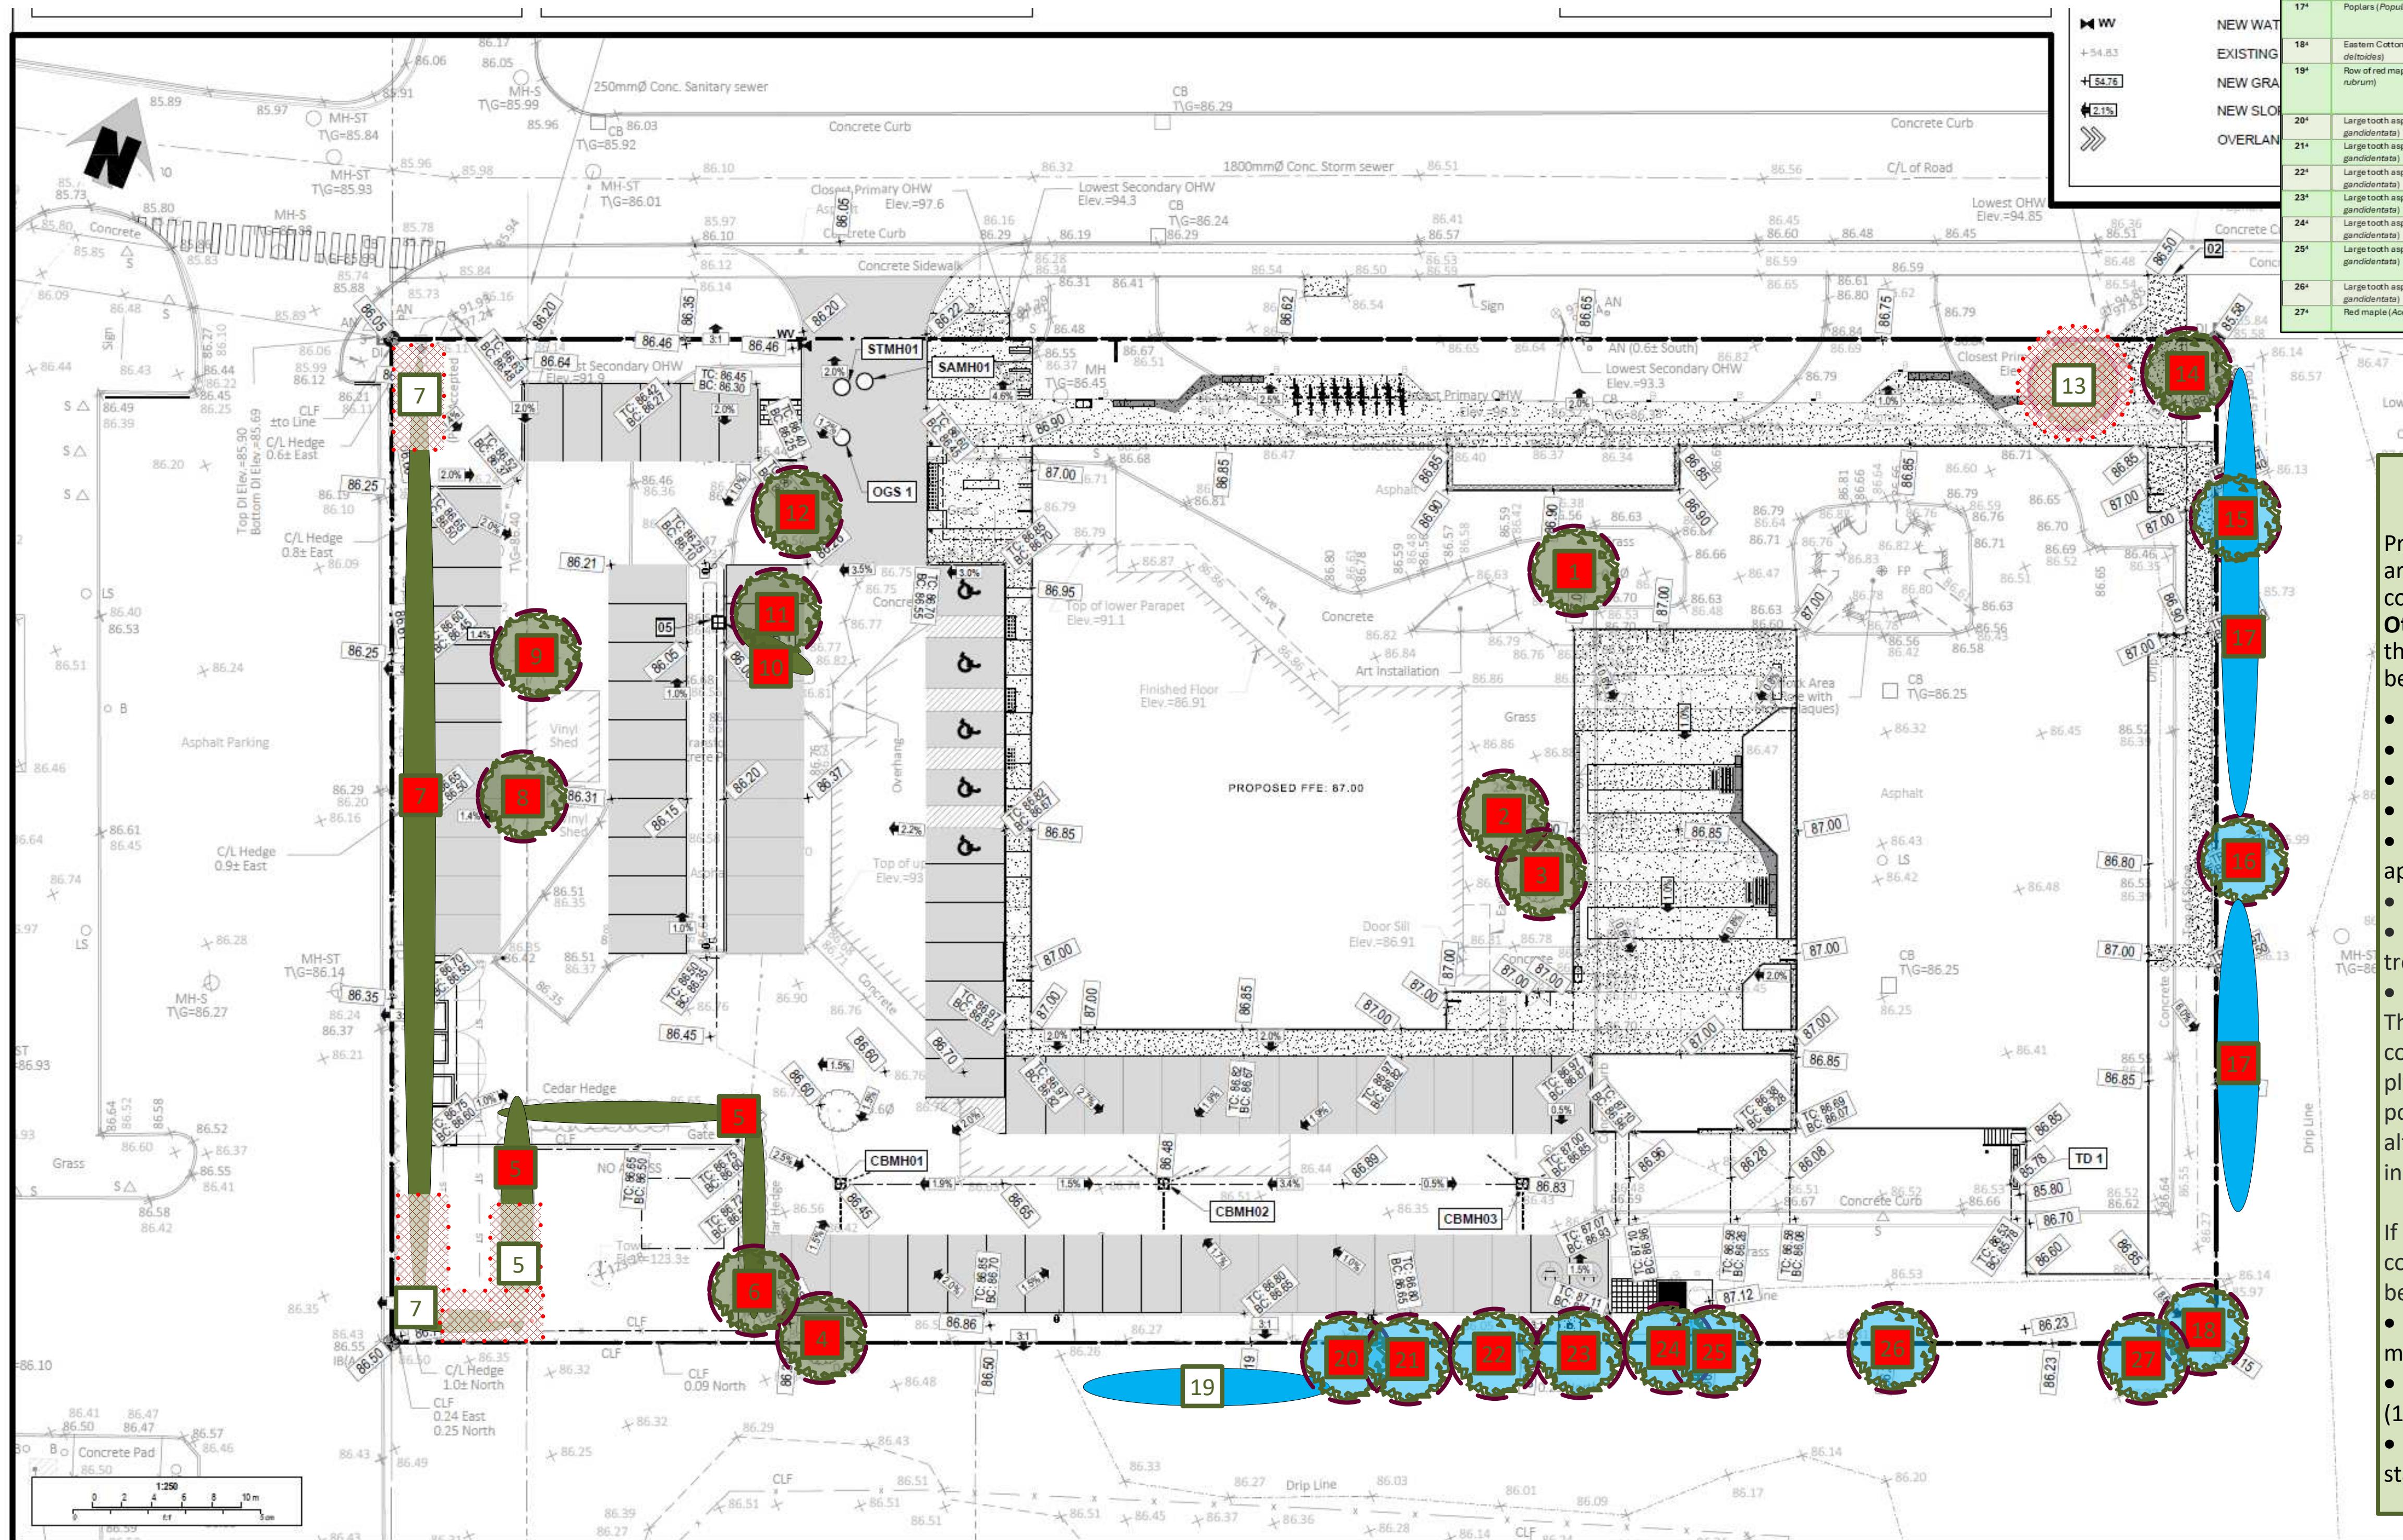
## Recommended Tree Protection Fencing Area

Details on the grading plan were lost when the pdf was imported, see original plan for details on grading and servicing.

Locations of trees 14-26 were estimated using the survey plan

er to any site works, protective fencing should be installed around the trees as indicated in Map and maintained until all construction on site has been completed as per the **City of Anoka Tree Protection Specifications (March 2021)**. Within fenced area, the following tree protection guidelines should be applied:
