Report

Trail Road Battery Energy Storage System (BESS)  
Fluvial Geomorphology Assessment

H375035-0000-2B0-066-0001

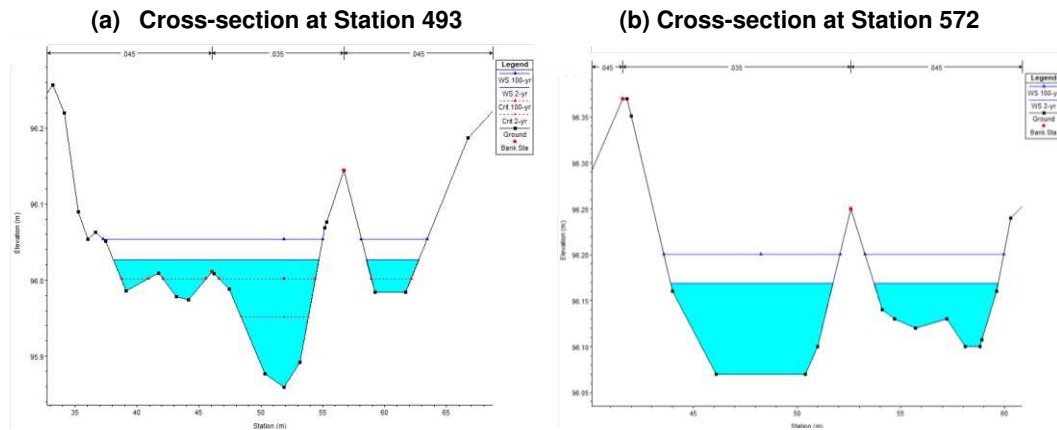
**Figure 4-2: Cross-sections with Critical Flow for 2-year and 100-year Storm Event**

The Hydraulic Analysis was performed for the 2-, 5-, 10-, 25-, 50-, and 100-year events. A Manning's 'n' coefficient of 0.035 was selected for the Creek channel, and 0.045 for the Creek banks based on vegetation and surface conditions following City of Ottawa Sewer Design Guidelines. The floodplain is covered with a heavy mix of vegetation on both banks (Figure 4-4). A summary of HEC-RAS hydraulic results is provided in Appendix C. A normal depth boundary condition was applied at the downstream end, based on the slope of 0.010011 which aligns with the hydraulic gradient line for the 100-year flow event at the downstream cross-section. Note that the flow in the cross-sections is subcritical ( $F_r < 1$ ) for all storm events except for one cross-section at station 460 is supercritical ( $F_r > 1$ ). Figure 4-2 shows the water levels in two cross-sections for 2-year and 100-year storm events.

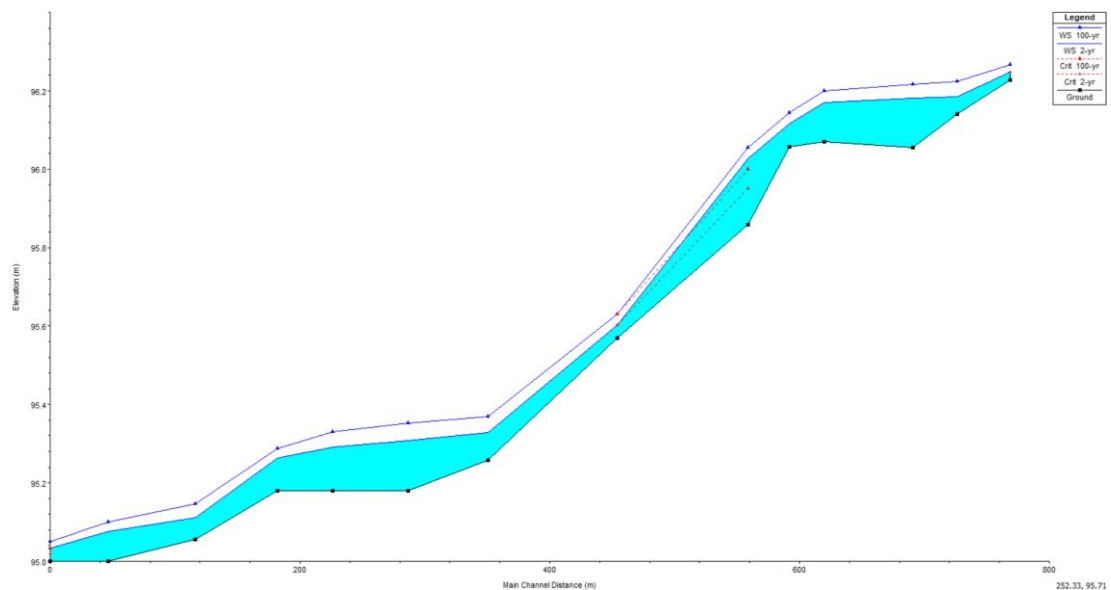
**Figure 4-3: Trail Road Creek Profile for 2-year and 100-year Storm Events**

Figure 4-3 shows the Creek profile for 2-year and 100-year storm events.

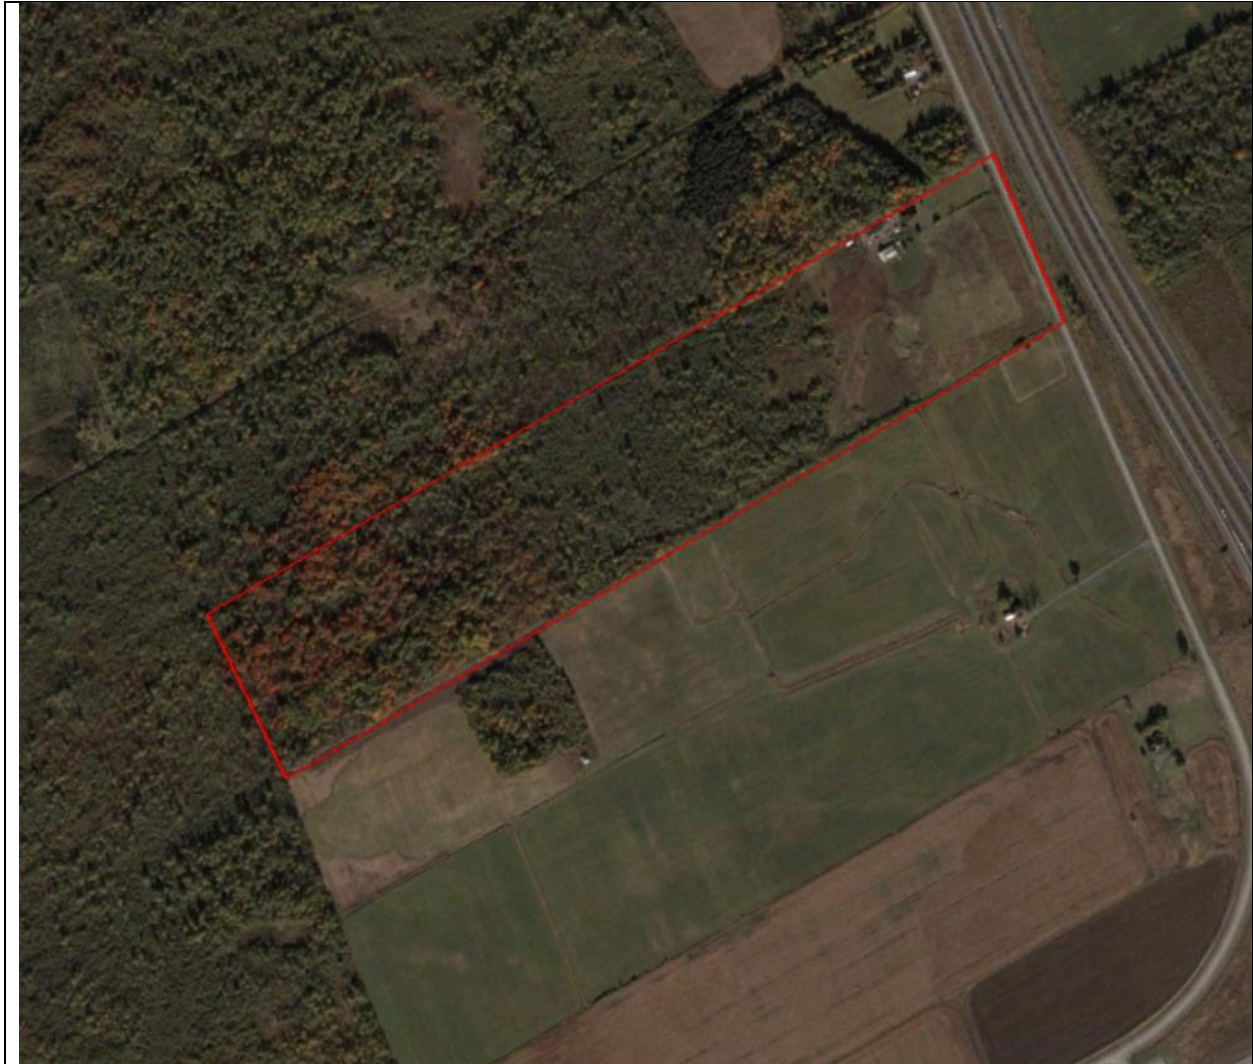
**Location:** Ottawa, ON  
**Year:** 2002  
**Scale:** 1:14,000  
**Source:** Google Earth Pro  
**Red Boundary:** Site Limits

Between 2002 and 2004, the watercourse is present in good condition, with no observable changes compared to the 1954 aerial photography. The surrounding land use appears unchanged.

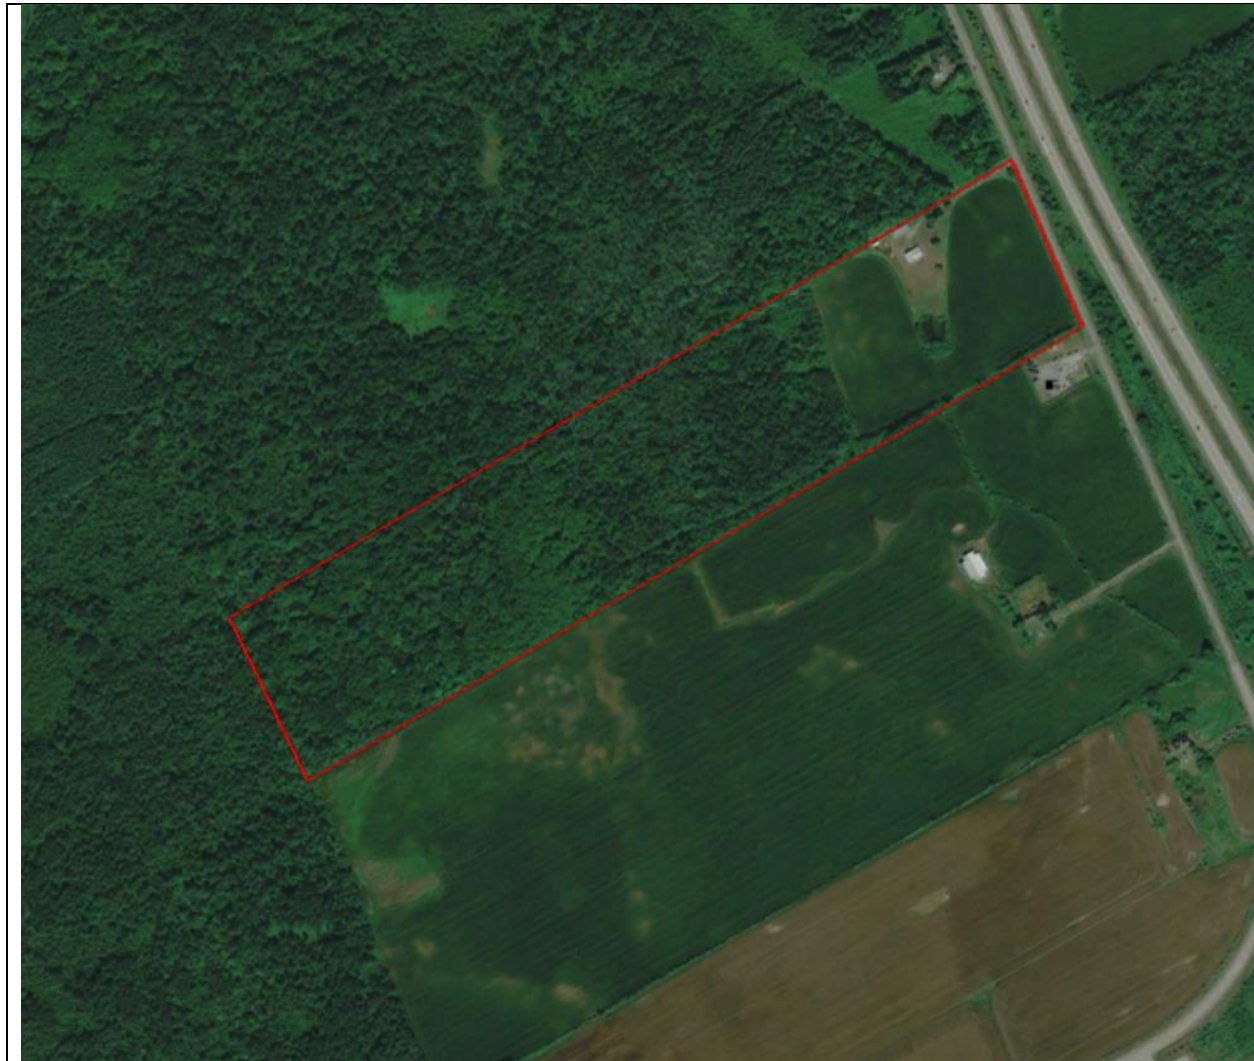
**Location:** Ottawa, ON  
**Year:** 2020  
**Scale:** 1:14,000  
**Source:** Google Earth Pro  
**Red Boundary:** Site Limits

By 2020, the constructed banks are no longer visible, and the condition of the Creek continues to degrade through to 2024. In general, the Creek within the Project site follows a straight alignment; however, no visible changes to the planform of the tributary are observable in all aerial imagery due to tree cover.

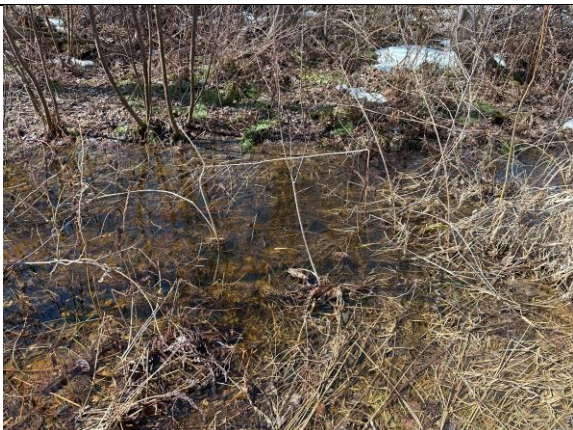
**Photo 17:** Side view at location S8 (Figure 3-1) on April 7, 2025.

In several locations, including the area shown at location S8 (Photo 16 in Appendix B), evidence of localized channel adjustment and planform variability was observed. The Creek exhibits minor sinuosity, with lateral deflections of the low-flow channel that suggest active, albeit limited, fluvial processes. These deviations in flow alignment are likely the result of small-scale bank erosion and scour occurring along the outer margins of emerging meander features. While the degree of meandering is minimal due to the confined nature of the corridor and limited stream power, these features may represent the early development of a meander belt within the system.
