Preliminary Geotechnical Investigation

Proposed Residential Subdivision
1154-1208 Old Montreal Road
Ottawa (Formerly Township of Cumberland), Ontario

OTT-00234493-A0

November 7, 2016

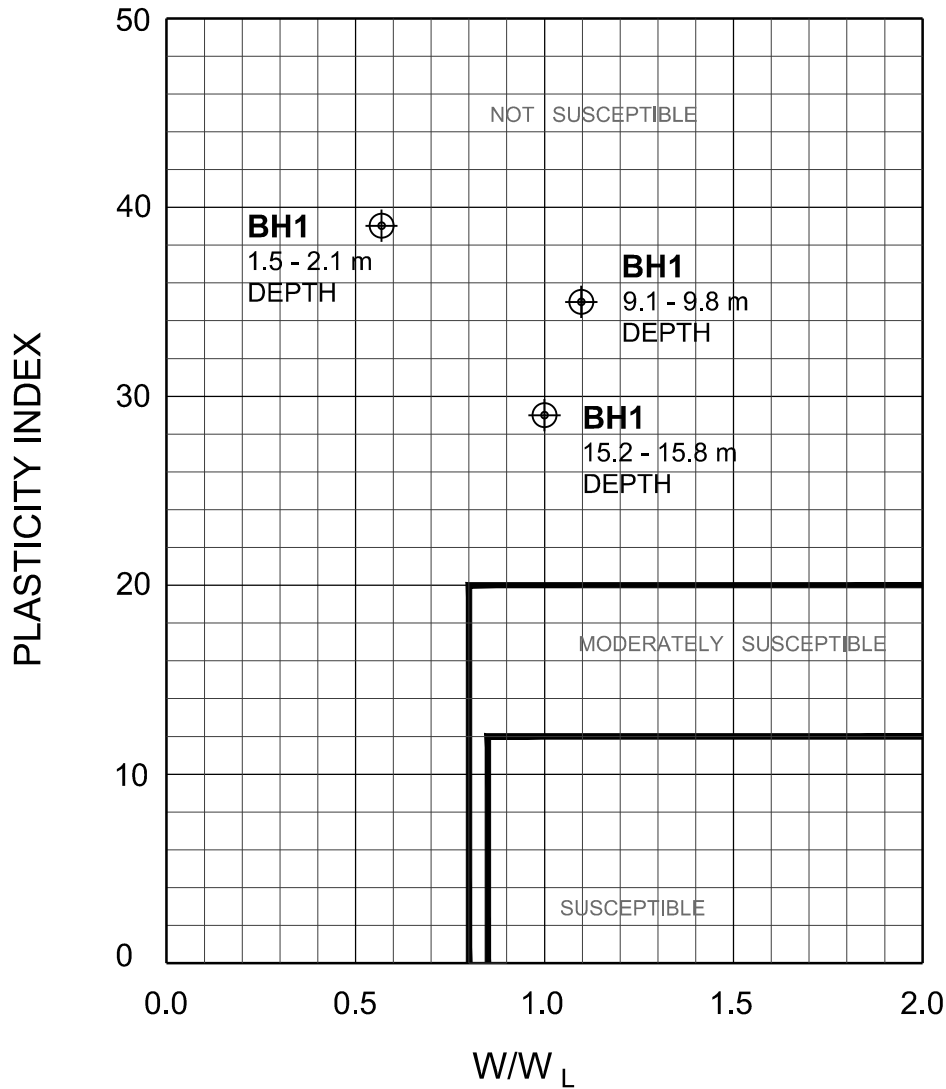
scale	N.T.S.	CLIENT: DCR PHOENIX GROUP OF COMPANIES	project no.	OTT-00234493-A0
date	OCT. 31, 2016	TITLE: PRELIMINARY GEOTECHNICAL INVESTIGATION	FIG 17	
drawn by	M.N.	1154 - 1208 OLD MONTREAL ROAD, OTTAWA, ON

The liquefaction potential of the clay on the site was assessed by plotting the results of Atterberg Limit Tests on Bray et al plot. A review of this figure (Figure 17) indicates that the clay is not susceptible to liquefaction during a seismic event.
